DOLOMITE RELATED RISK MANAGEMENT  
AT THREE TAILINGS PUMPSTATIONS  
AND ROUTES - VAAL RIVER OPERATIONS

REPORT NO : FWA 02/17/393

6 February 2017

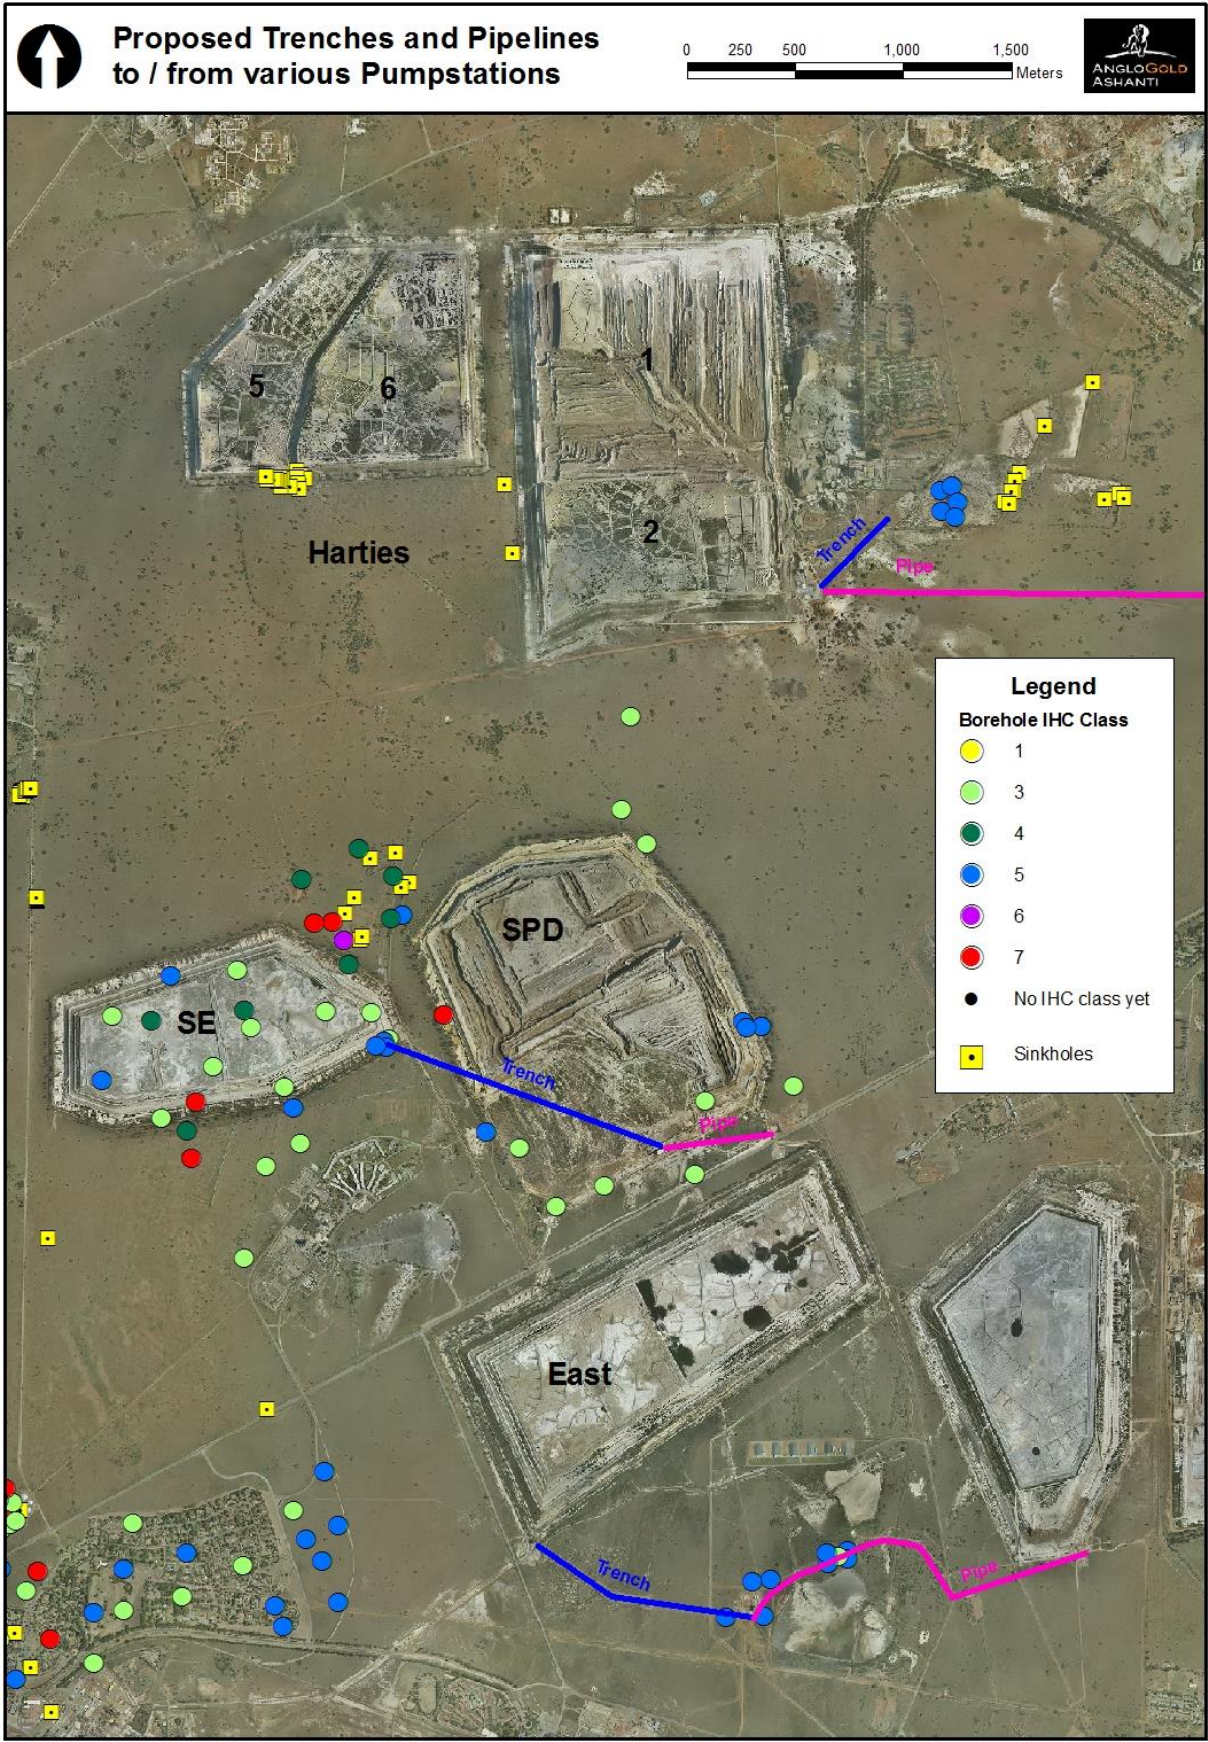
APPENDIX 1  
GIS DATABASE INFORMATION AVAILABLE  
IN THE AREA.

A map showing proposed Trenches and Pipelines, included in Appendix 1, show the locations of the abovementioned three facilities in relation to the positions of existing sinkholes as well as the positions of boreholes for which inherent hazard assessments have been prepared as part of Subtask 2 of the Hazard Study at Vaal River Operations. Each of these are discussed separately below.

The area east of these Harties TSF's has previously been used for the storage of storm and excess return water decanted from the TSF and was known as the "paddy fields". This has triggered a large number of sinkholes in locations as shown on the area map. In addition some of the sinkholes have been infilled with tailings and are thus not shown. Continued ponding of storm water will result in more sinkholes. In addition any leaking tailings conveyance will trigger sinkholes on this particular Formation on the dolomite.

Sinkholes occurred in the SPD when the TSF was originally commissioned. In addition seven sinkholes exist towards the north of the SE TSF. These were triggered in the past when water accumulated in old borrow areas.

In general terms therefore the dolomite hazard class assigned to the area on which the facilities are located is IHC 3, 5 (7) // 5. Prior knowledge suggest that alluvium/colluvium/ residuum should generally be thin and with bedrock near surface, but some boreholes suggest that significantly deep slot structures are present (those assigned IHC 7 on the plan in Appendix 1). These slots are able to generate up to large sinkholes. The water table at

From the above it is apparent that the facilities are located on dolomite land with a high hazard for generating small, intermediate and large sinkholes upon ingress of water. It is therefore imperative that these facilities be designed so as to be watertight and that it be operated and maintained with this requirement in mind.
