# **MPONENG MINE TAILINGS STORAGE FACILITY LOWER COMPARTMENT GEOTECHNICAL INVESTIGATION**

Report No. P134-01

Title : Mponeng Mine - Tailings Storage Facility Lower  
Compartment: Geotechnical investigation

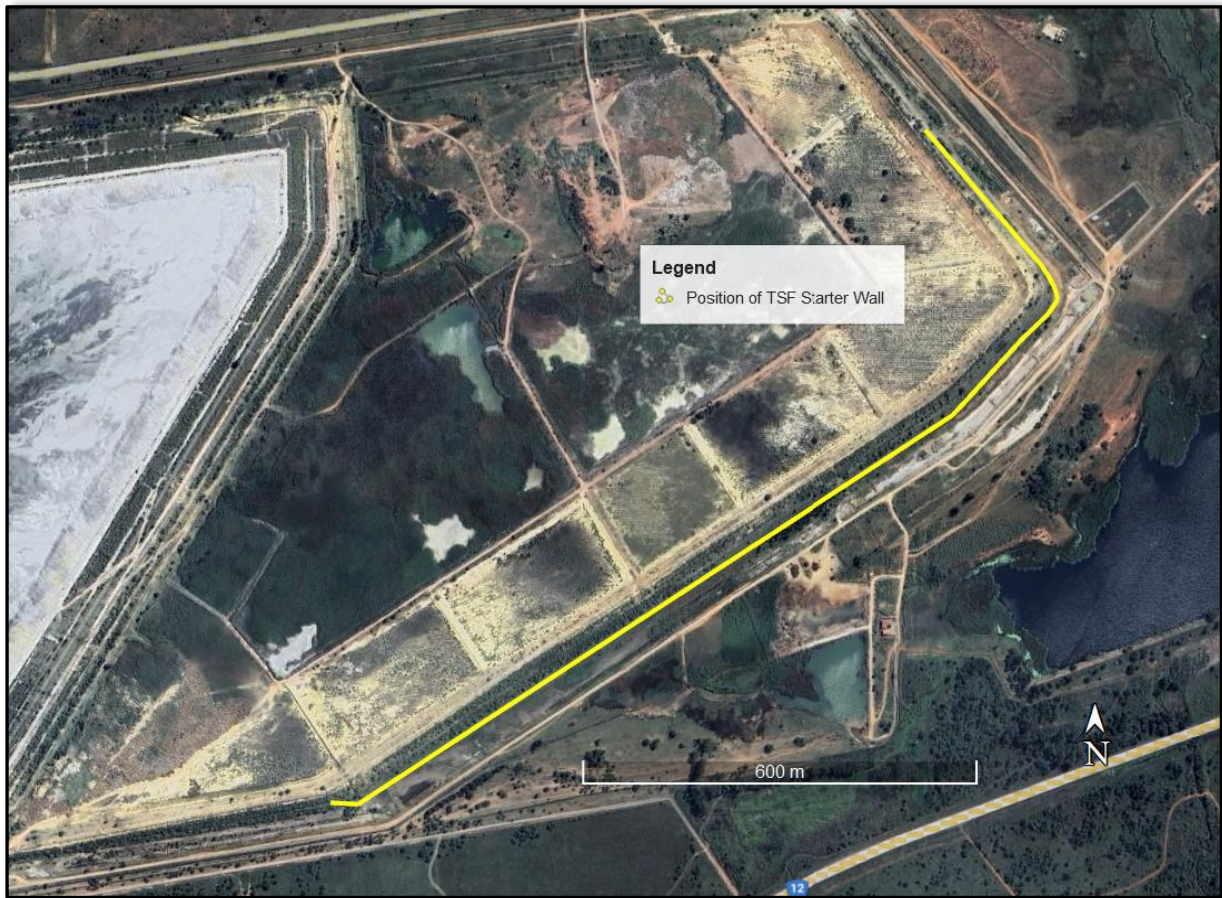
**Figure 12. Position of TSF Starter Wall**

During the site fieldwork an inspection on the downstream starter wall was made. The starter wall appears to be constructed along the south-eastern to southern embankment of the TSF, which is indicated in **Figure 12** below:

- Lastly, a large pool of seepage was noted on the downstream corner of the starter wall (south-eastern corner), which indicates that seepage does occur, either from the catchment area of the lower compartment, or along bedrock originating from the intersection of lineations.

- Test pit excavations along the foundation of the starter wall, to determine whether the structure was placed on bedrock.
- Rotary cored geotechnical boreholes, to determine the foundations conditions across the TSF footprint, especially within the eastern and southern portions of the TSF and to understand the potential seepage source.
- Additional boreholes are required on the starter wall.
- CPTu penetration tests to determine the in-situ strength of the tailings materials with depth, as well as to provide supplementary information regarding the seepage levels and depths within the TSF storage area.

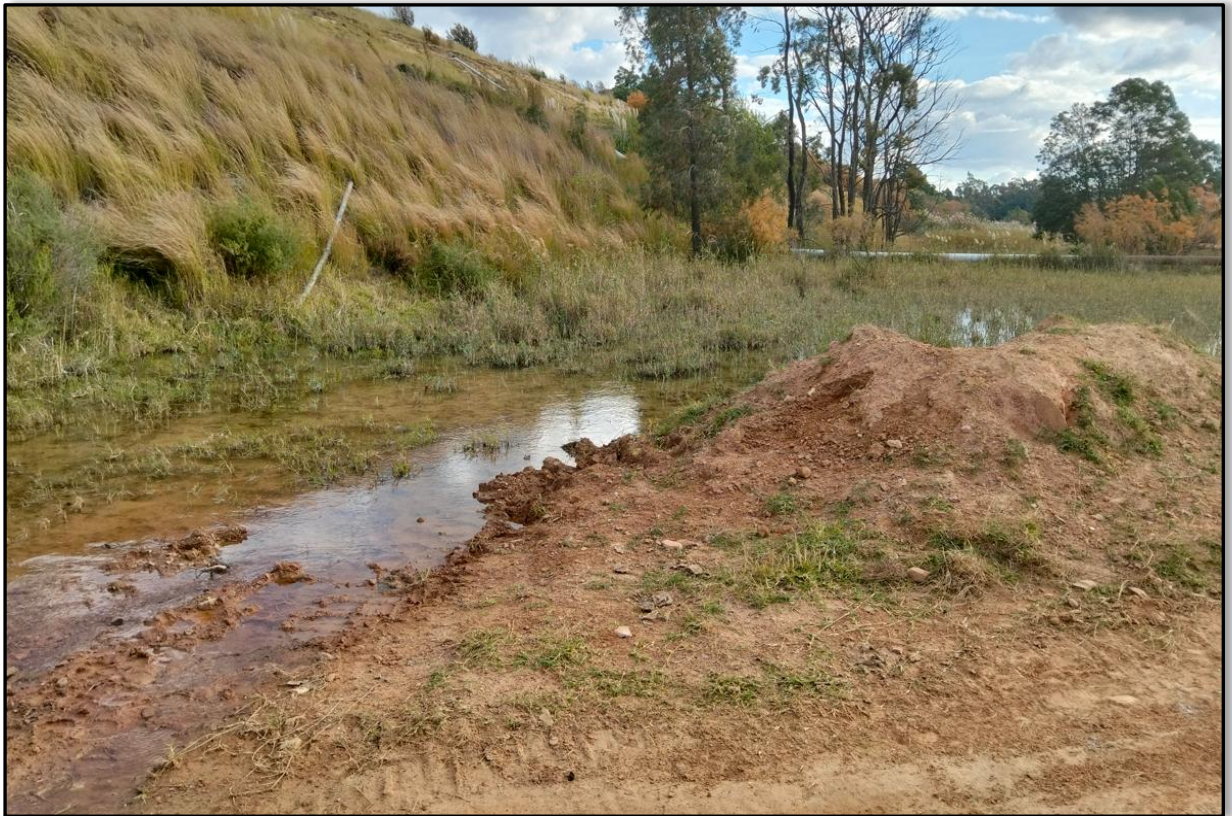
Abundant seepage is present at the entrance to both the lower compartment and the landfill site (plates 2 to 4). As discussed in Section 4, the “Mponeng Spring” is located near the entrance to the lower compartment and presumably flows into the clean water storage dam (indicated in Figure 3). Localised seepage, potentially originating from the upper compartment, was encountered along the toe of the embankment (plates 5 & 6), although this may be from seepage along bedrock from the spring.

Plate 2. Water seepage at the lower compartment entrance.

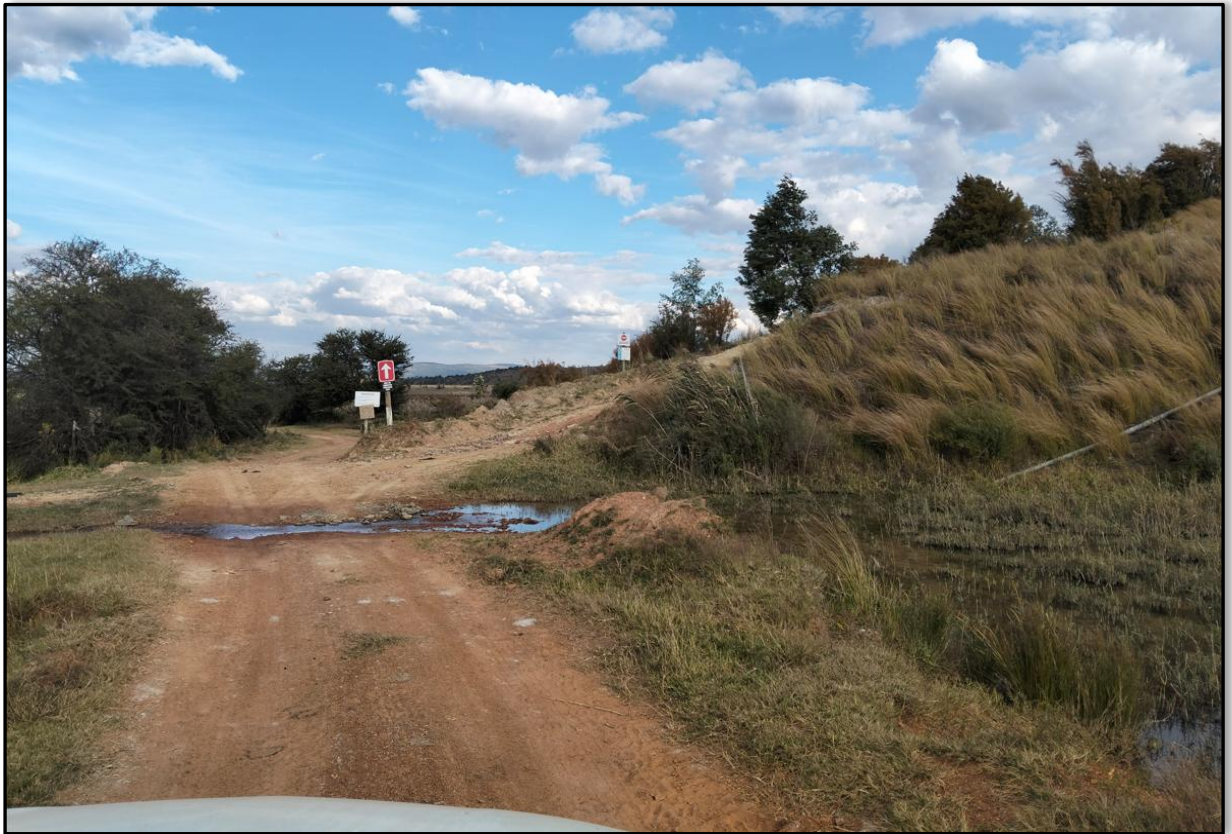
Plate 3. Groundwater seepage outside the TSF at the lower compartment entrance.

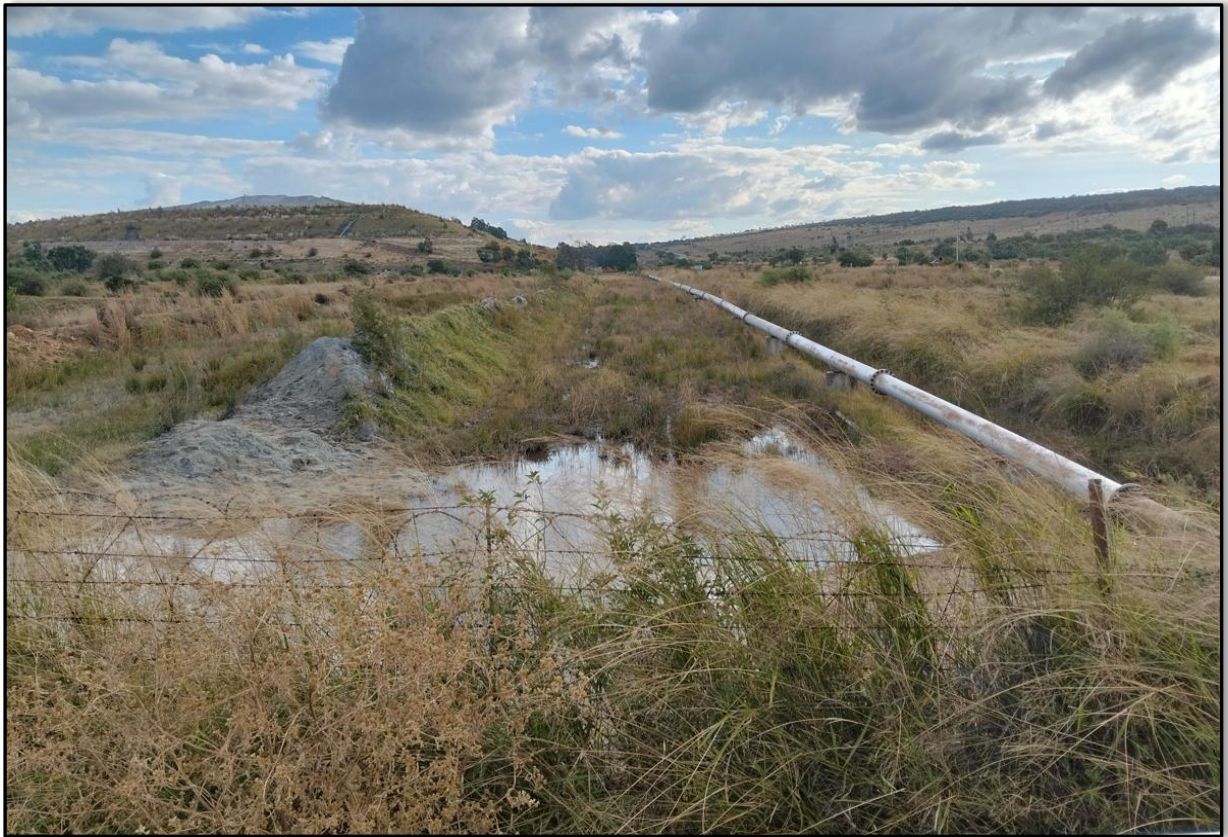
Plate 4. Water seepage the entrance to the solid waste landfill site, in a western direction.

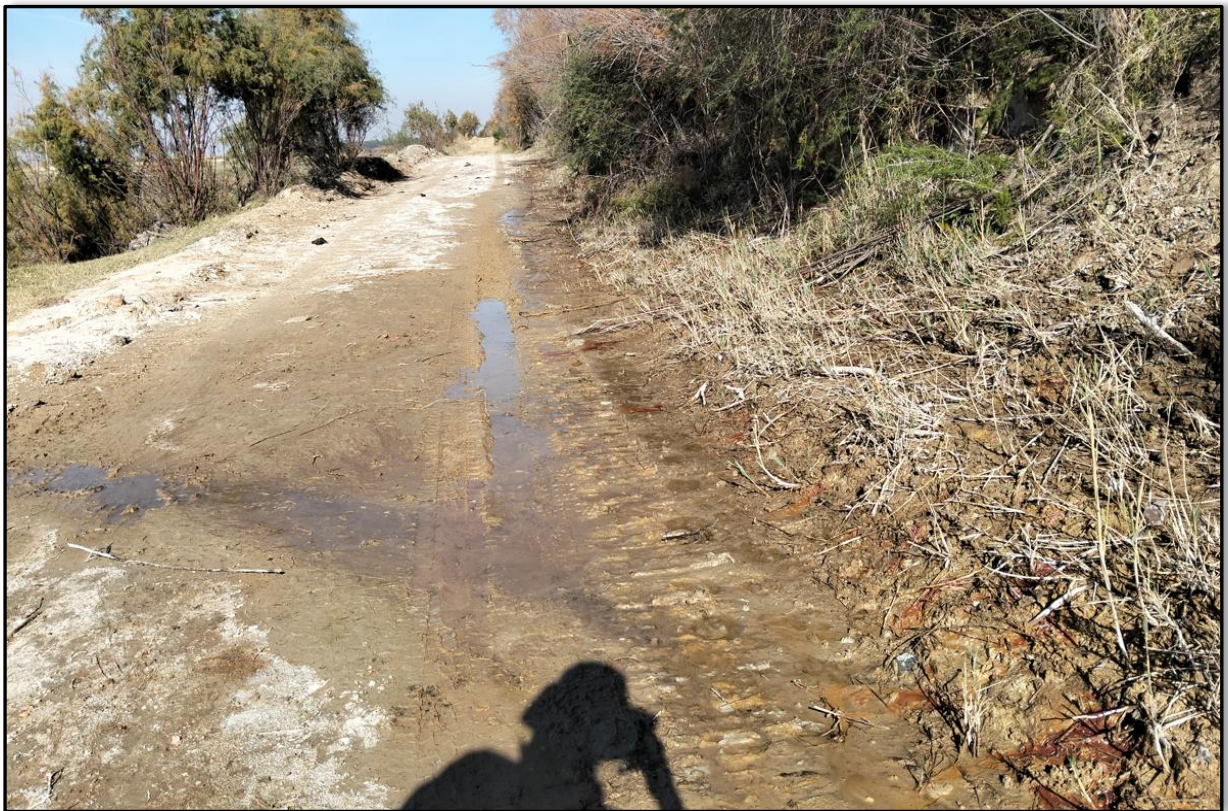
Plate 5. Seepage along the toe of the upper compartment embankment near test pit TP32.

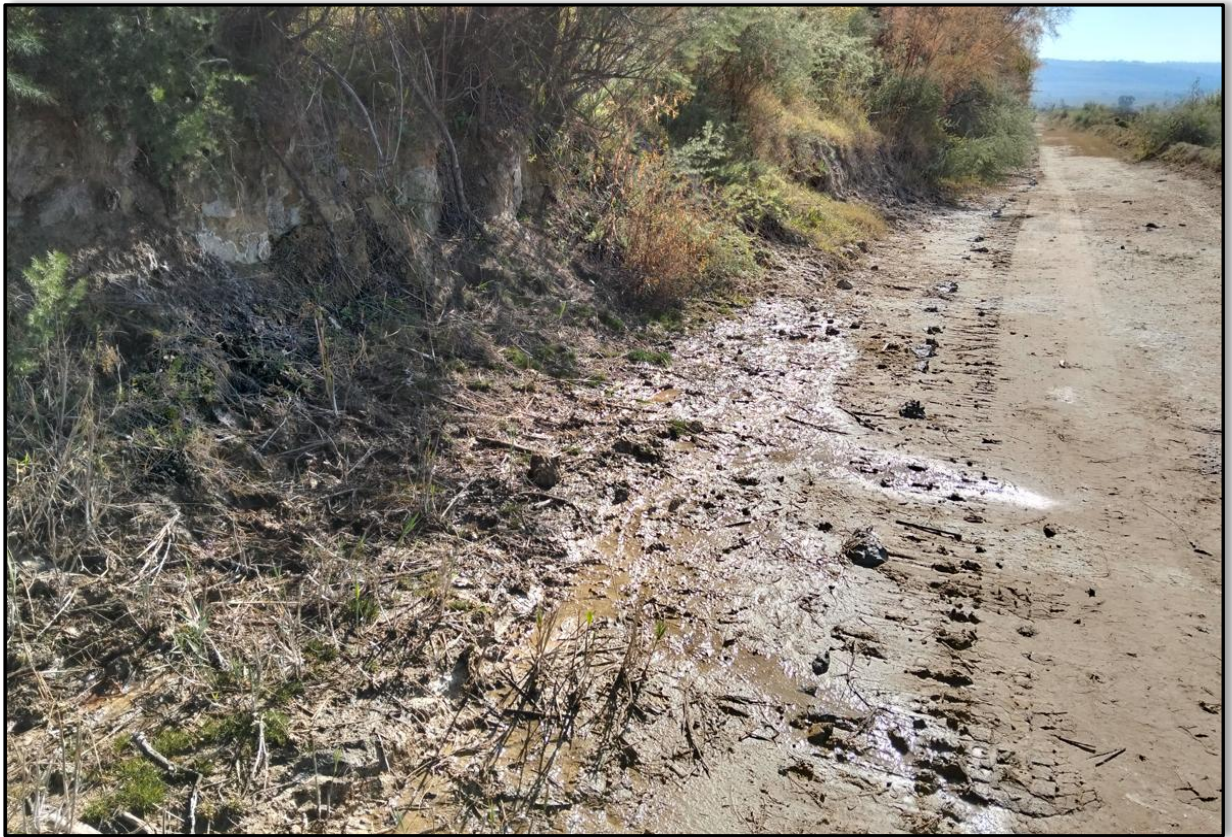
Plate 6. Seepage along the toe of the upper compartment embankment near test pit TP32.

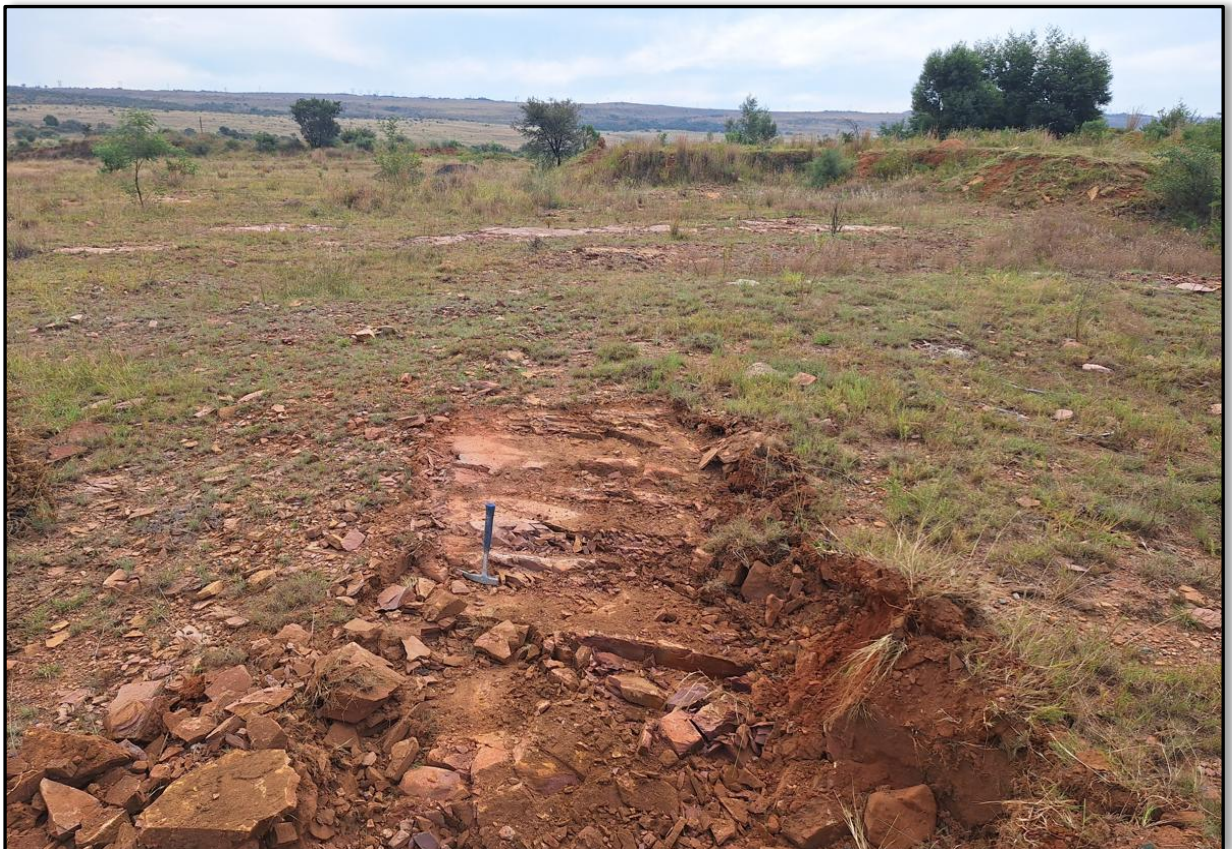
Several bedrock outcrops (plates 7 & 8) were noted in the northwestern portion of the site, between the landfill site and the area used for clean water storage. The eastern portion of the landfill hosted significantly more waste material (plate 9) as opposed to the western portion (plate 10).

Plate 7. Shallow bedrock with outcrops at test pit TP23.

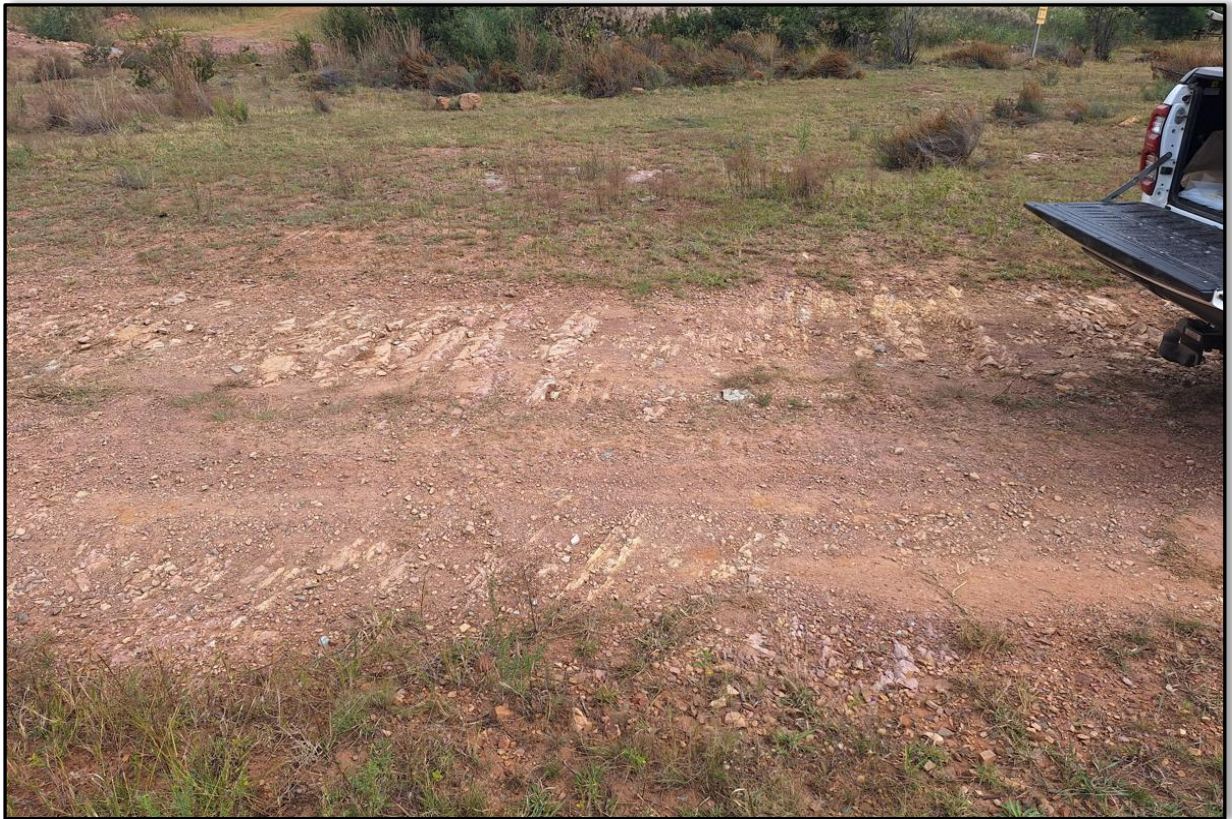
Plate 8. Bedrock outcrop located south-east of test pit TP23

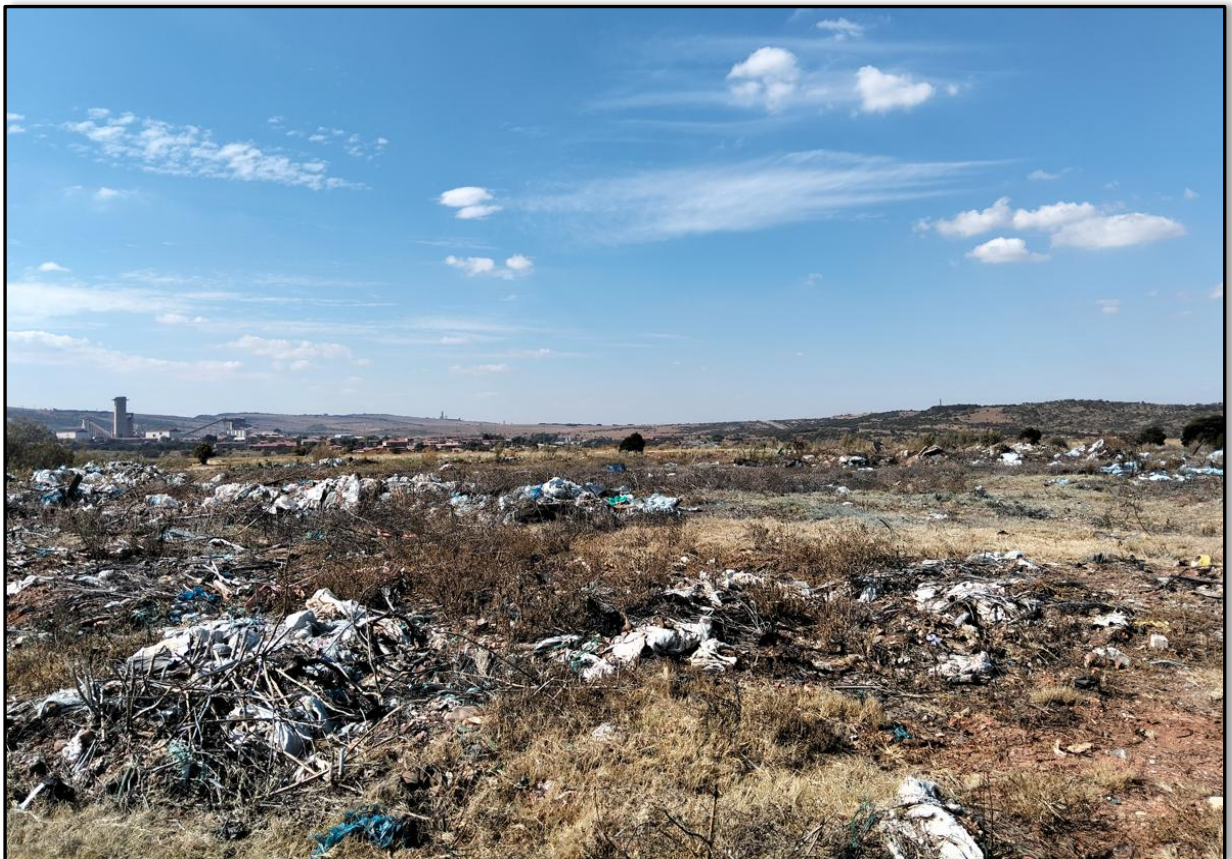
Plate 9. Dumping at the Solid Waste Landfill Site.

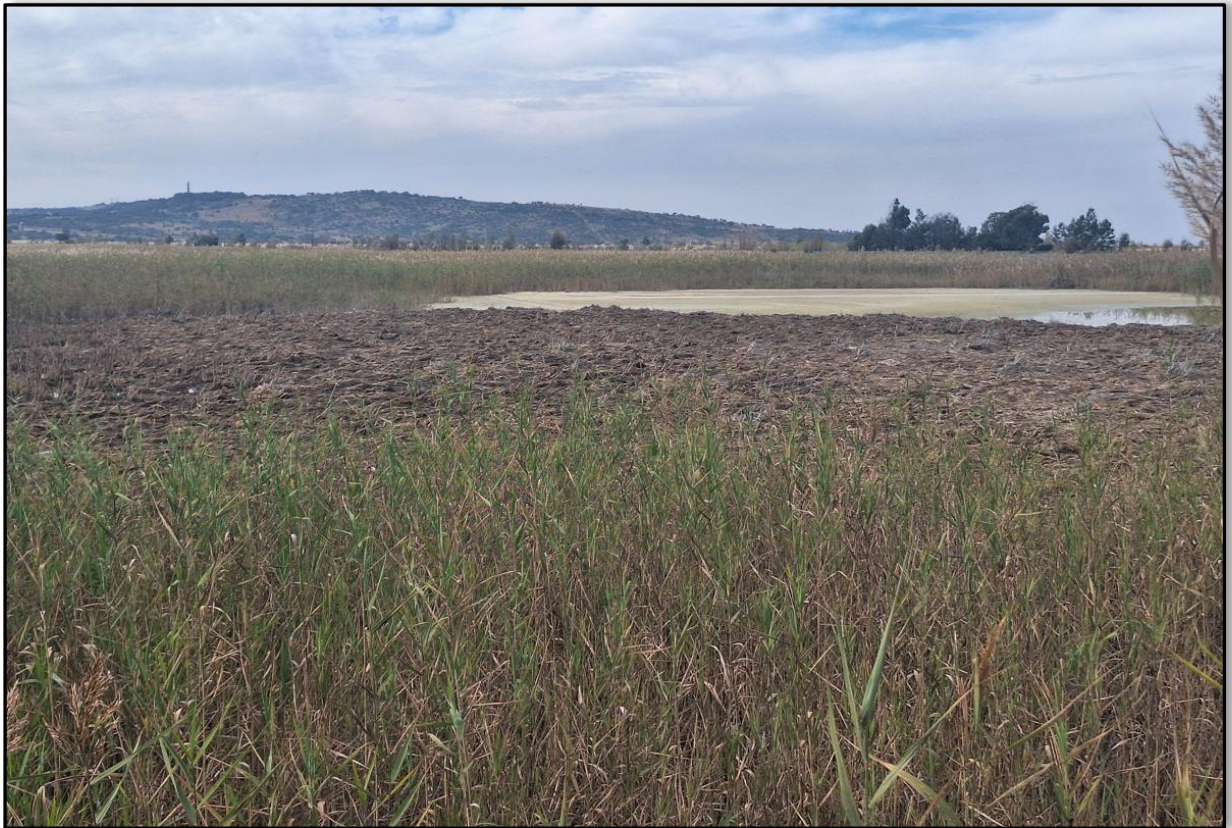
The area located south of the landfill was dry but hosted dense hydrophilic vegetation (plates 14 & 15), whilst wet and marshy conditions were encountered directly east of the dirty water dam (plate 16 & 17). The dirty water dam was mostly covered with reeds (plate 18), and water was only visible in localised areas (plate 19).

Plate 16. Marsh Conditions east of the dirty water dam as viewed from test pit TP25.

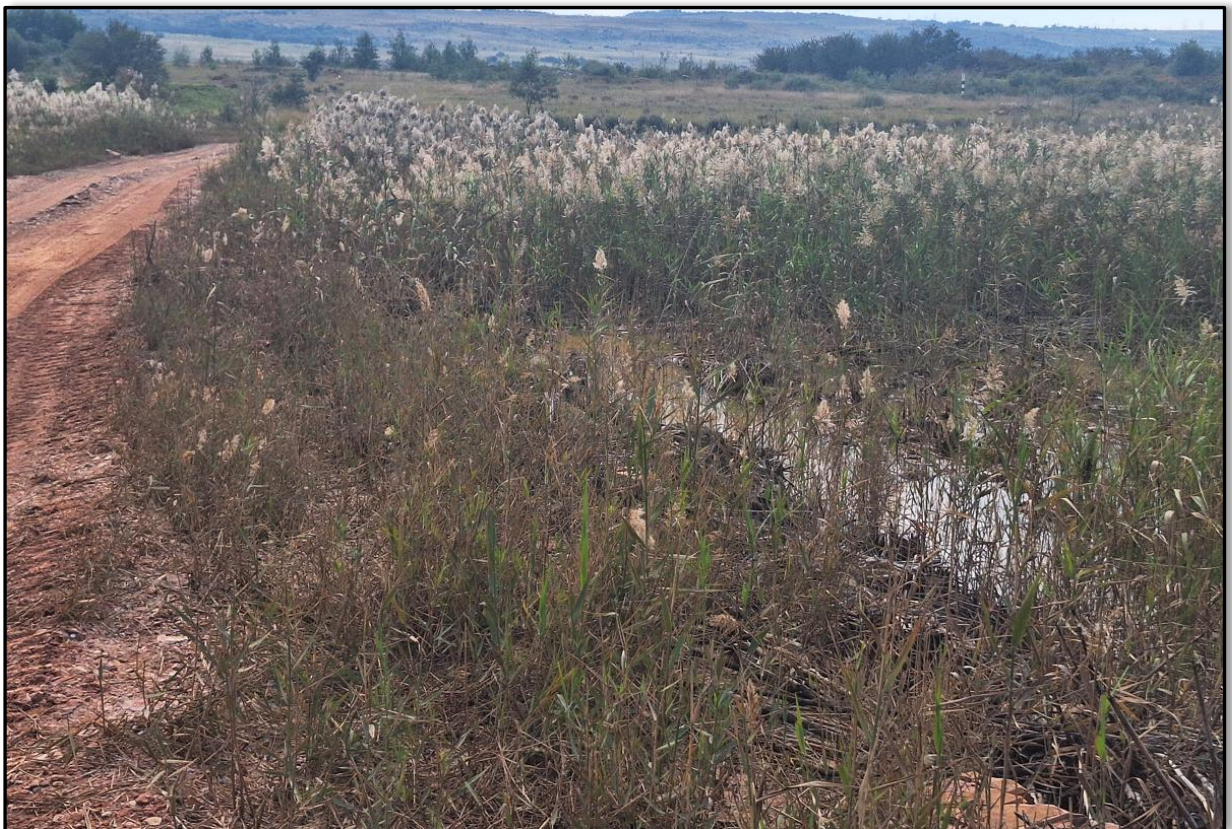
Plate 17. Wet Conditions east of the dirty water dam as viewed from test pit TP25.

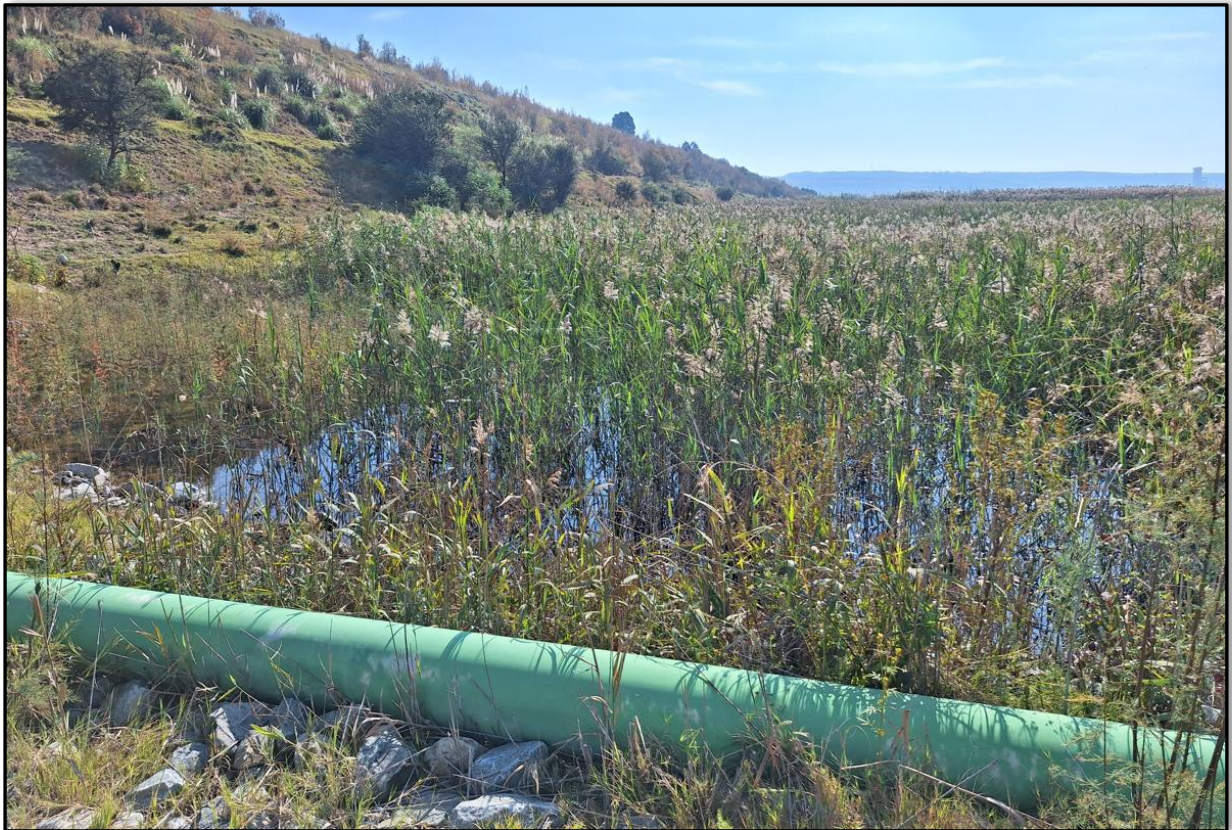
Plate 18. View of dirty water dam from test pit TP1 facing north.

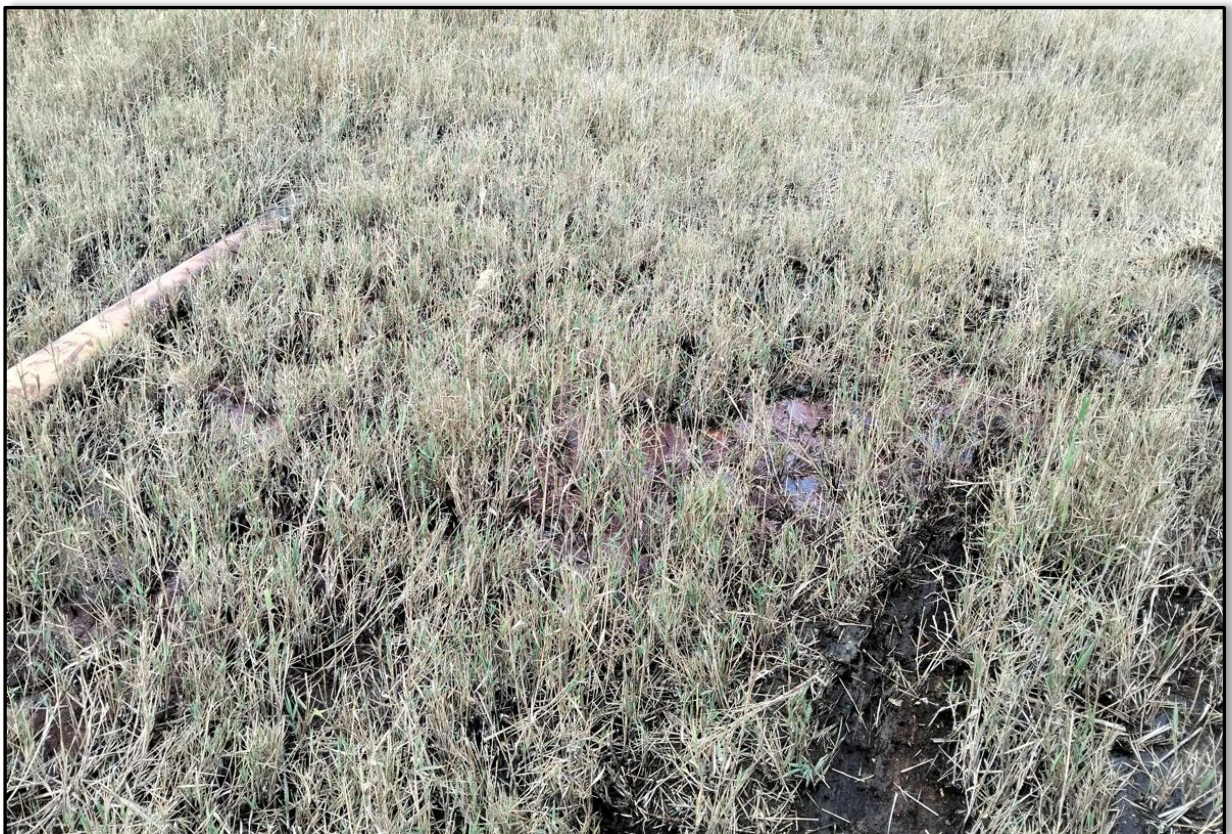
The area between the clean and dirty water dams was also saturated and covered with grass and hydrophilic vegetation (plate 24 & 25). An inspection was conducted along the south-eastern embankment of the lower compartment to determine the extent of the starter wall, viewed in plates 26 to 28. This will be described in detailed in the results. Abundant seepage was noted at the toe of the starter wall at the south-eastern corner (Plate 29).

Plate 25. Old pipe and saturated conditions adjacent to test pit TP32.

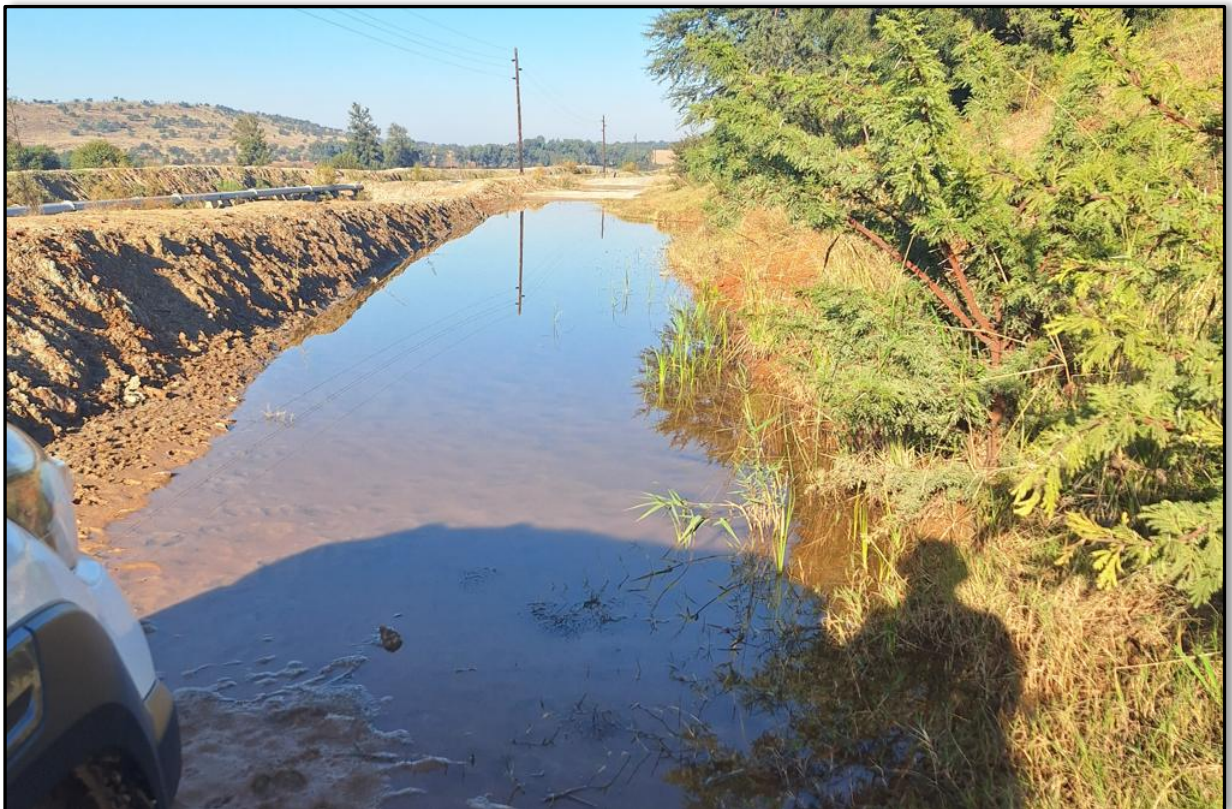
Plate 29. View of abundant seepage below the starter wall at south-eastern embankment.
