Harmony Mponeng- TSF Spring Hydrogeological Investigation (PHASE 1)

Version - Final

14 April 2025

GCS Project Number: 24-0660

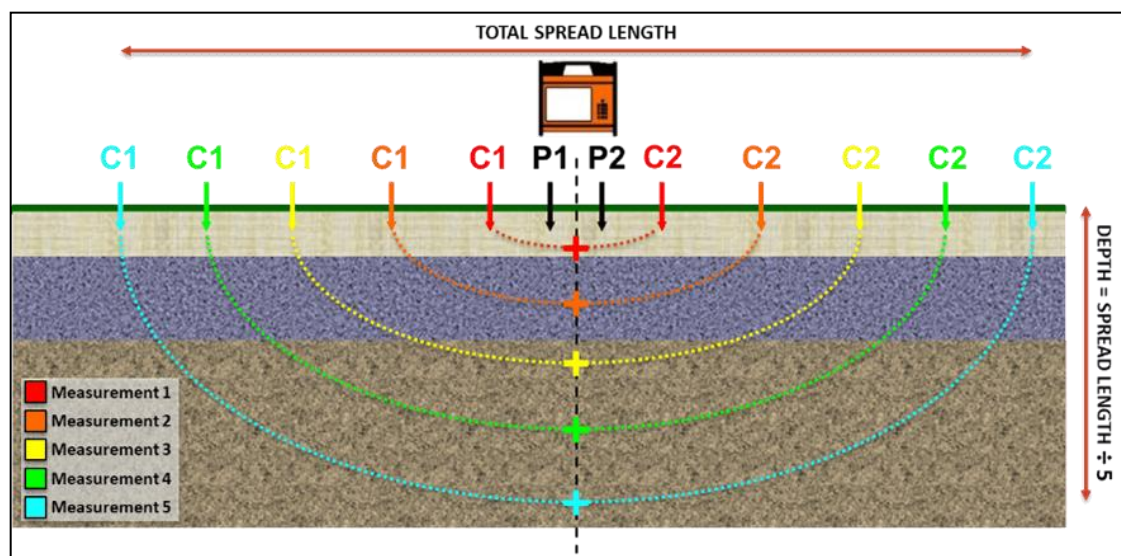
Figure 3-1: Typical Resistivity Electrode Array Setup (Guideline Geo, 2024)

ERT is a process in which electrical current is introduced into the subsurface and measured at various points using an array of electrodes embedded into the ground surface. By varying the spacing between the point at which current is introduced, and the point at which the resistance is measured, different observation depths are achieved. The result is a 2D pseudo section or “slice” of the sub surface’s apparent electrical resistivity. This can help identify groundwater, contaminants and subsurface layers by their electrical resistivity signature.

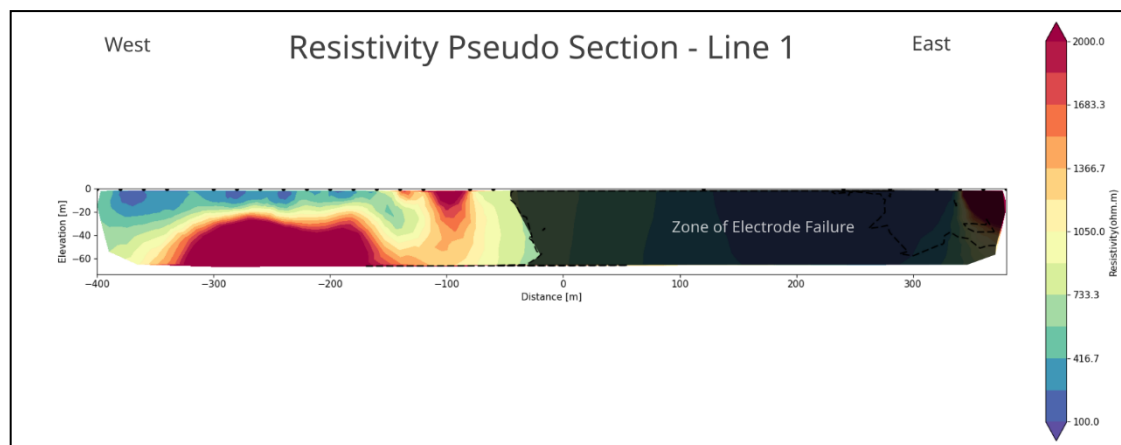
Line 1 (Figure 4-1) is 800m long and located upgradient of the TSF and the seepage/spring area. In general, the resistivity of the area is very high (ranging from 100 Ohm.m to 2000 Ohm.m and upwards). Several electrodes failed directly within the suspected flow path of the spring. This indicates that the area has extremely high resistance, with the subsurface behaving as an electrical insulator. The zone of failure was investigated with a second electrode array (200m), and all electrodes failed in this area, ruling out the possibility of equipment failure.

Figure 4-1: Pseudo Section (Line 1)

Line 1 indicates a more resistive profile (maximum readings of 2000 Ohm) than line 2 (maximum readings of 235.2 Ohm) and line 3 (max reading 1195 Ohm). Line 2 and 3, which are located downgradient of the Mponeng TSF both have less resistive profiles than line 1, which is located upgradient of the Mponeng TSF. Resistivity is lowered both by the solute content, and presence of groundwater in the subsurface. The results therefore indicate that shallow groundwater is present on the eastern toe slope of the TSF.

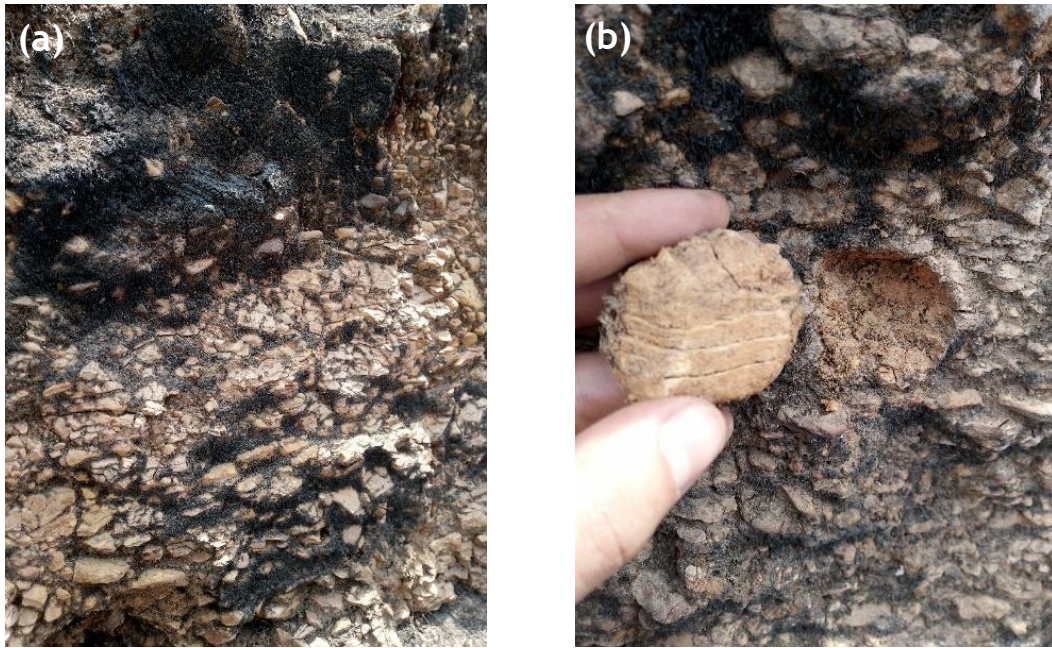
Due to the electrode failure, the shallow interception trench upgradient of this zone was inspected. Results revealed dry, weathered mudstone from very shallow depths. The dry mudstone particles and the air pockets between them are believed to be the cause of the electrode failure (refer to Figure 4-2).

Figure 4-2: A profile of the geology upgradient of the spring (a), and a close view of the mudstone clasts (b) the material is expected to have low infiltration potential.

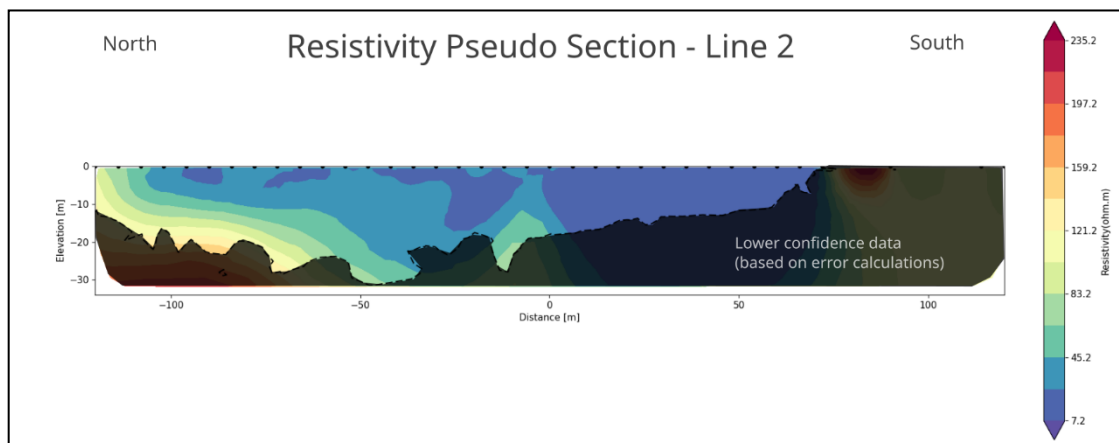
Line 2 (Figure 4-3) is 200m long and located directly between the TSF and the area of seepage/spring flow. The resistivity in this zone trends from 7 Ohm.m to 50 Ohm.m and is much lower than was observed at line 1. This can be the result of elevated salt ions in the TSF material underlying the array. It is likely that this zone could be the result of toe seepage migrating under the TSF.

Figure 4-3: Pseudo Section (Line 2)

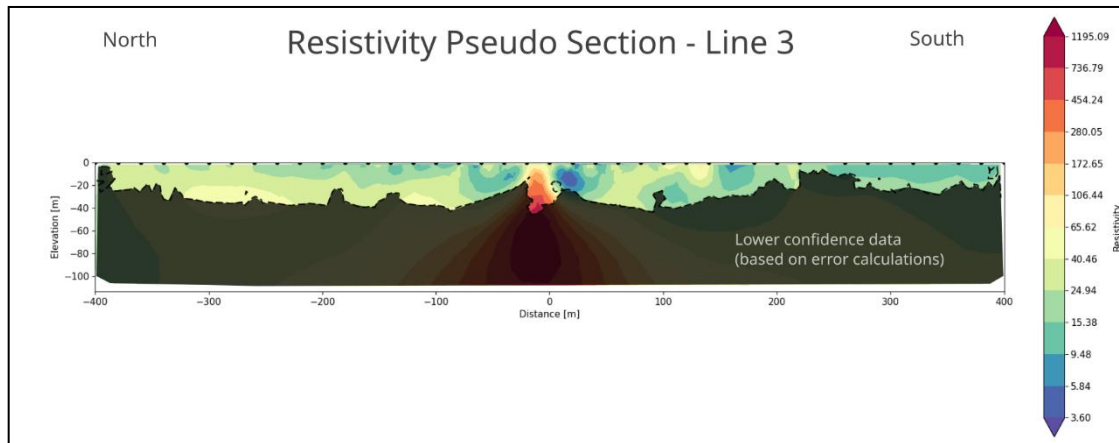
Line 3 (Figure 4-4) is 200m long and located further south on the boundary of the TSF. The results indicate similarly low resistivity values in the range of 7 to 60 Ohm.m. a high resistivity (1200 Ohm.m) is present around the center of the survey line. This is likely caused by high resistivities on the contact zone between the two underlying lithologies.

Figure 4-4: Pseudo Section (Line 3)

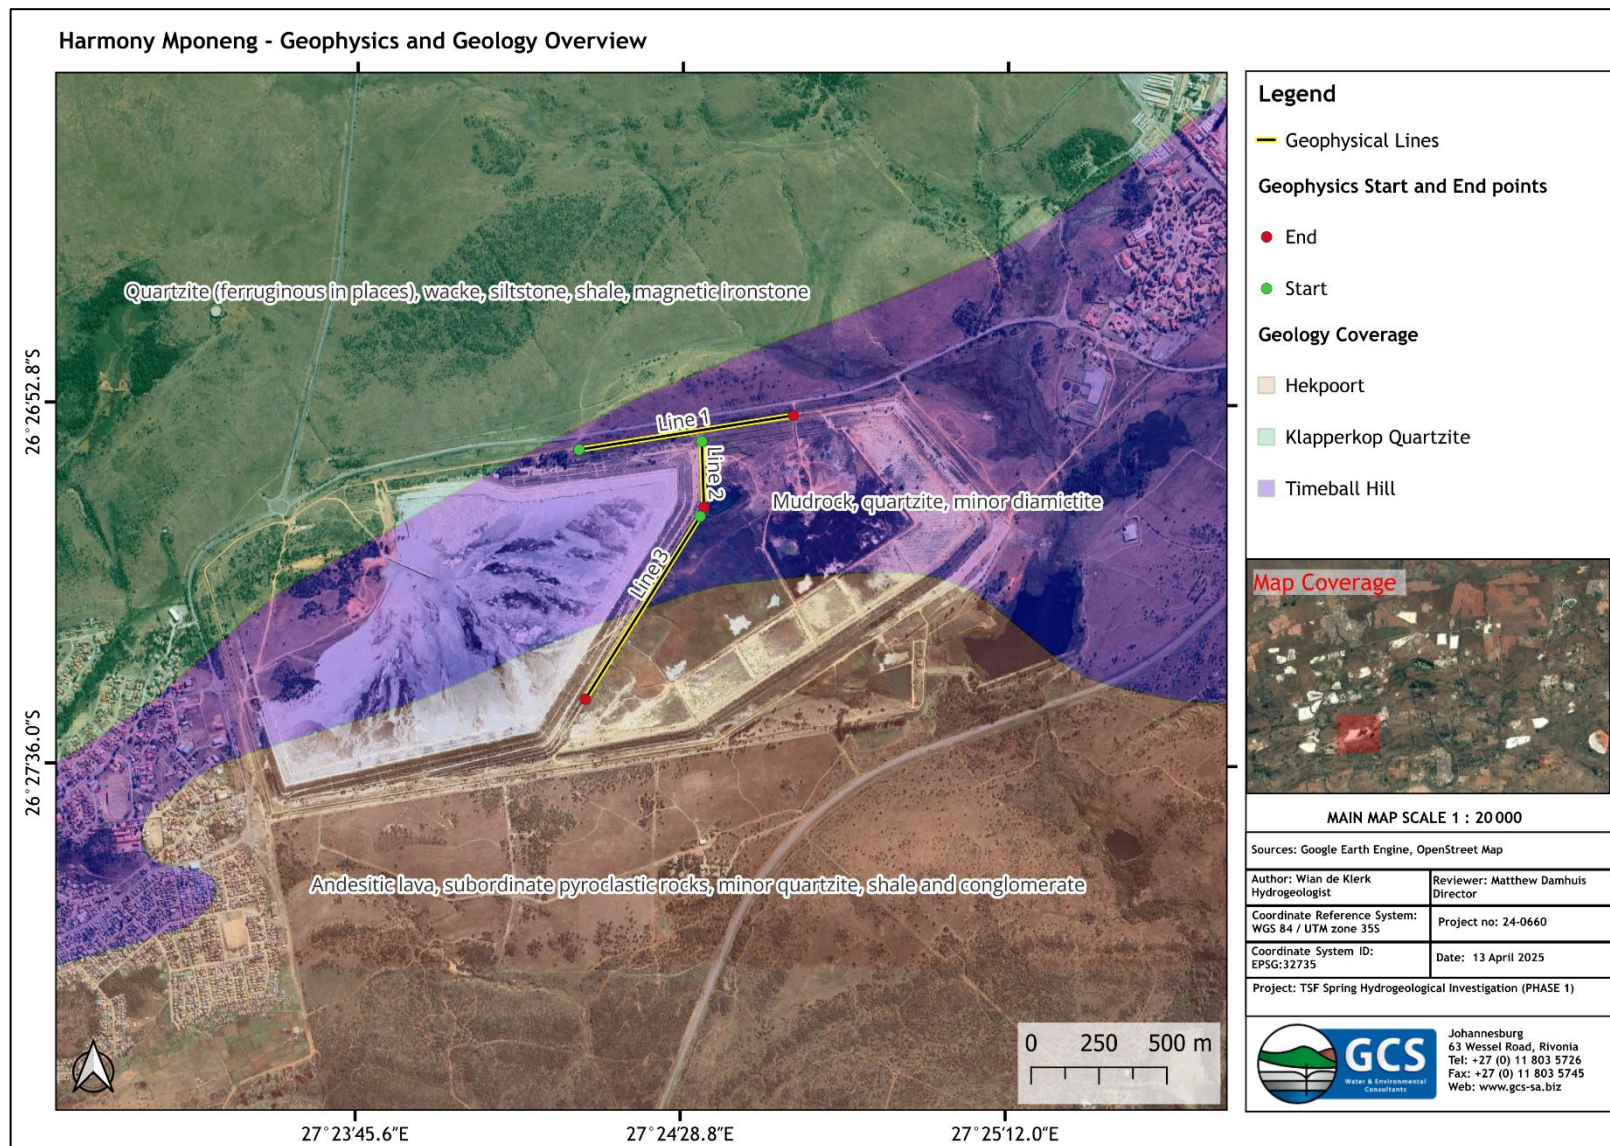
Figure 4-5: Geophysics locations and underlying geology (Geological Survey [South Africa], 1986)

ERT Surveys were conducted around the reported location of the spring to determine the most likely pathways of groundwater movement. Three (3) lines, with a total distance of ~1800m were conducted at the Mponeng TSF. The coordinates and details of the lines are presented in Table 4-1, with their locality and site the Mponeng TSF geology presented in Figure 4-5.

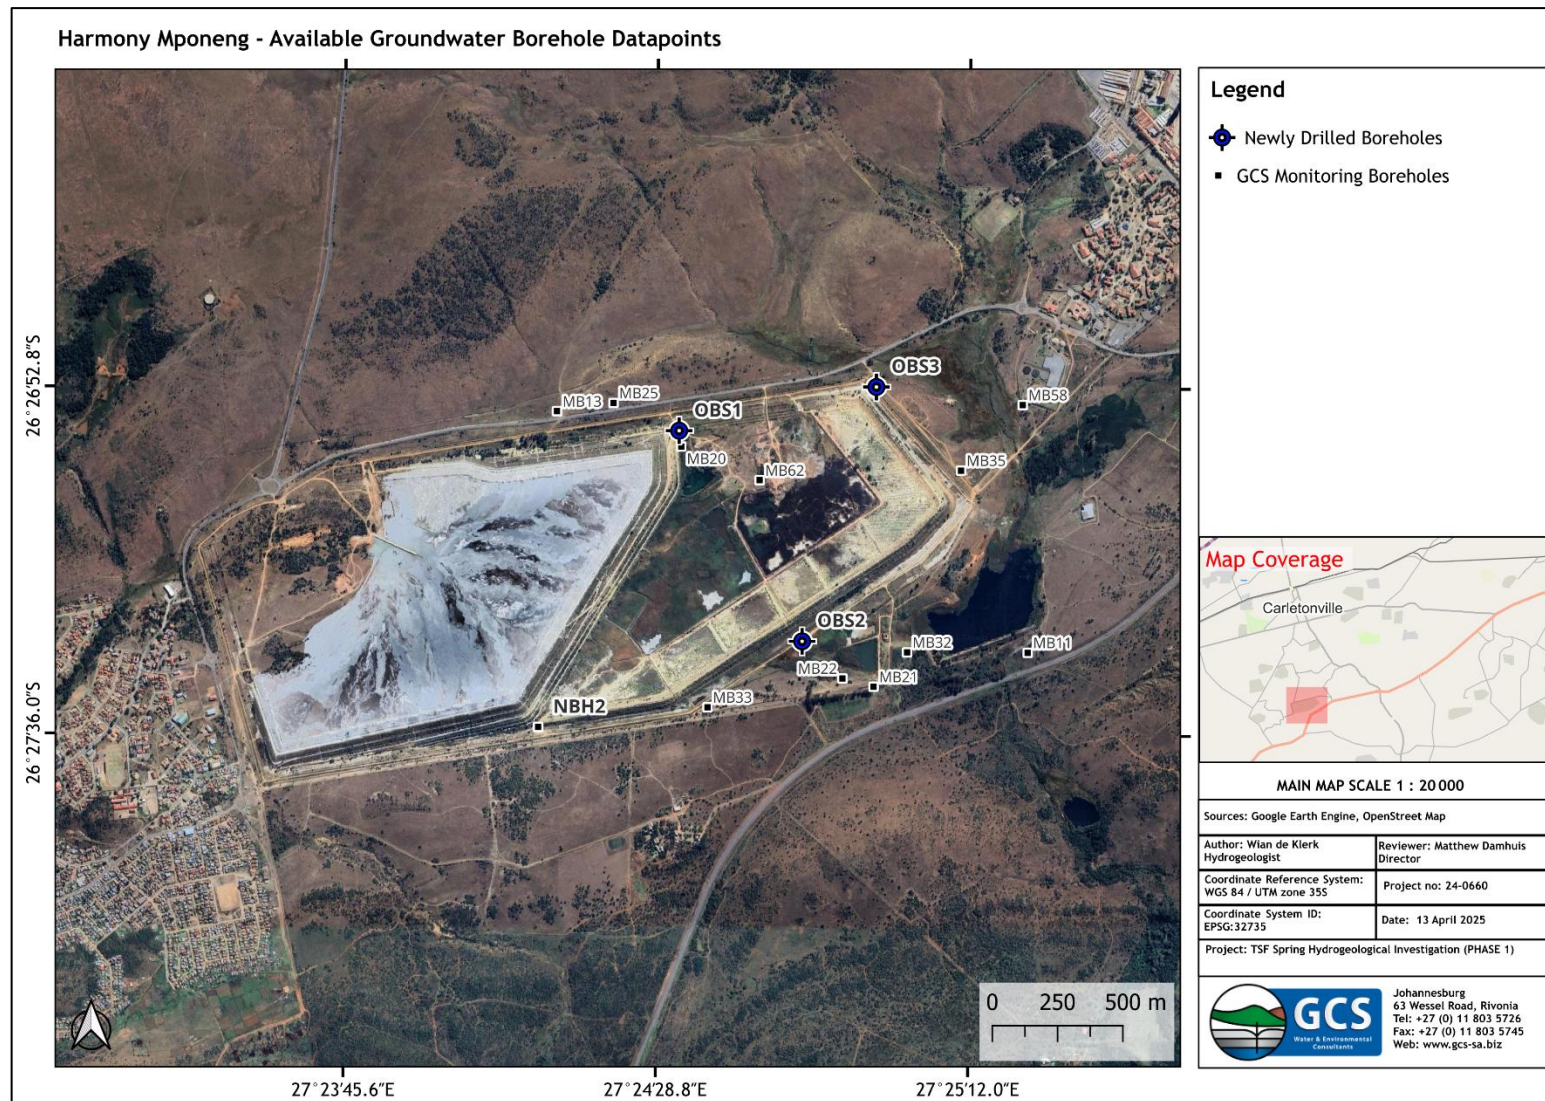
Figure 5-1: Overview of boreholes referenced in this report

GCS conducted drilling of three (3) hydrogeological characterisation boreholes at the Mponeng TSF. The locations and the siting motivations of each observation borehole are provided in Table 5-1 and Figure 5-1. The location of NBH2 (GCS, 2024) is also indicated, as it is referred later in the report.

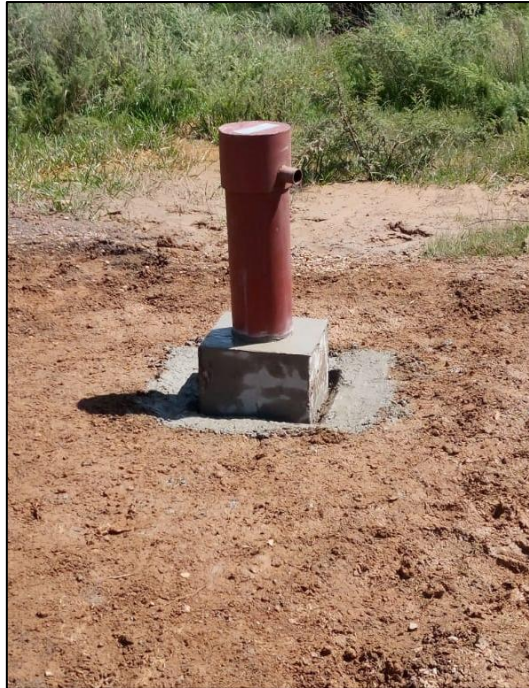
OBS1 (Figure 5-2) was sited to the North of the Mponeng TSF, site of the spring to collect water chemistry data and determine if the water source is indeed a spring. The water level in this borehole was shallow, at 1.08mbgl. The hydrogeological log of borehole OBS1 is provided in Figure 5-5

OBS 1 was drilled to a depth of 24m and constructed with 177mm diameter steel casing down to a depth of 12m. The borehole was then fitted with 24m of Class 9 UPVC, Perforated from 3mbgl. The annulus was filled with gravel pack, and a lockable standpipe and cement block was installed for secure access.

Figure 5-2: OBS1 Headworks

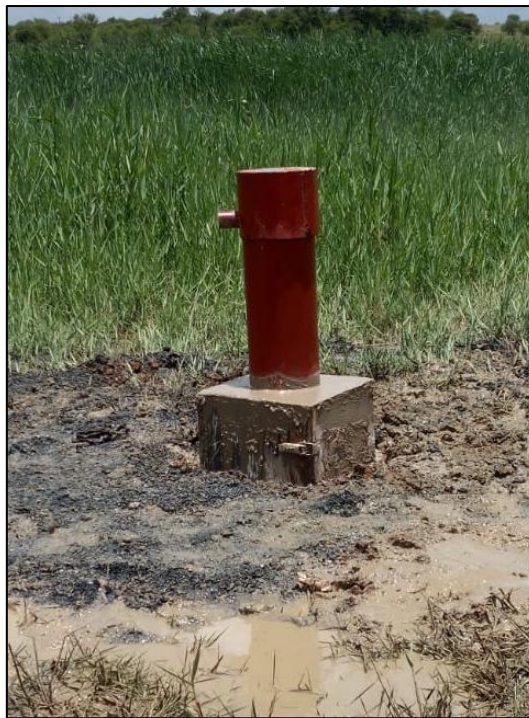
OBS2 (Figure 5-3) was drilled on the southern side of the Mponeng TSF, to be downgradient of potential environmental impacts, and within a wetland area. The water level in this borehole is artesian and pushed out above the upper confining clay layer once drilling has stopped. The hydrogeological log of borehole OBS2 is provided in Figure 6 5

OBS2 was drilled to a depth of 24m and constructed with 177mm diameter steel casing down to a depth of 9m. The borehole was then fitted with 24m of 165mm diameter, Class 9 UPVC, Perforated from 3mbgl. The annulus was filled with gravel pack, and a lockable standpipe and cement block was installed for secure access.

Figure 5-3: OBS2 Headworks

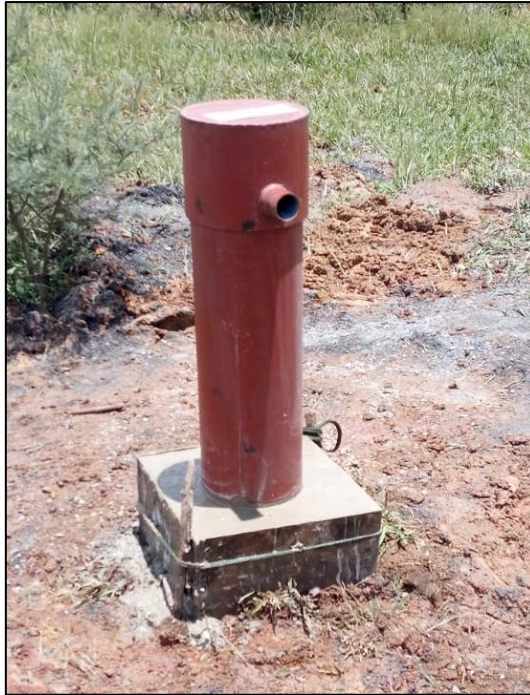
OBS3 (Figure 5-4) was drilled to the northeast of the TSF to assess piezometric water levels and evaluate geological conditions, as no prior datapoints were available in this area. A summary page of OBS3 is provided in Figure 5-7.

OBS 2 was drilled to a depth of 24m and constructed with 177mm diameter steel casing down to a depth of 9m. The borehole was then fitted with 24m of 165mm diameter, Class 9 UPVC, Perforated from 3mbgl. The annulus was filled with gravel pack, and a lockable standpipe and cement block was installed for secure access.

Figure 5-4: OBS3 Headworks

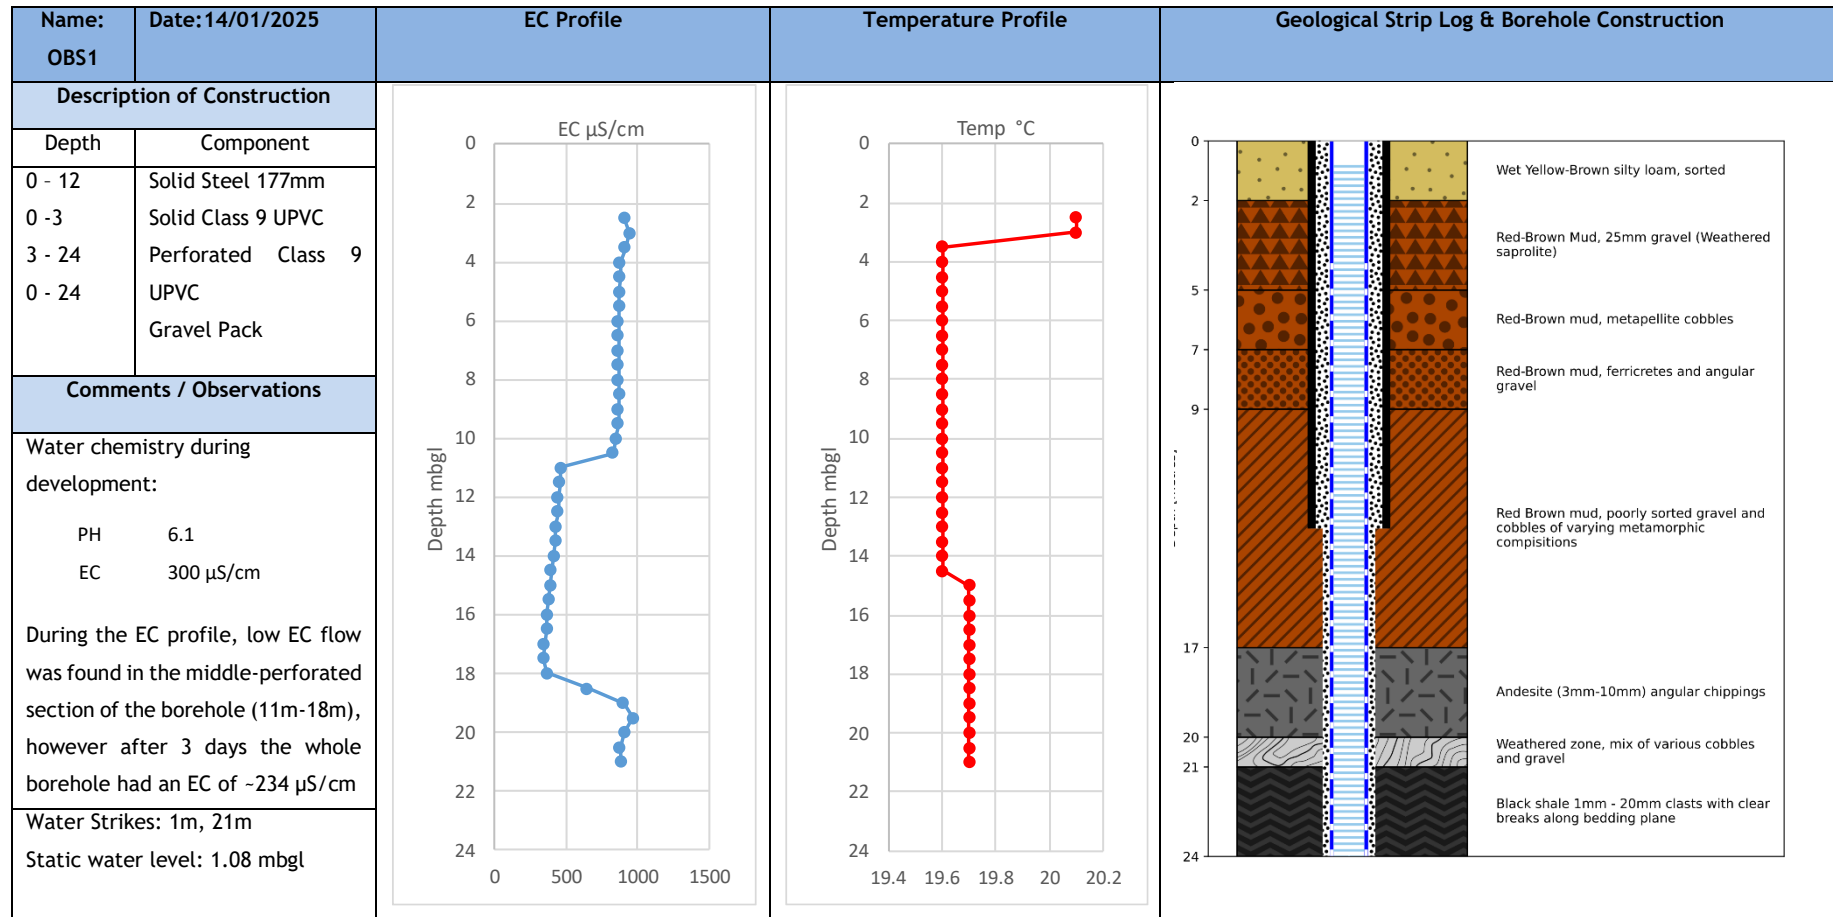
The geology is red soil mixed with cobbles, gravels, and other materials. The varied formations between 2mbgl and 17mbgl are derived from authorized historical waste dumping at the Mponeng TSF (GCS, 2018), with varied composition among the gravel and cobble pieces. Two water strikes were noted in the borehole, a shallow water strike within the first meter with the most significant increase in water volume observed at the contact between the andesite and the weathered zone at 21mbgl.

The water from OBS1 was generally clear during development with a low pH, low electrical conductivity (EC), and low total dissolved solids (TDS). The EC profile was taken 24 hours after drilling was completed, with lower values (below 500 $\mu\text{S}/\text{cm}$) observed from 11 to 18 meters. This represents the perforated section of the borehole. Above 11 meters (in the cased section with limited flow) and below 18 meters, the EC values were higher (approximately 1000 $\mu\text{S}/\text{cm}$).

Figure 5-5: Borehole OBS1 hydrogeological log

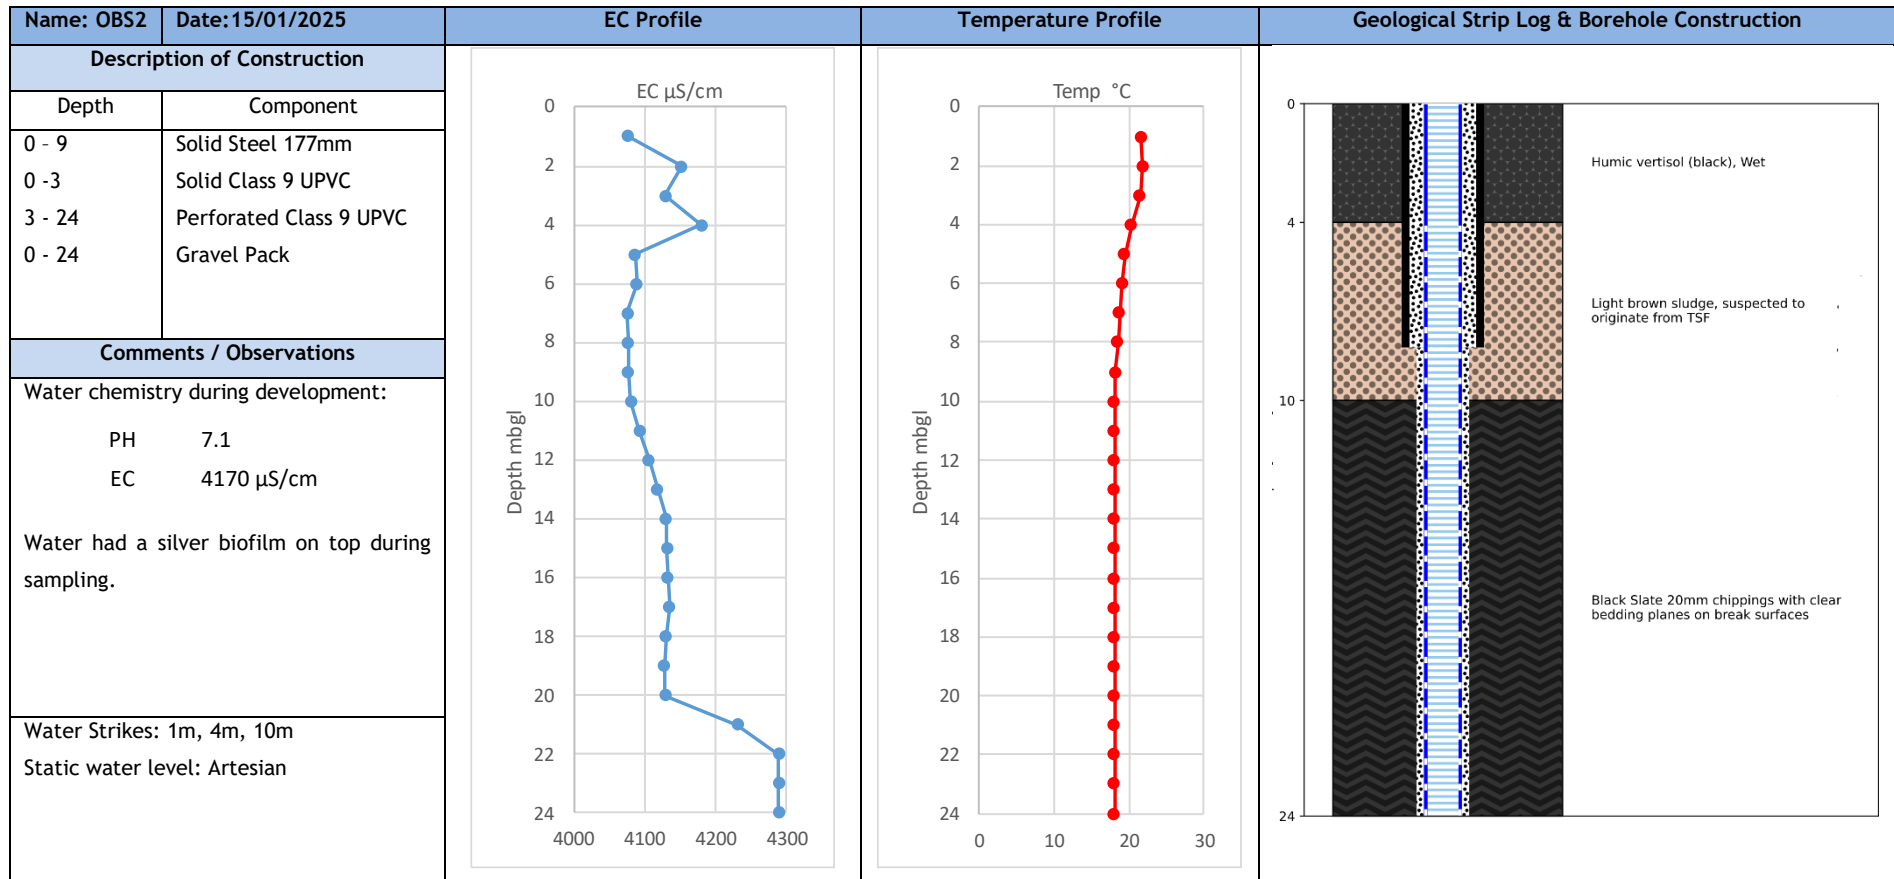
The uppermost layer, from 0 to 4 meters, consisted of humic black clay. Below which is a poorly structured light brown sludge from 4 to 10 meters, identified as fine TSF slurry. Below this, from 10 to 24 meters, black slate was encountered, similar the formation found upgradient of the Mponeng TSF. Artesian groundwater conditions were observed. This was also identified in borehole NBH2 (GCS project 24-0123) also drilled in the area south of the TSF. The artesian conditions in NBH2 were encountered within a water strike in the black shale formation. A similar water strike was encountered at OBS2 at a depth of 10m.

The EC of OBS2 revealed saline conditions relative to the other boreholes at the Mponeng TSF, with EC values exceeding 4000 $\mu\text{S}/\text{cm}$ (an order of magnitude above readings in OBS1 and OBS2).

Figure 5-6: Borehole OBS2 hydrogeological log

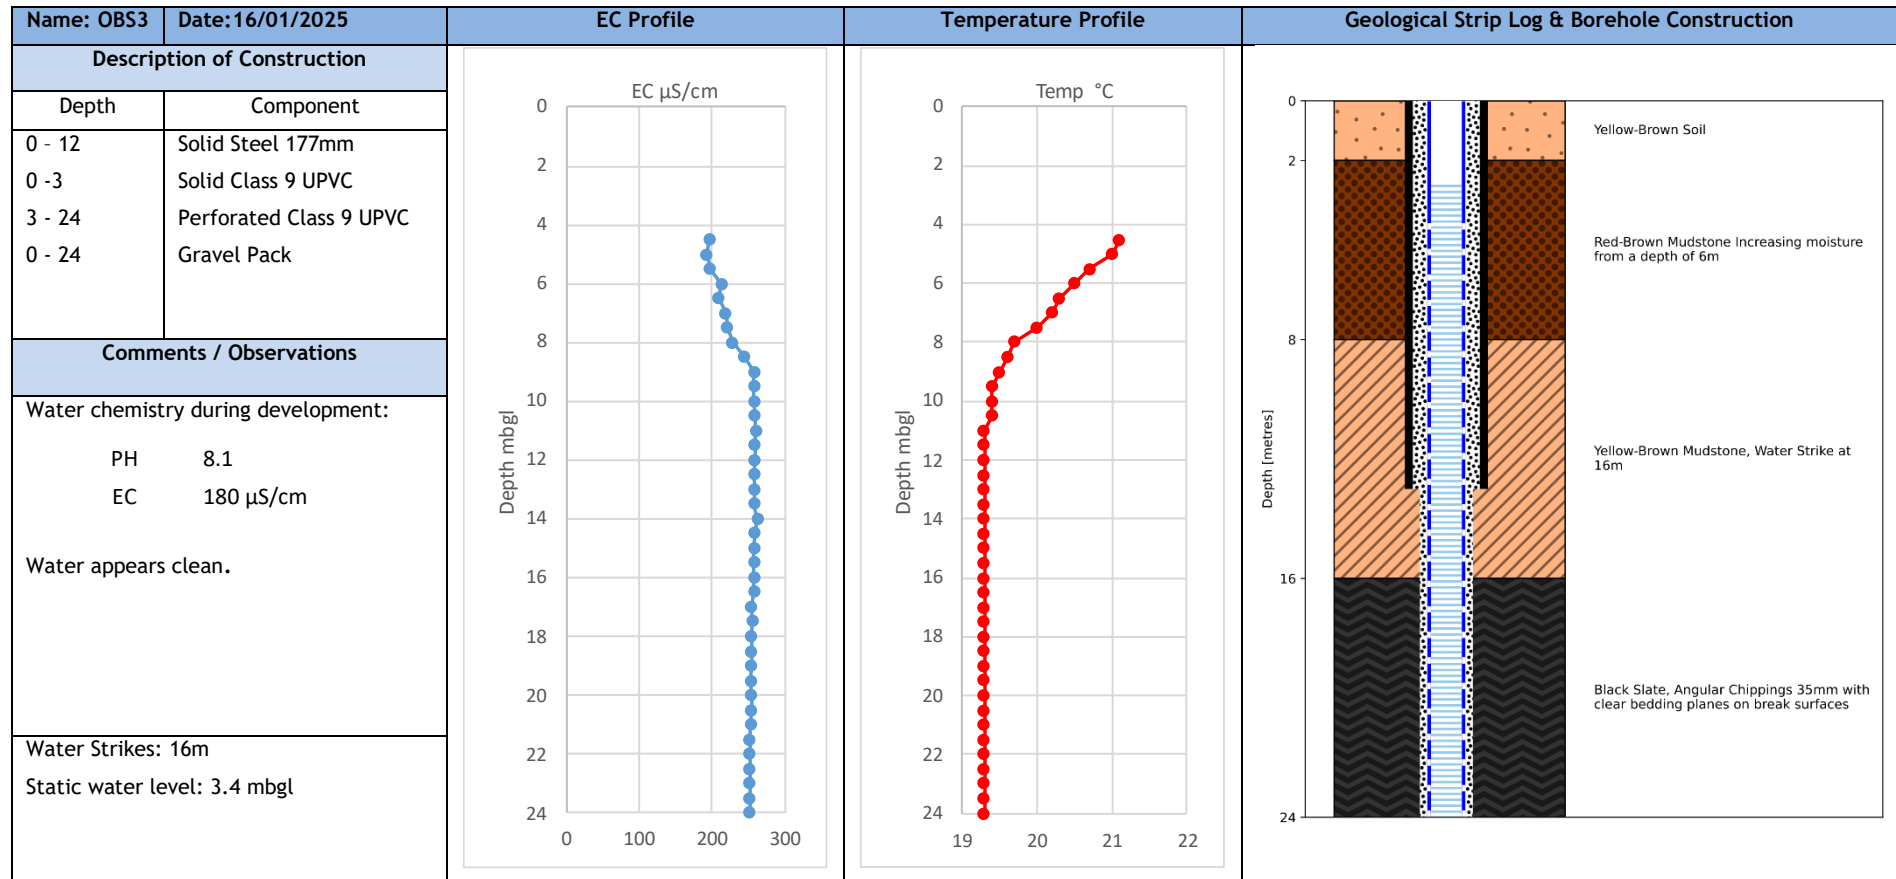
The borehole revealed a surface layer (2m thick) of yellow-brown soil, underlain by red-brown mudstone that was moist from 6 to 8 meters in depth. Below this, the geology transitioned into yellow-brown mud and eventually black slate at greater depths (16 meters. A water strike was encountered at 16 meters, corresponding to the contact zone between the mudstone and black slate).

OBS3 showed very clear water with a low EC of 180 $\mu\text{S}/\text{cm}$ and TDS of around 90 ppm. The pH was slightly basic at 8.1, and the water quality appeared unaffected by TSF pollution. The EC profile was heterogeneous, with slightly lower EC values near the static water level compared to the deeper sections of the borehole. This indicates that some surface water contributes to the borehole at shallow depths, but most of the water appears to originate from the black shale formation.

The temperature profile of Borehole 3 is particularly notable. Surface water temperatures were around 21°C but dropped quickly to 19.5°C at 10 meters, with the primary water strike at 16 meters. This suggests that the colder, cleaner water originates from a deeper, confined or semi-confined aquifer in the black shale. The borehole's low EC and stable temperature profile indicate high-quality groundwater with minimal influence from surface or anthropogenic contaminants

Figure 5-7: Borehole OBS3 hydrogeological log

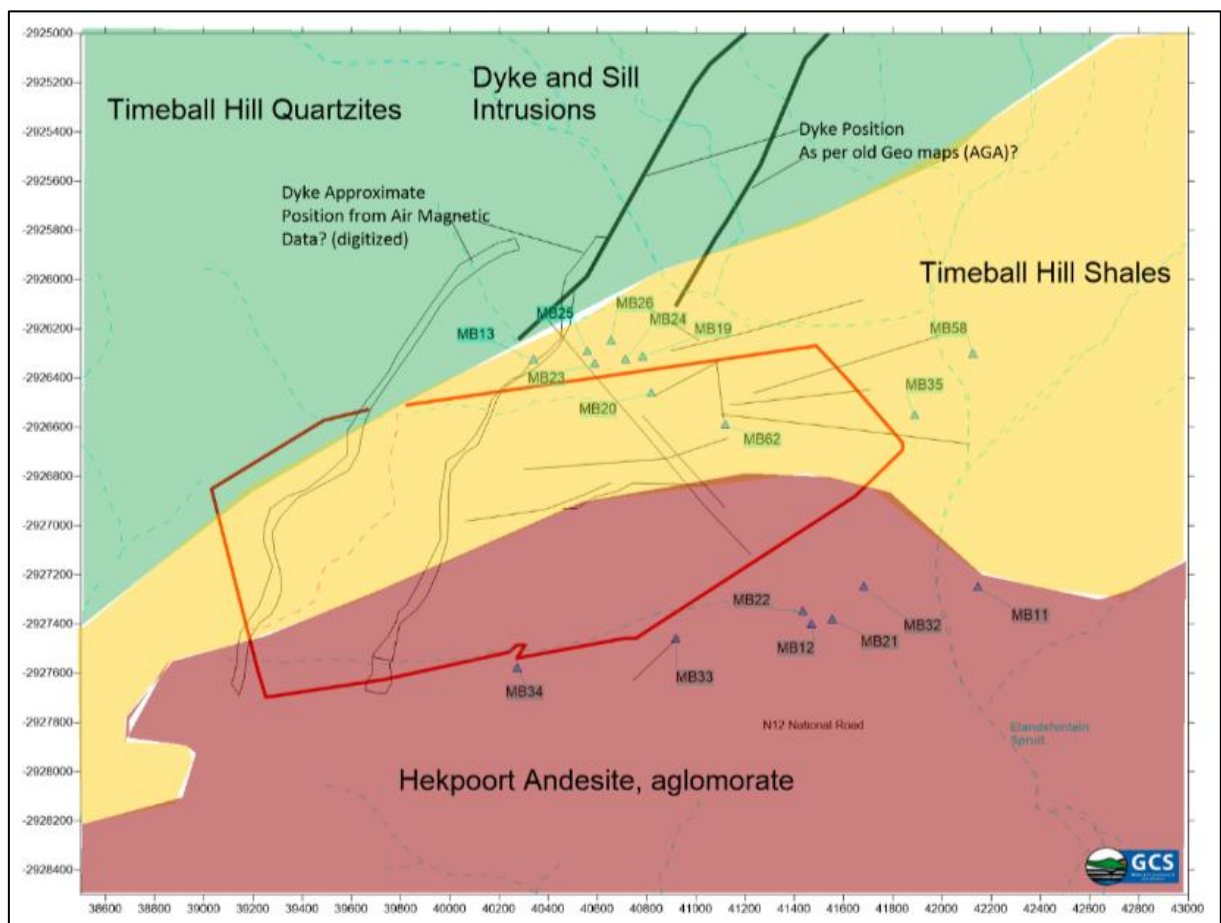
The Mponeng TSF Area is constructed on top of Pretoria Group sediments belonging to the Transvaal Supergroup (Figure 6-1). The Timeball Hill quartzite formation forms the Gatsrand, also known as the West Witwatersrand ridge, and makes up the geology to the north, upgradient of the Mponeng TSF. To the south of the ridge the ground slopes away under the Timeball hill shales towards the valley. The predominant portion of the Mponeng TSF is built upon the Timeball hill shales without the presence of a geomembrane or lining material, allowing hydraulic interaction between the TSF and underlying aquifer. The Hekpoort andesite discordantly overlies the sedimentary formations on the southern perimeter of the Mponeng TSF property

Figure 6-1: Regional Geological Setting with potential dyke locations (GCS, 2019)

Several fault related lineaments can be observed in the area (refer to in Figure 6-1 and Figure 6-2). The lineaments trend in a north-westerly direction - perpendicular to the strike of the Transvaal supergroup sediments and metasediments (GCS, 2019).

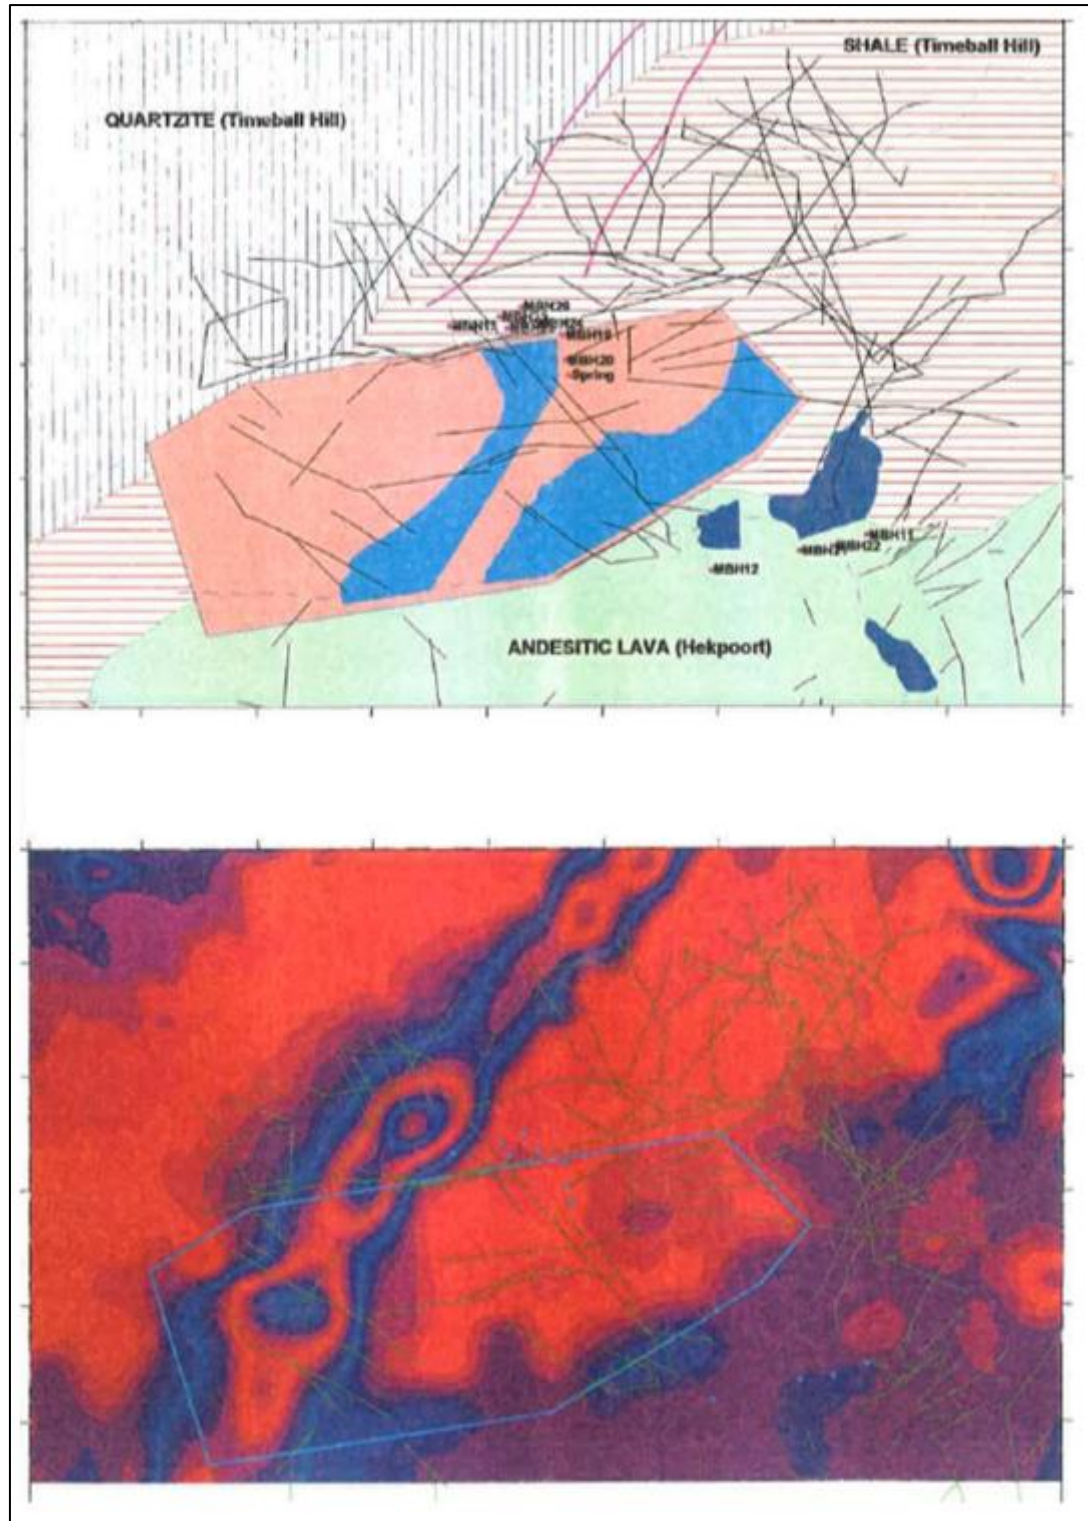
Figure 6-2: Structural lineaments mapped and site-specific aeromagnetic data (GCS, 2019) taken from (Van Rensburg & Bush, 2001)

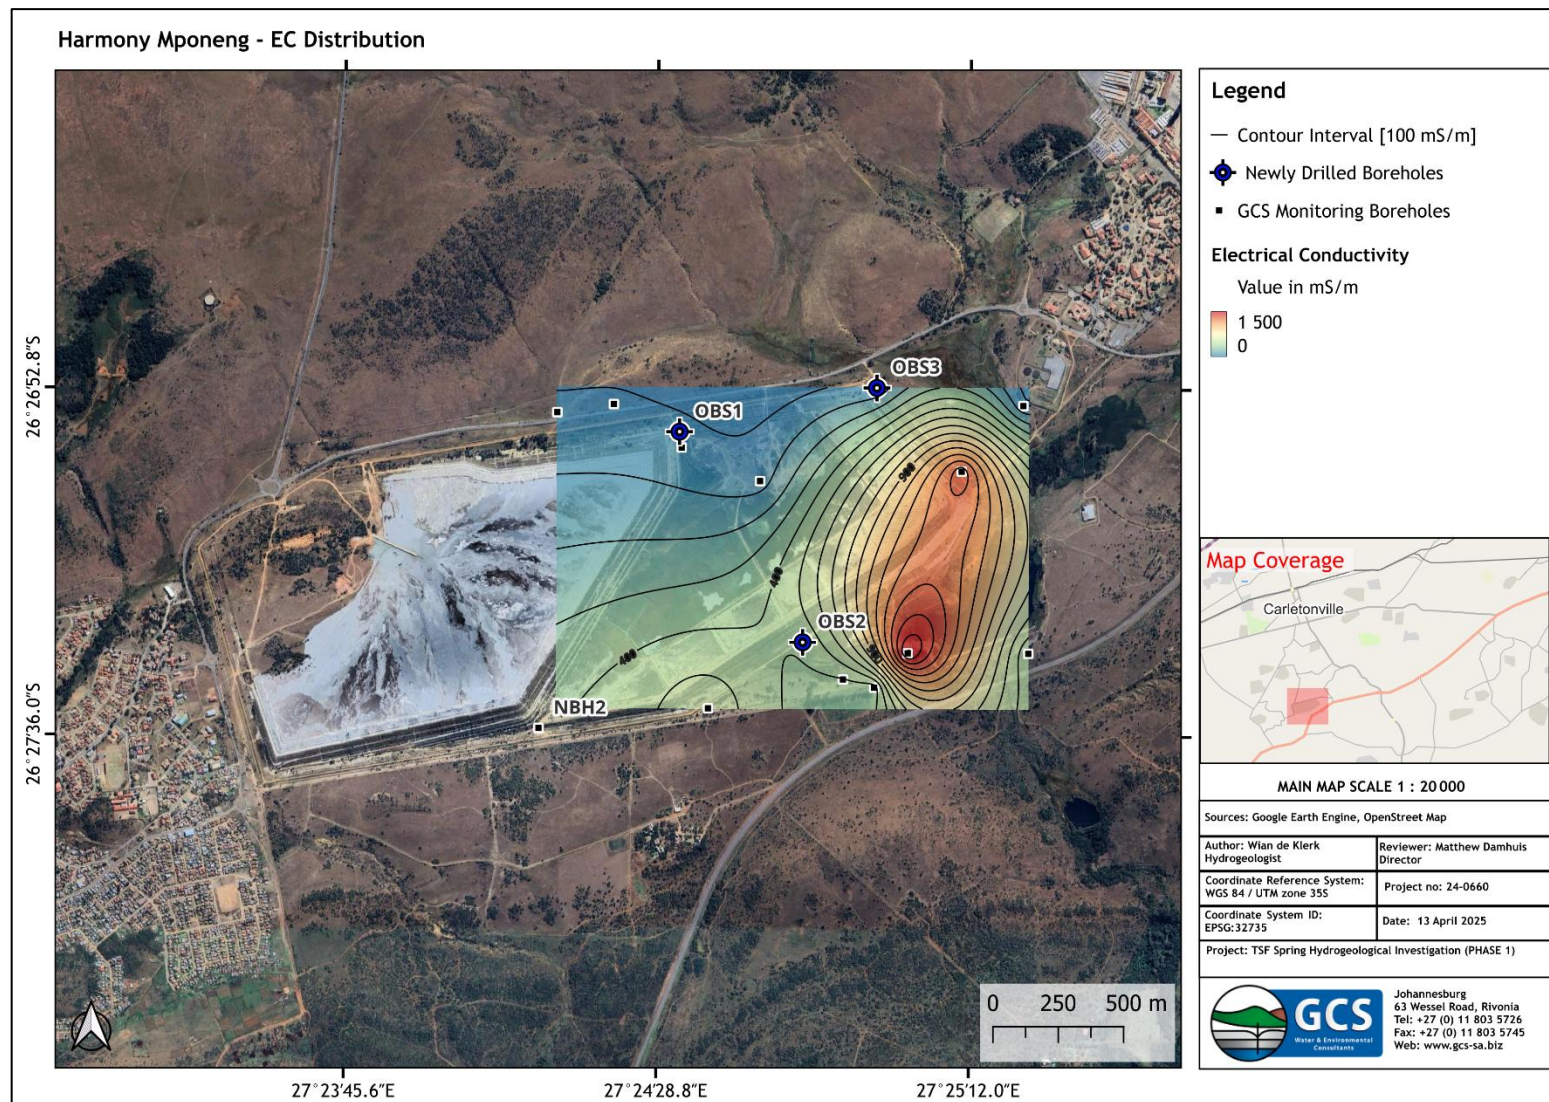
Available monitoring data for the Mponeng TSF was used to create coverage datasets representing groundwater elevation (Figure 6-4), groundwater EC distribution (Figure 6-3), and a calculated delineation of potential artesian sites at the TSF (Overlay of areas where the piezometric GW level exceeds the surface topography, refer to Figure 6-5). The processed dataset used to create these coverages is provided in Appendix B.

Figure 6-3: Groundwater EC map based on latest available monitoring data

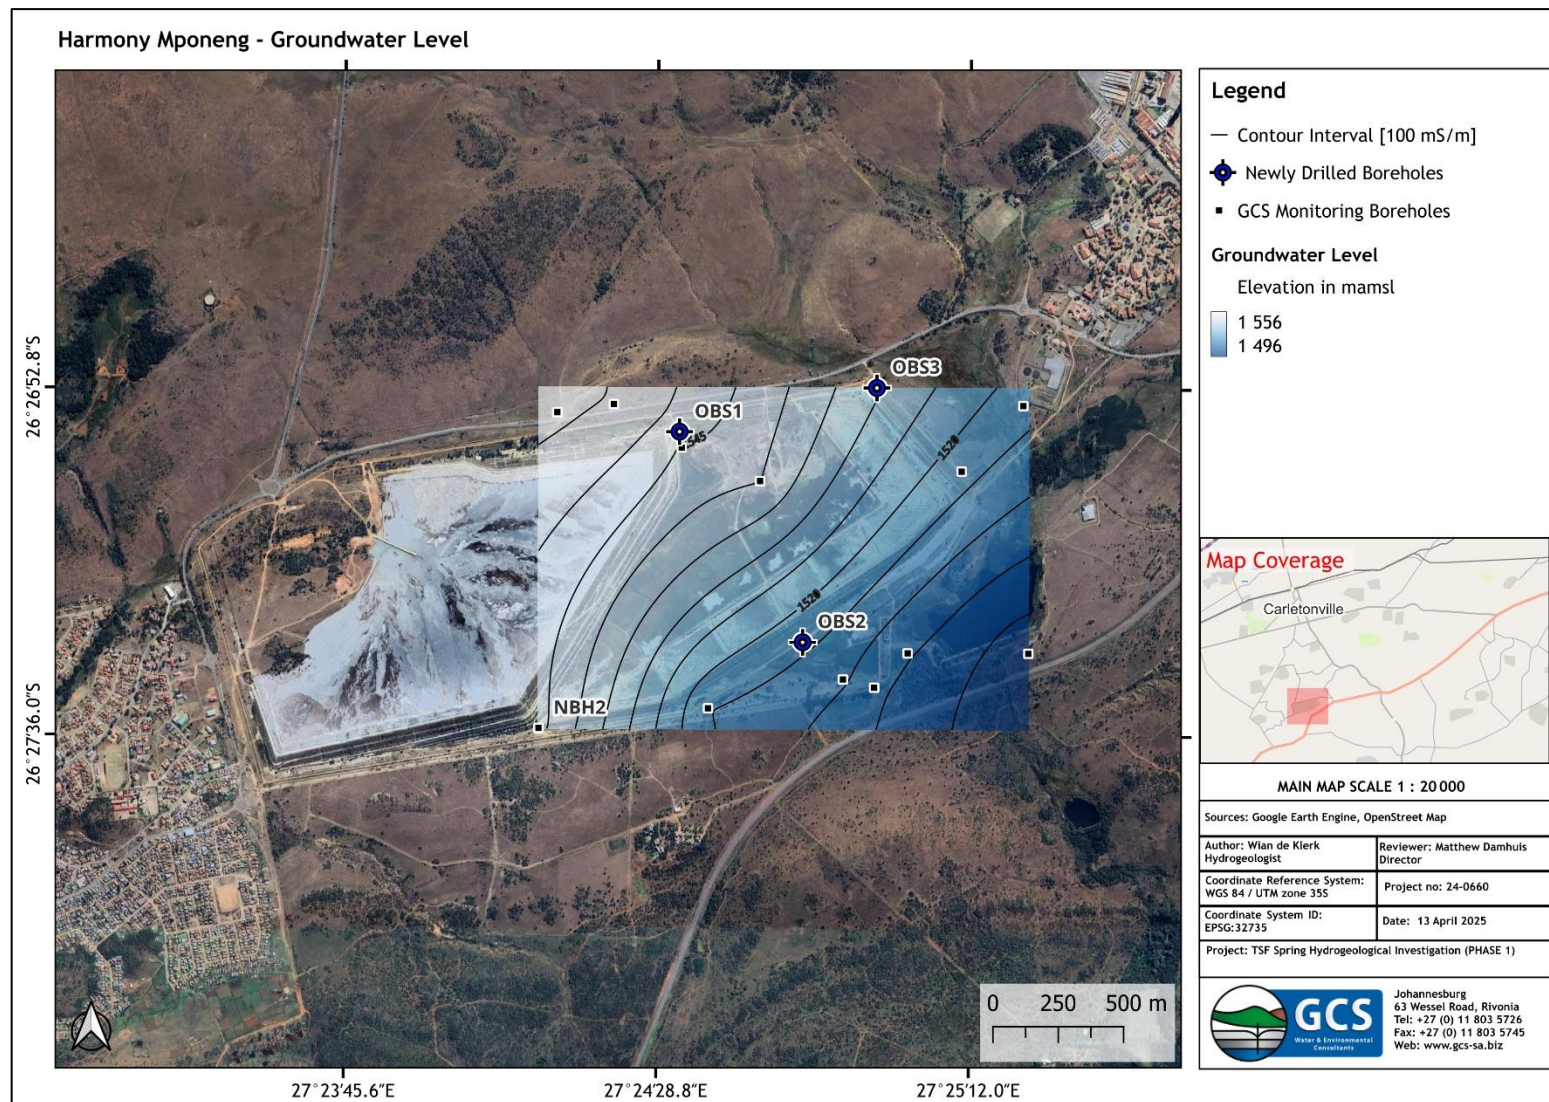
The spring is located upgradient of the TSF and the groundwater quality indicated that the spring is not impacted on by the TSF seepage before the water reaches surface. The groundwater TDS increases by roughly 4000 $\mu\text{S}/\text{cm}$ between OBS1 and OBS2, indicating that interaction is taking place between the spring water, and contaminated rainwater seepage from old portions of the Mponeng TSF. The general direction of groundwater movement is in a southeast direction (Figure 6-4).

Figure 6-4: Groundwater level map based on latest available monitoring data
