Harmony Mponeng- TSF Spring Hydrogeological Investigation (PHASE 1)

Version - Final

14 April 2025

GCS Project Number: 24-0660

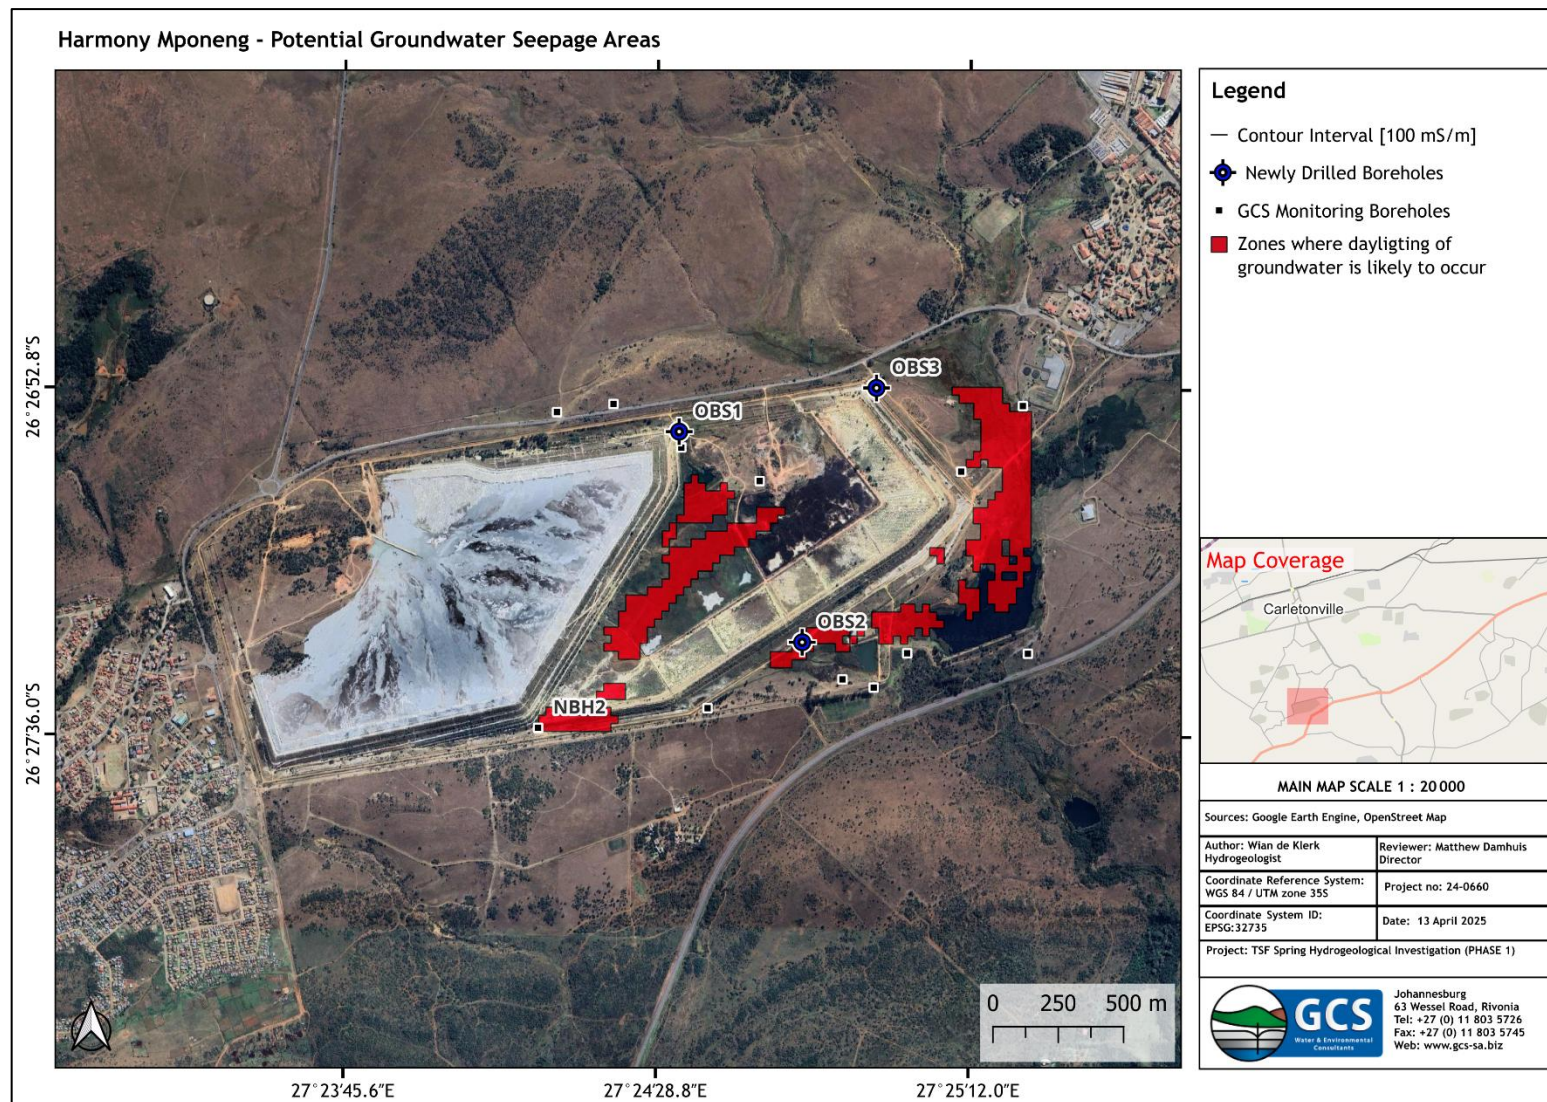
Figure 6-5: Potential areas of artesian conditions indicated in red.

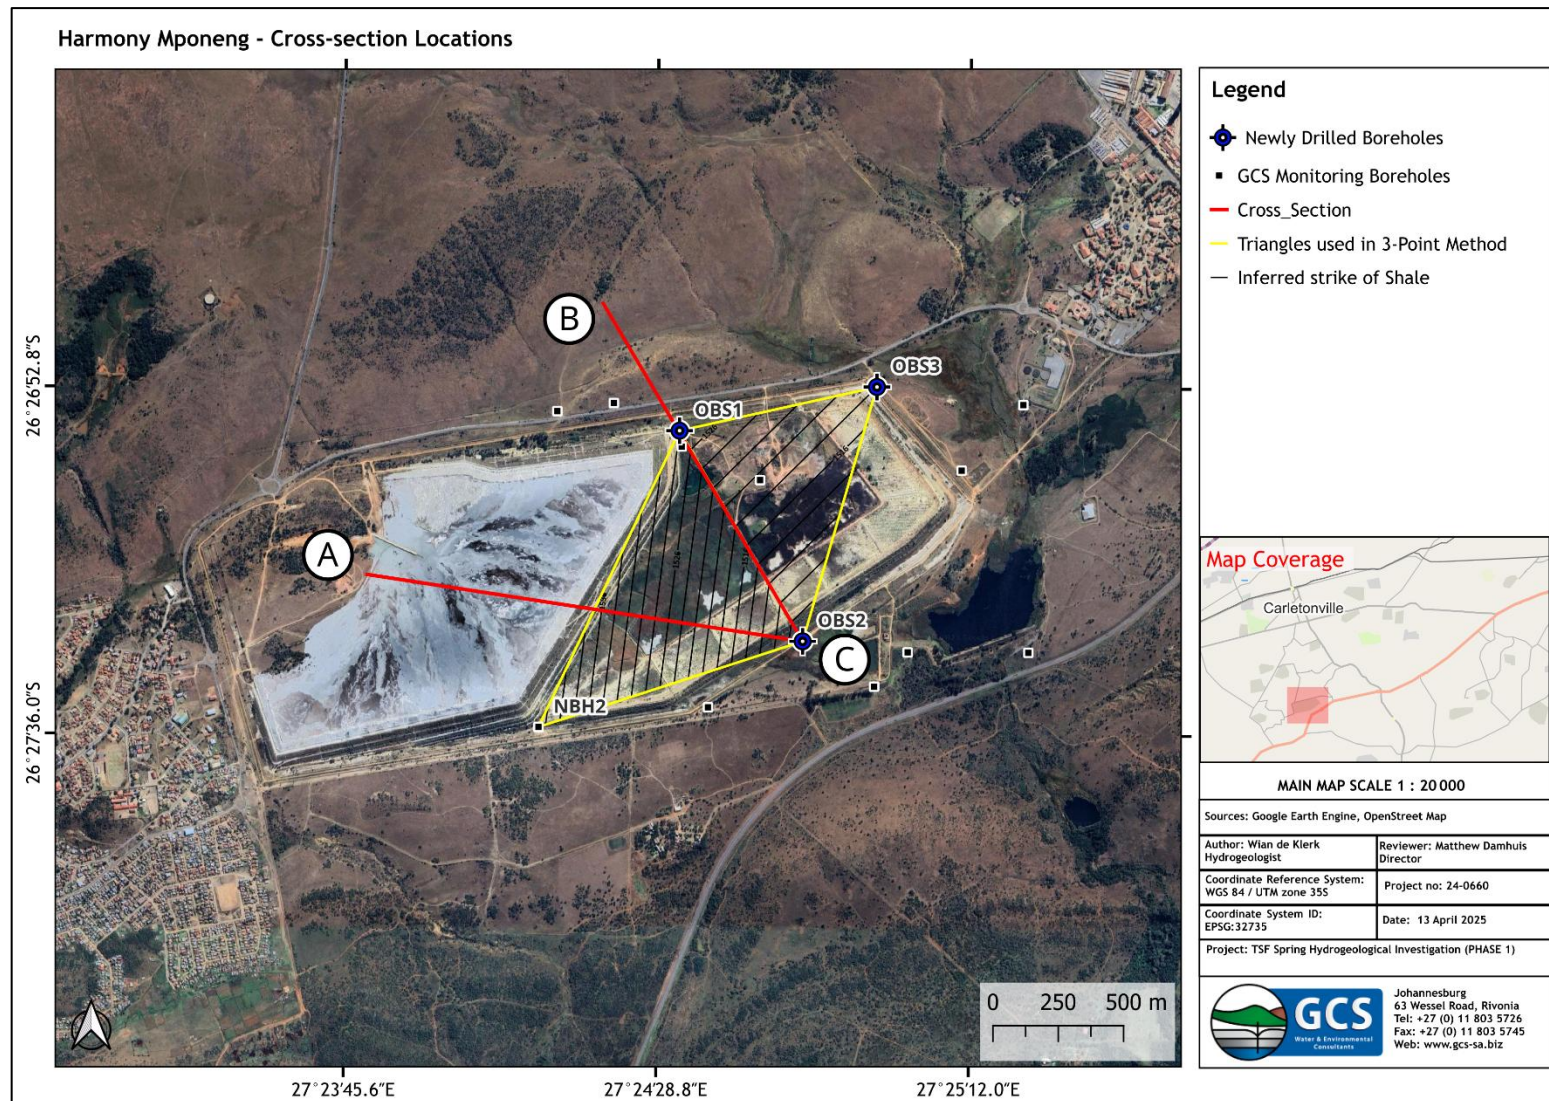
To investigate the shale formation, its depth was calculated using the 3-point method from available areas of known geological intersection (Figure 6-6). The results show that changes in the apparent strike and dip of the shale occur between the north and south portions of the Mponeng TSF. This is the result of a geological lineament or fault.

Figure 6-6: Overview of the inferred shale layer dip directions using the 3-point method. Cross-sections indicated in red.

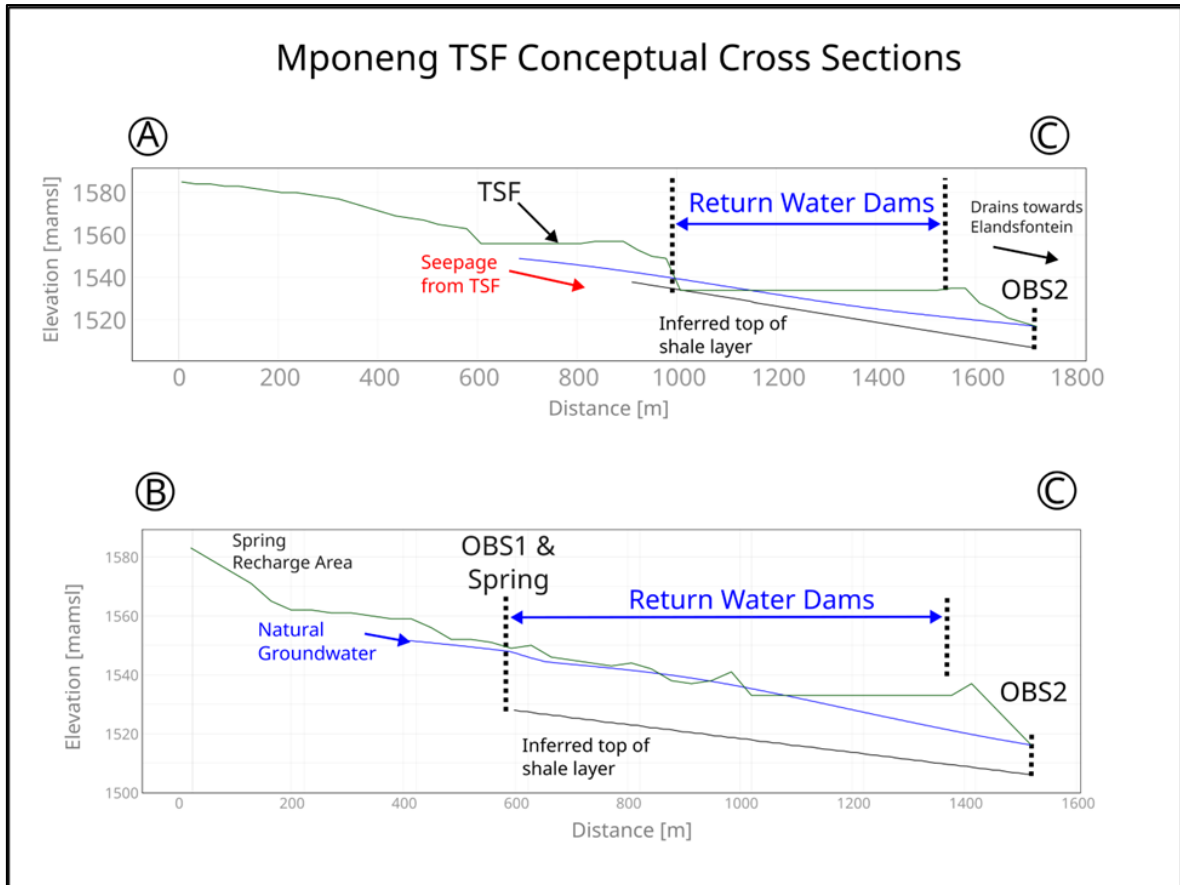
Furthermore, conceptual cross sections (Figure 6-7) were drawn from geological data that was acquired from OBS1, OBS2 and NBH2. Data for NBH2 is sourced from project 24-0321 (GCS, 2024). Based on this information, the TSF was constructed on top of and to the south of the shale outcrop and surrounding geological contacts (Cross section AC). The TSF is not lined with a geomembrane which results in the contaminated rainwater seepage from the TSF recharging the underlying aquifer/s, resulting in a contamination plume that will migrate downgradient towards the toe of the TSF.

Figure 6-7: Cross Sections as indicated on Figure 6-6
 Green = Topography, Black = Top of Shale Layer, Blue = Groundwater level

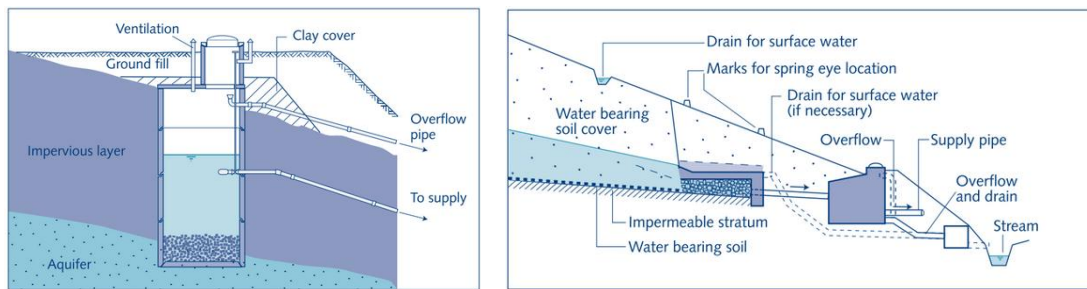
Figure 6-8: Example of Spring Boxes for confined (left) and unconfined (right) systems (Smet & van Wijk, 2002)

1. **Management of the Spring:** GCS recommends that a spring capture system be implemented north of the TSF. Several techniques can be considered
 - a. **Spring Boxes:** Concrete or steel structures built around the spring to collect water. Water is then transferred via a network of pipes connected to the collection structure (refer to Figure 6-8).
 - b. **Horizontal Drains:** Pipes or drains installed into the hillside upgradient of the Mponeng TSF to intercept groundwater before it daylights at the spring, redirecting it safely (refer to Figure 6-9).
 - c. **Gravel Packs and French Drains:** Used to enhance water collection while minimizing sediment entry (refer to Figure 6-10).

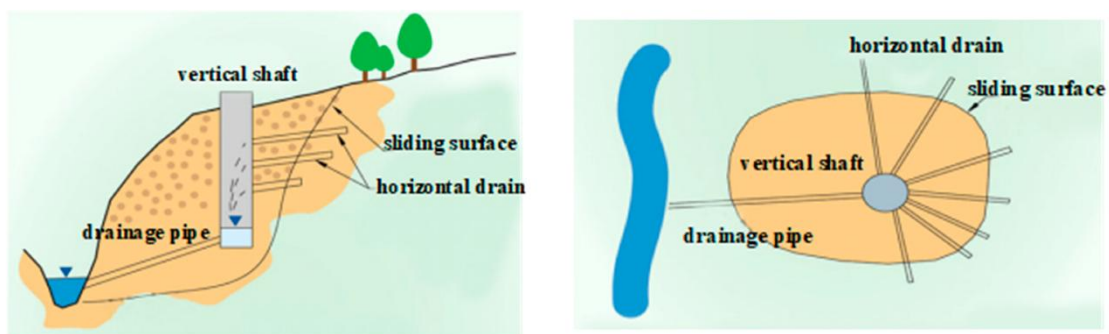
Figure 6-9: A side view (left) and top view (right) of a horizontal drain system (Soil and Water Conservation Bureau, 2003)

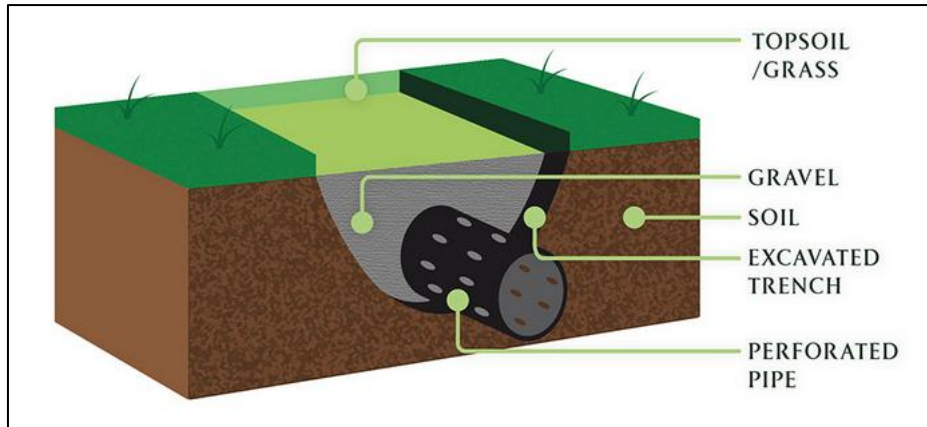
Figure 6-10: French Drain System (Grade Solutions, 2025)

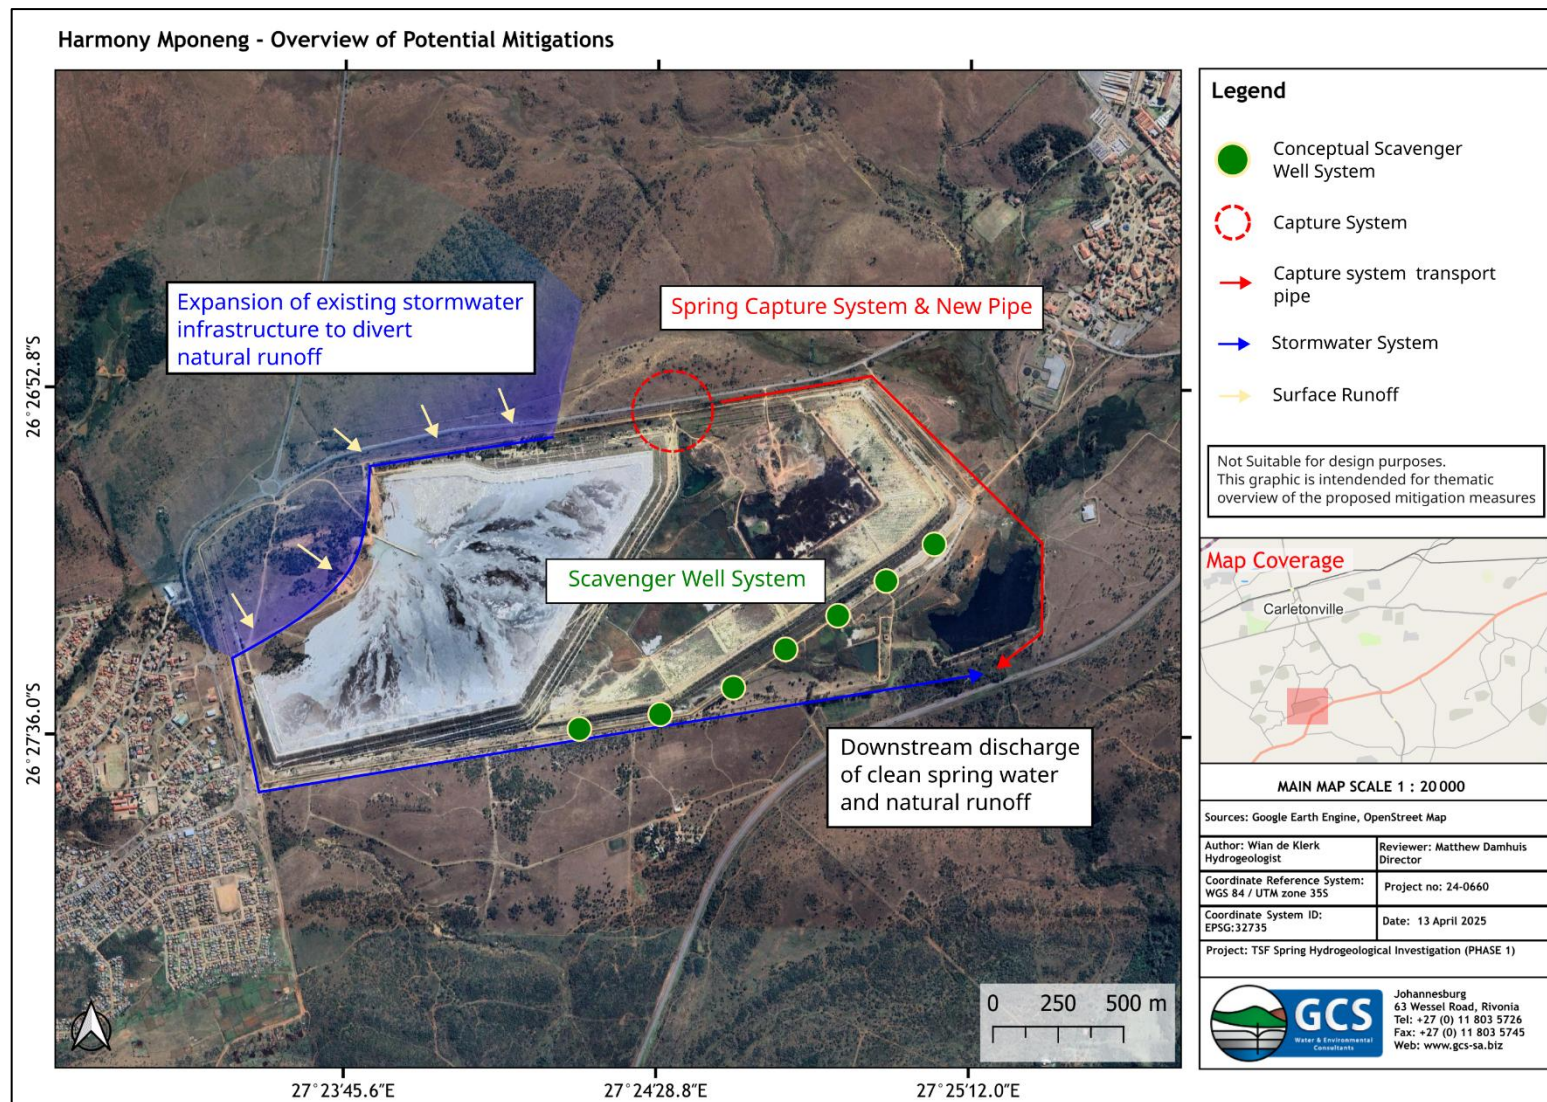
Figure 6-11: Conceptual Overview of each respective mitigation strategy proposed.

2. **Management of Stormwater Runoff:** To more effectively reduce the amount of rainwater interacting with the TSF, and thereby decrease the volume of contaminated rainwater seepage, it is proposed that the stormwater management plan and associated infrastructure north of the TSF be assessed and updated. The existing storm water diversion trench will need to be extended to fully intercept all runoff north of the TSF

3. **TSF Seepage Mitigation:** To address the expected contaminant plume emanating from the unlined TSF, scavenger boreholes can be used to intercept and abstract groundwater from the aquifer for treatment before it impacts downgradient water sources. This will help protect vital resources like the nearby spruit and other downgradient ecosystems. It is envisaged that these boreholes are to remain operational until rehabilitation of the TSF is complete and the TSF rainwater seepage quality improves.

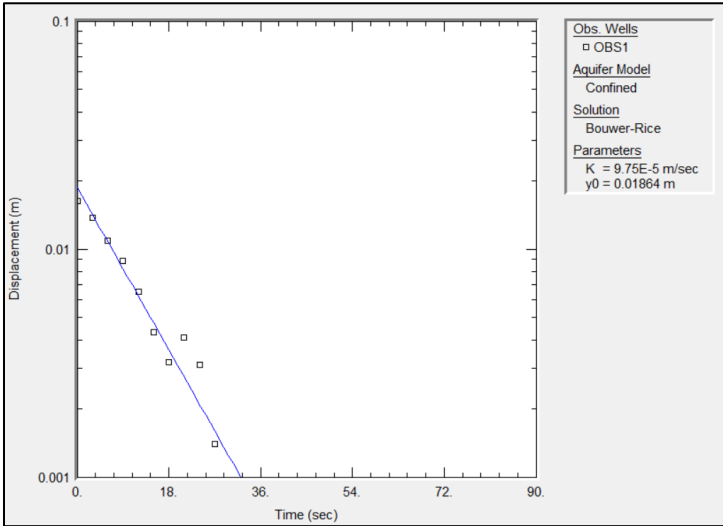
Figure 8-1: Slug test for OBS1

Results	OBS1	OBS2	OBS3
K [m/s]	9.75E-05	6.14E-06	3.24E-06
K [m/d]	8.42	0.53	0.28

The slug test results for the three boreholes revealed notable differences in hydraulic conductivity, with OBS1 showing high conductivity of **8.42 m/d**, while Boreholes 2 and 3 exhibited much lower values of **0.53 m/d** and **0.28 m/d**, respectively. The individual data fittings for each borehole interpretation are presented **Appendix A**. The resulting hydraulic conductivities are discussed as part of the borehole characterization in Section 5.1

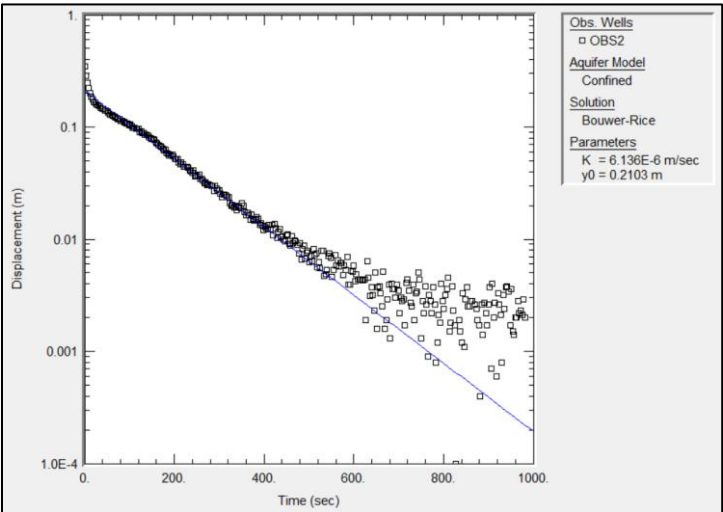
Figure 8-2: Slug test for OBS2

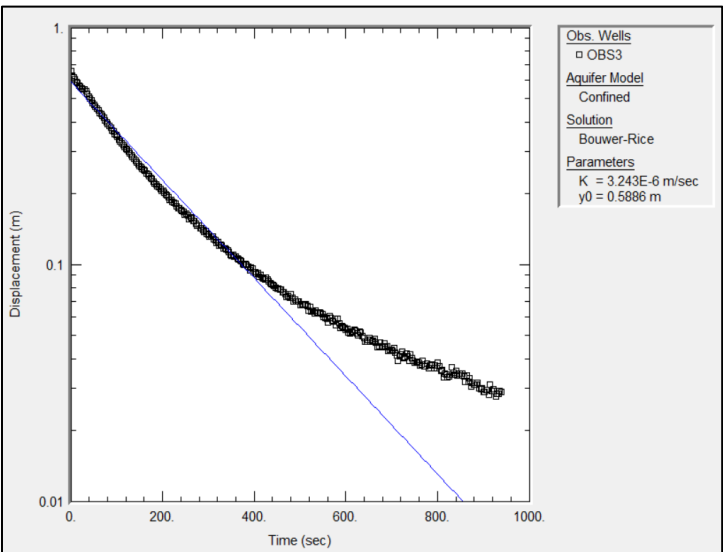
Figure 8-3: Slug test for OBS3
