**SCREENING REPORT FOR AN ENVIRONMENTAL AUTHORIZATION AS
REQUIRED BY THE 2014 EIA REGULATIONS – PROPOSED SITE
ENVIRONMENTAL SENSITIVITY**

Project name: Harmony Valley Tailings Storage Facility

Project title: The proposed expansion to include the valley area located between the existing the tailing storage facilities (FSN 1 and FSN 2) at Harmony Welkom Operations

Pre-disturbance Environmental Site Assessment and Site Specific EMP

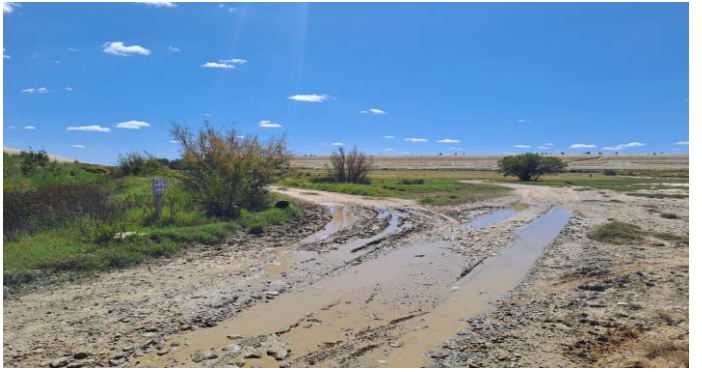
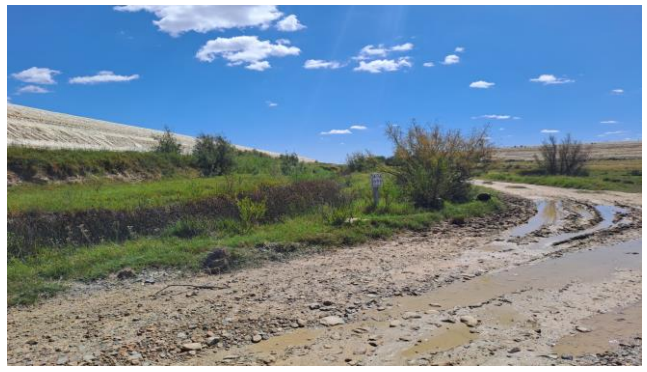
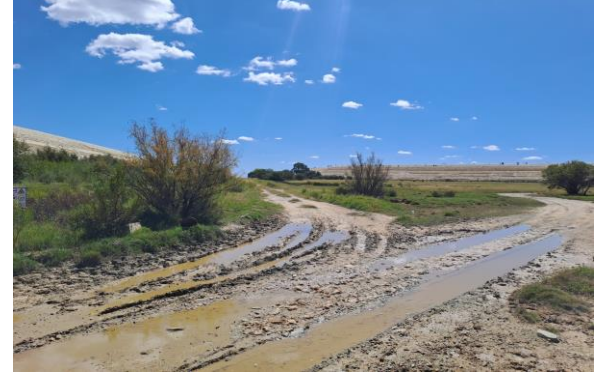
<p>Describe area and adjacent land use:</p>	<p>View north from southern area of site towards existing TSFs. The only adjacent land use is mining. The vegetation in the area could be described as mostly natural vegetation with limited alien infestation.</p>	<p>View north-east from southern area of site between existing TSFs. The only adjacent land use is mining. The vegetation in the area could be described as mostly natural vegetation with limited alien infestation.</p>	<p>View east from southern area of site along access road between TSFs. The only adjacent land use is mining. The vegetation in the area could be described as mostly natural vegetation with limited alien infestation.</p>
<p>Aspect: General TSF area</p>

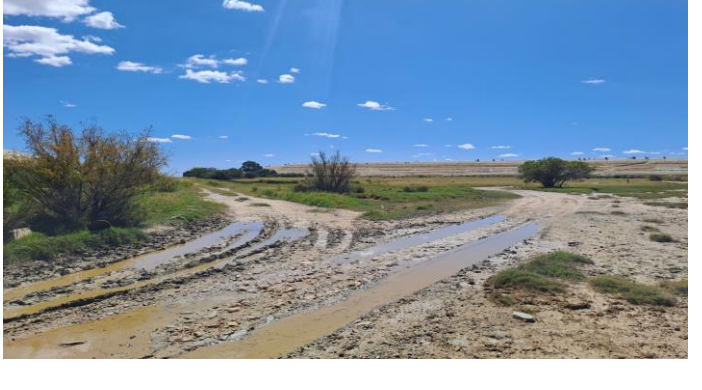
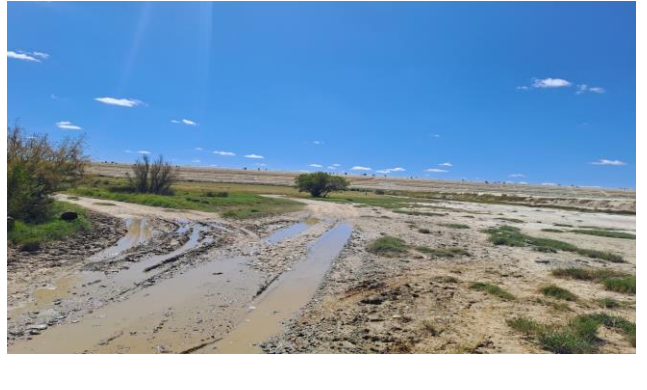
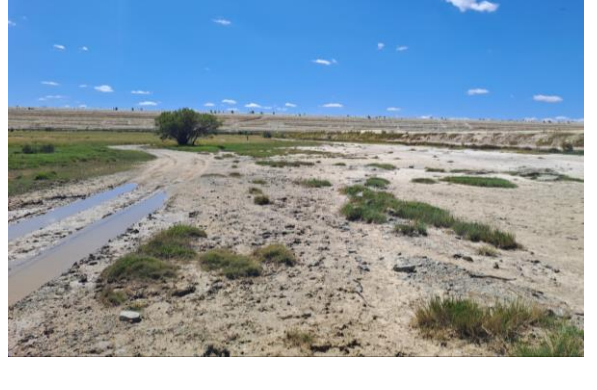
<p>Describe area and</p>	<p>View south-east from southern area of site. The only adjacent land use is mining. The vegetation in the area could be described as mostly natural vegetation with limited alien infestation.</p>	<p>View south from southern area of site. The only adjacent land use is mining. The vegetation in the area could be described as mostly natural vegetation with limited alien infestation.</p>	<p>View south-west southern area of site. The only adjacent land use is mining. The vegetation in the area could be described as mostly natural vegetation with limited alien</p>

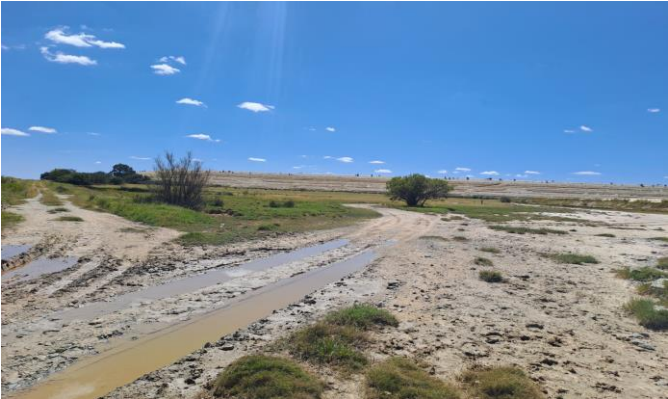
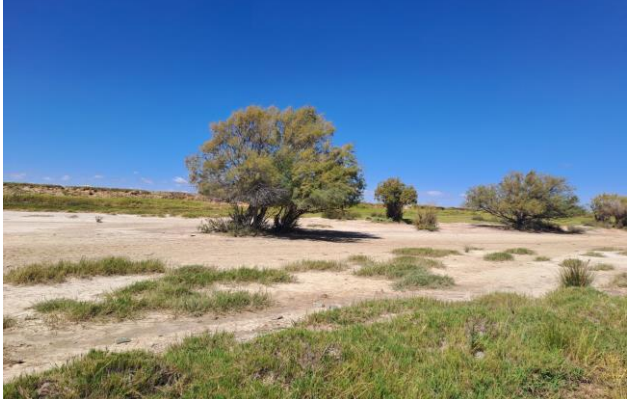
adjacent land use:			infestation.
Aspect: General TSF area

Describe area and adjacent land use:	<p>View west from southern area of site. The only adjacent land use is mining. The vegetation in the area could be described as mostly natural vegetation with limited alien infestation.</p>	<p>View north-west from southern area of site. The only adjacent land use is mining. The vegetation in the area could be described as mostly natural vegetation with limited alien infestation.</p>
