# **MPONENG MINE TAILINGS STORAGE FACILITY LOWER COMPARTMENT GEOTECHNICAL INVESTIGATION**

Report No. P134-01

Title : Mponeng Mine - Tailings Storage Facility Lower  
Compartment: Geotechnical investigation

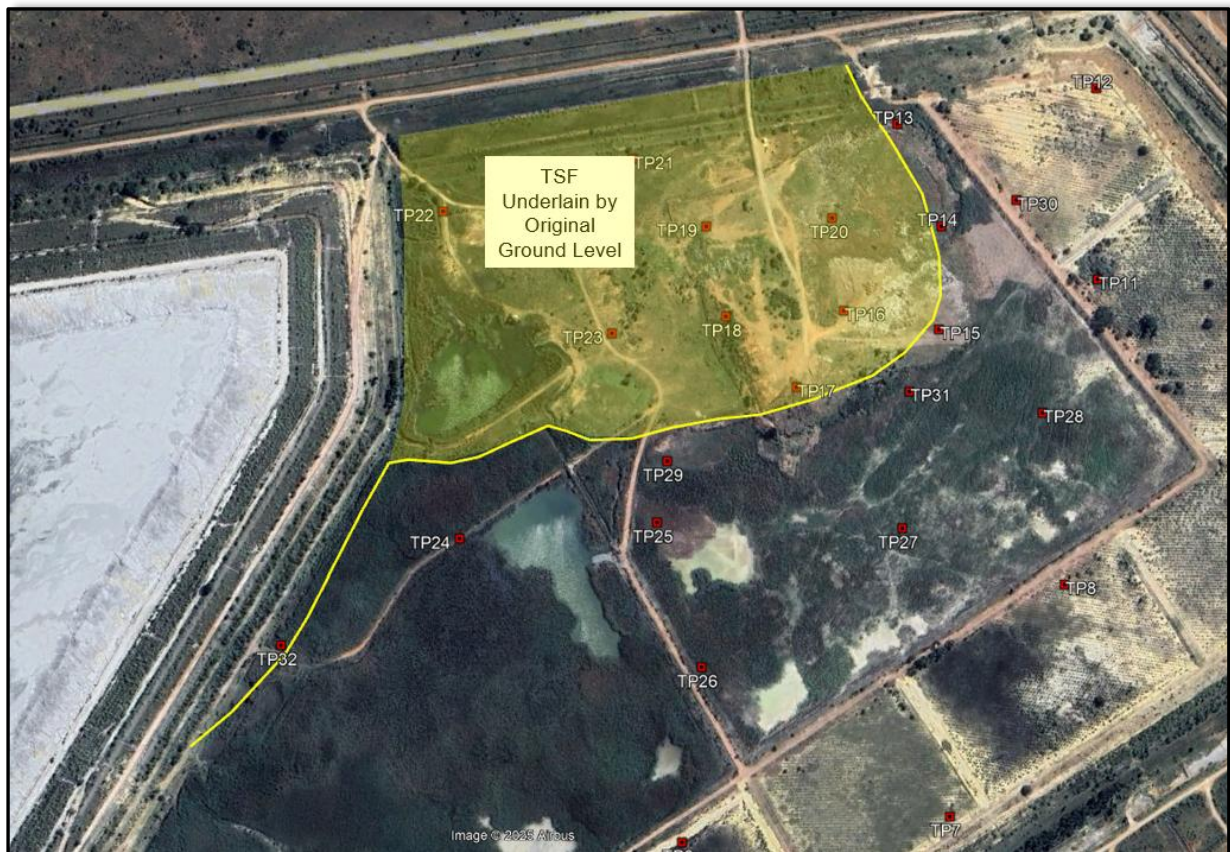
**Figure 11. TSF Area Underlain by Original Ground Level**

This boundary delineates where no tailings deposition has occurred. The test pits excavated within the area indicates the following:

- Shale bedrock occurred at shallow depths in the area of TP21 to TP23 and is described as highly weathered soft rock.
- The same conditions were prevalent at TP32, next to the embankment of the upper compartment. It is assumed that shallow bedrock occurs along the toe of the embankment from the north, west of TP22, and continues past TP32 to some extent. It is not clear where the toe of the upper embankment is underlain by tailings material towards the south.

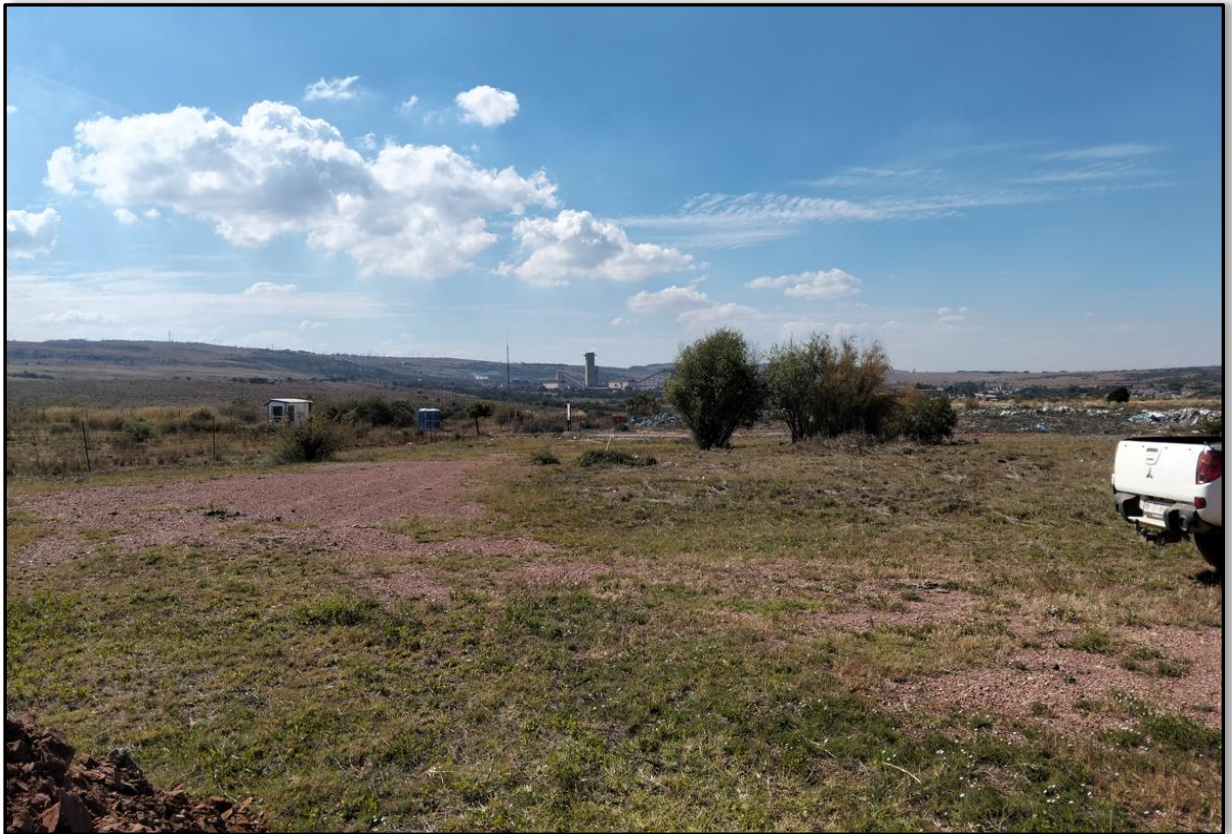
Several bedrock outcrops (plates 7 & 8) were noted in the northwestern portion of the site, between the landfill site and the area used for clean water storage. The eastern portion of the landfill hosted significantly more waste material (plate 9) as opposed to the western portion (plate 10).

Plate 10. Portion of the Solid Waste Landfill Site with minimal dumping.

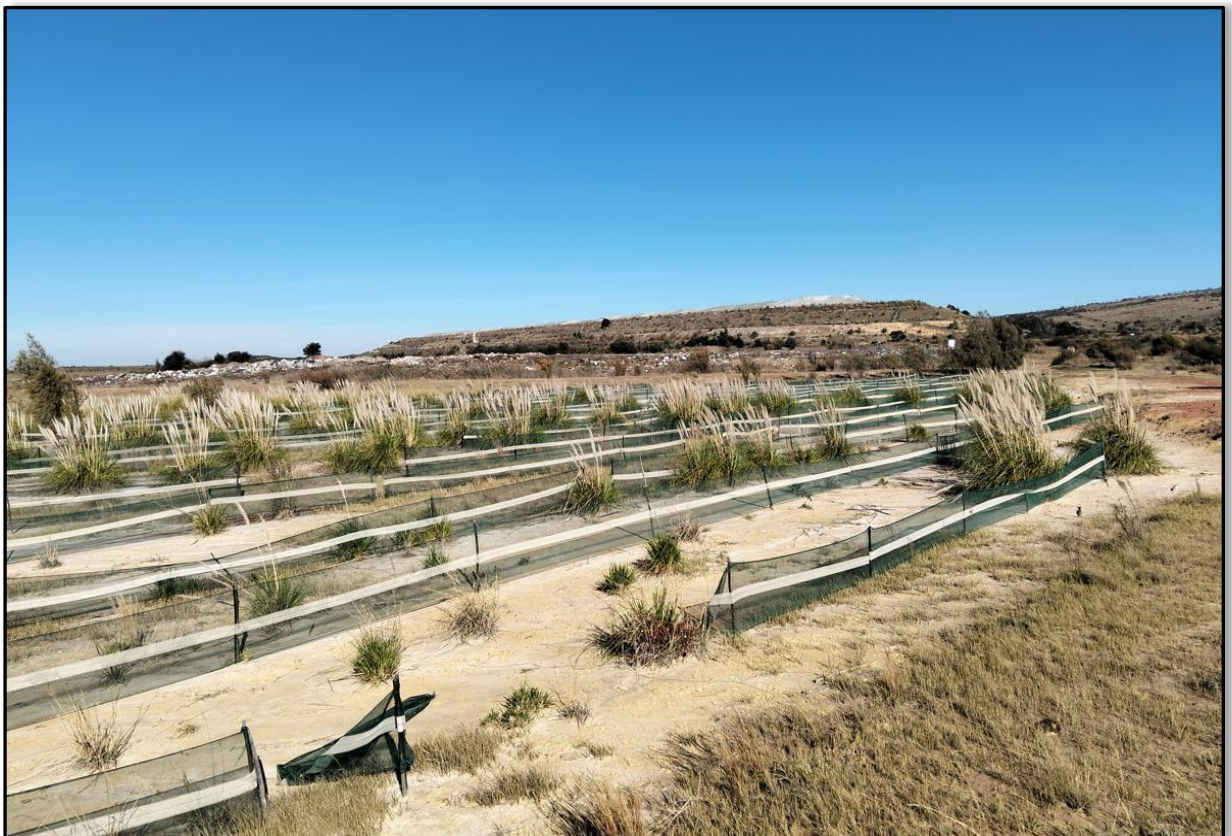
Evaporation paddocks were constructed along the site’s eastern and southern perimeters. Some of the paddocks hosted erosion control measures, which consisted of parallel rows of shade cloth and planted vegetation (plate 11), while most of the paddocks either lacked erosion control measures or have not been maintained (plates 12 & 13). The paddock embankments served as access roads across the TSF.

Plate 11. Paddocks at test pit TP12 with erosion control measures.

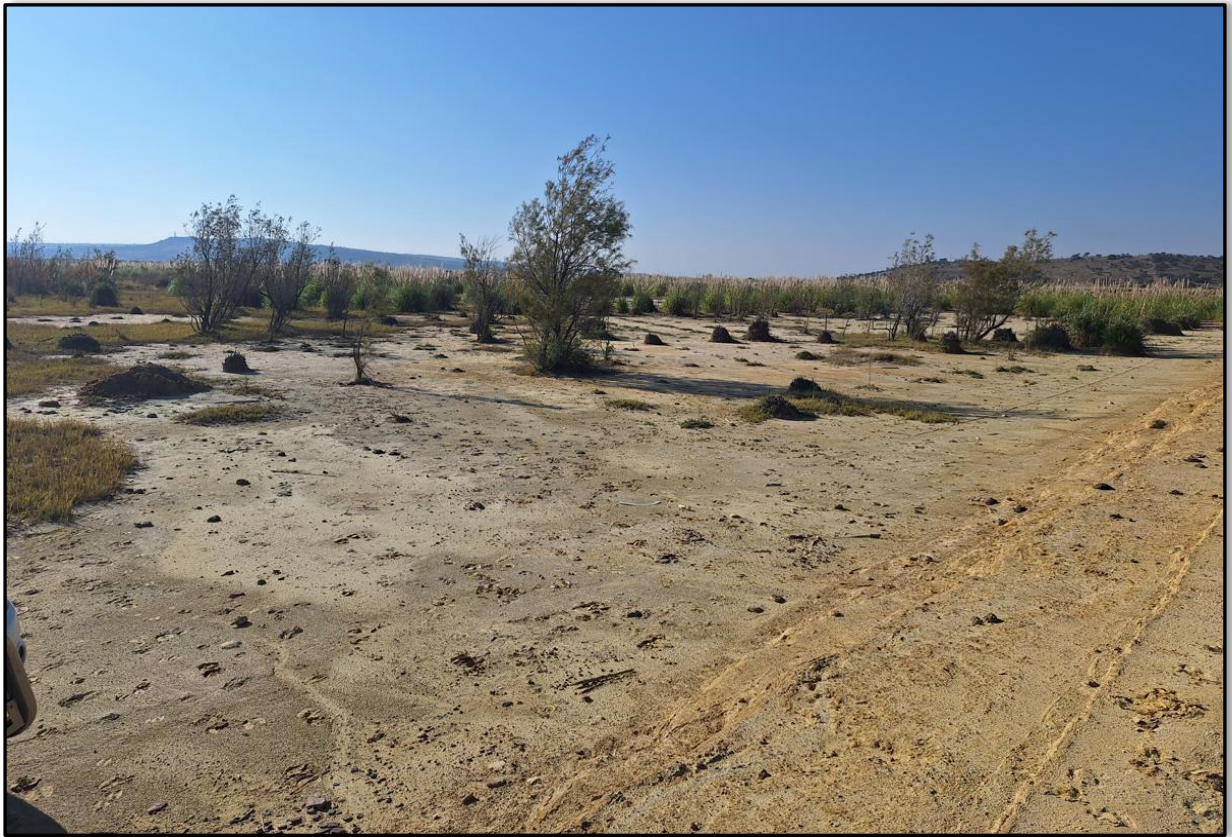
Plate 12. Paddock at test pit TP11 facing north-east.

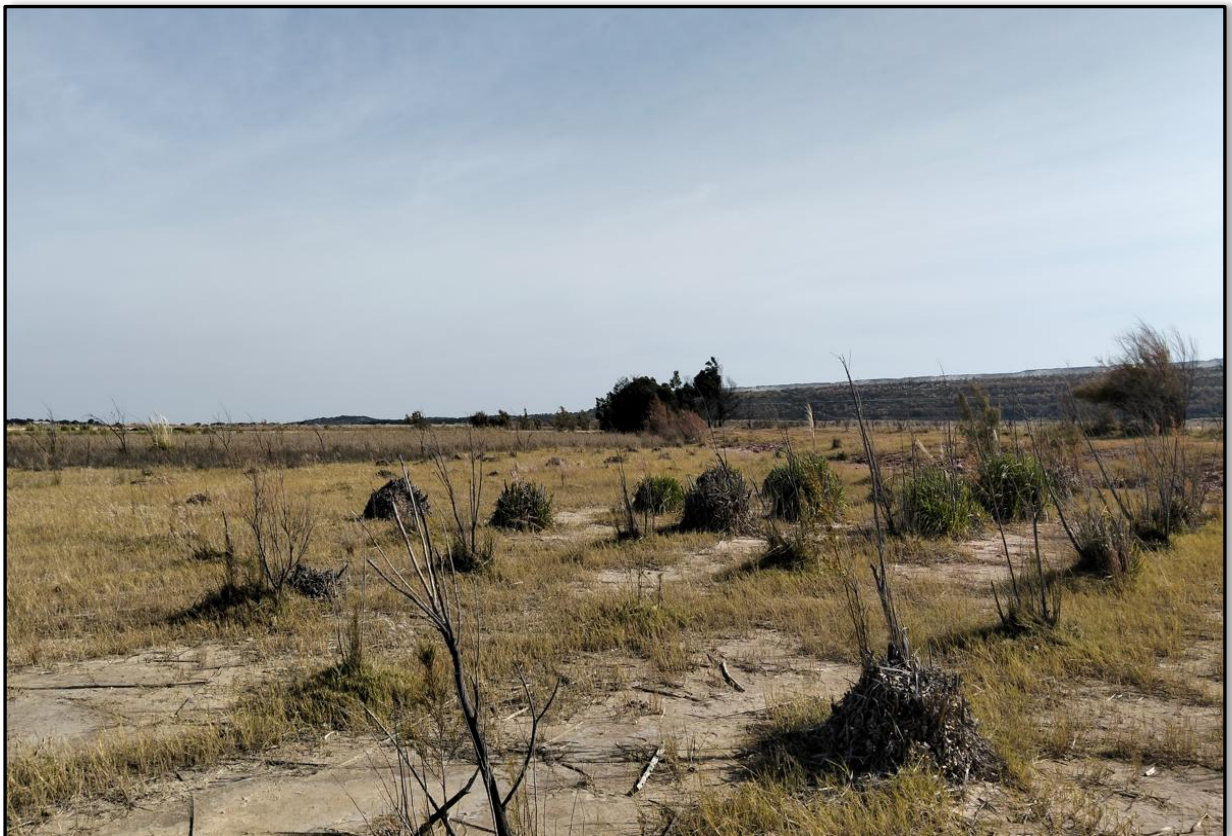
Plate 13. Paddocks at test pit TP8 facing south-west.

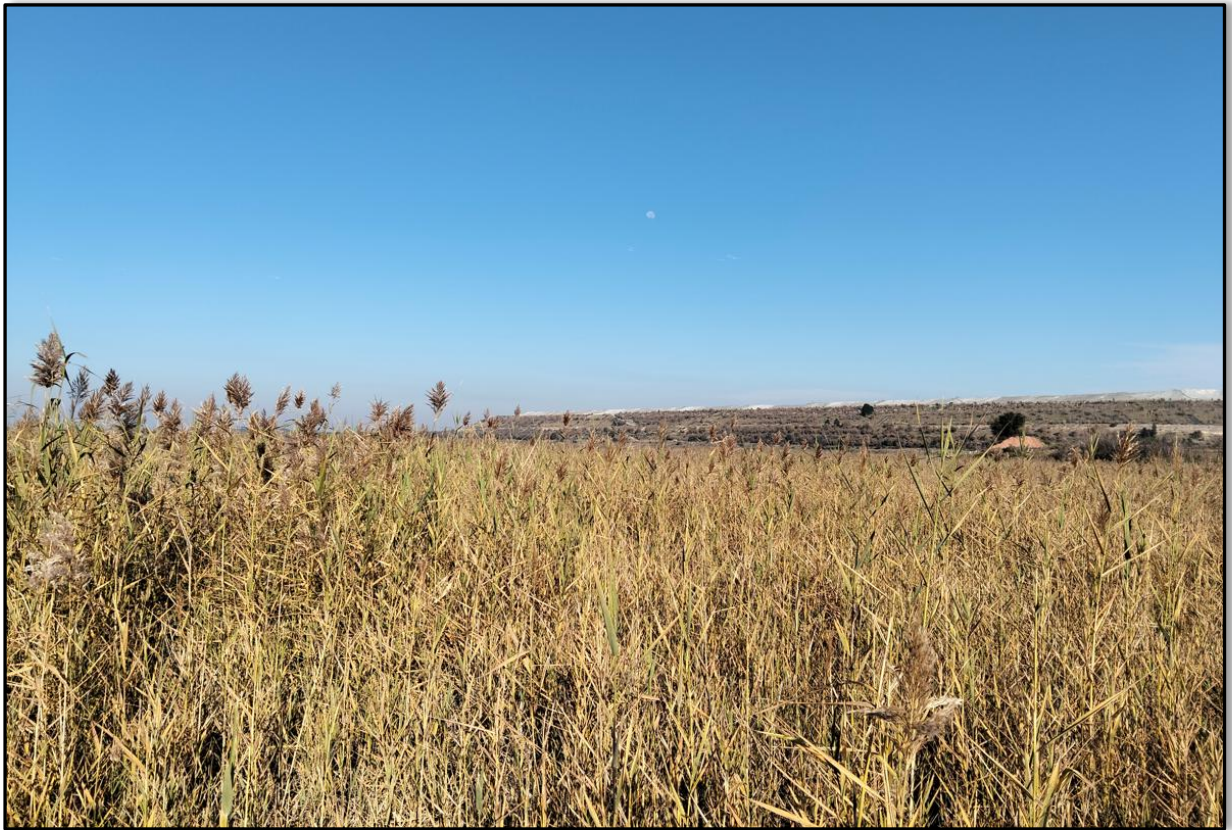
The area located south of the landfill was dry but hosted dense hydrophilic vegetation (plates 14 & 15), whilst wet and marshy conditions were encountered directly east of the dirty water dam (plate 16 & 17). The dirty water dam was mostly covered with reeds (plate 18), and water was only visible in localised areas (plate 19).

Plate 14. Hydrophilic vegetation across the central portions of site as viewed from test pit TP27.

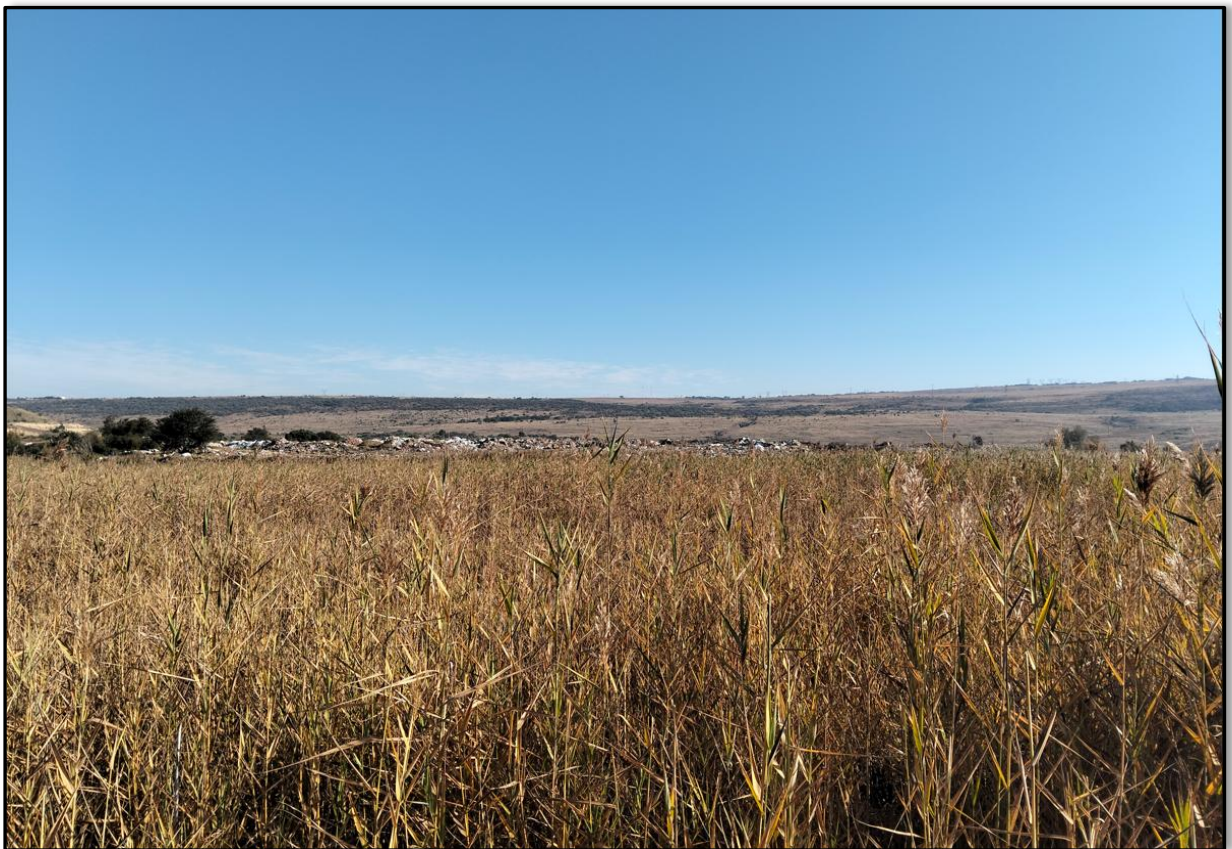
Plate 15. View from test pit TP28 facing north-west.

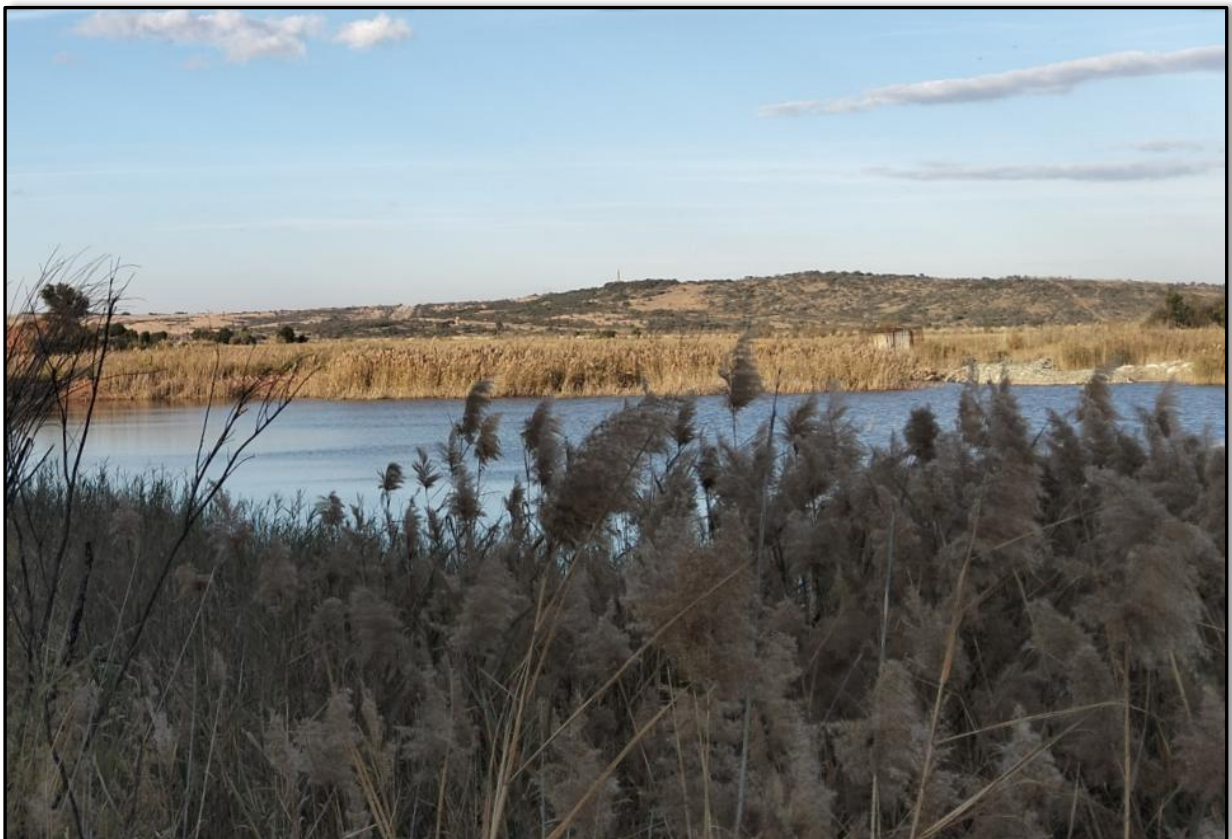
Plate 19. View of dirty water dam from test pit TP24 facing east.

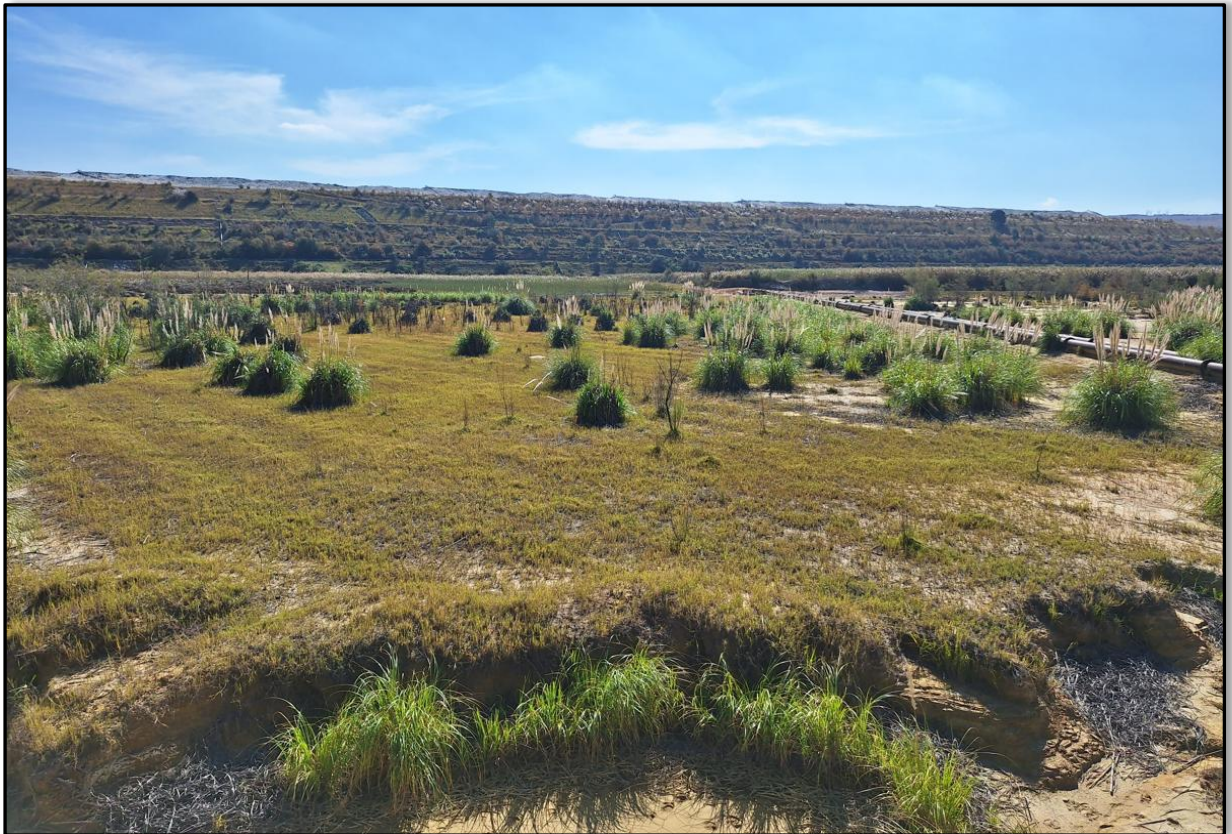
Several pipelines are present and were located both within the evaporation paddocks and along the paddock berms (plates 20 & 21). The far south-western portion of the site hosted some stagnant water (plate 22), and the area was covered with stockpiles of silt material (plate 23) that has been extracted from the return water dam as part of its desilting process.

Plate 20. Paddock with existing pipe leading from the upper compartment.

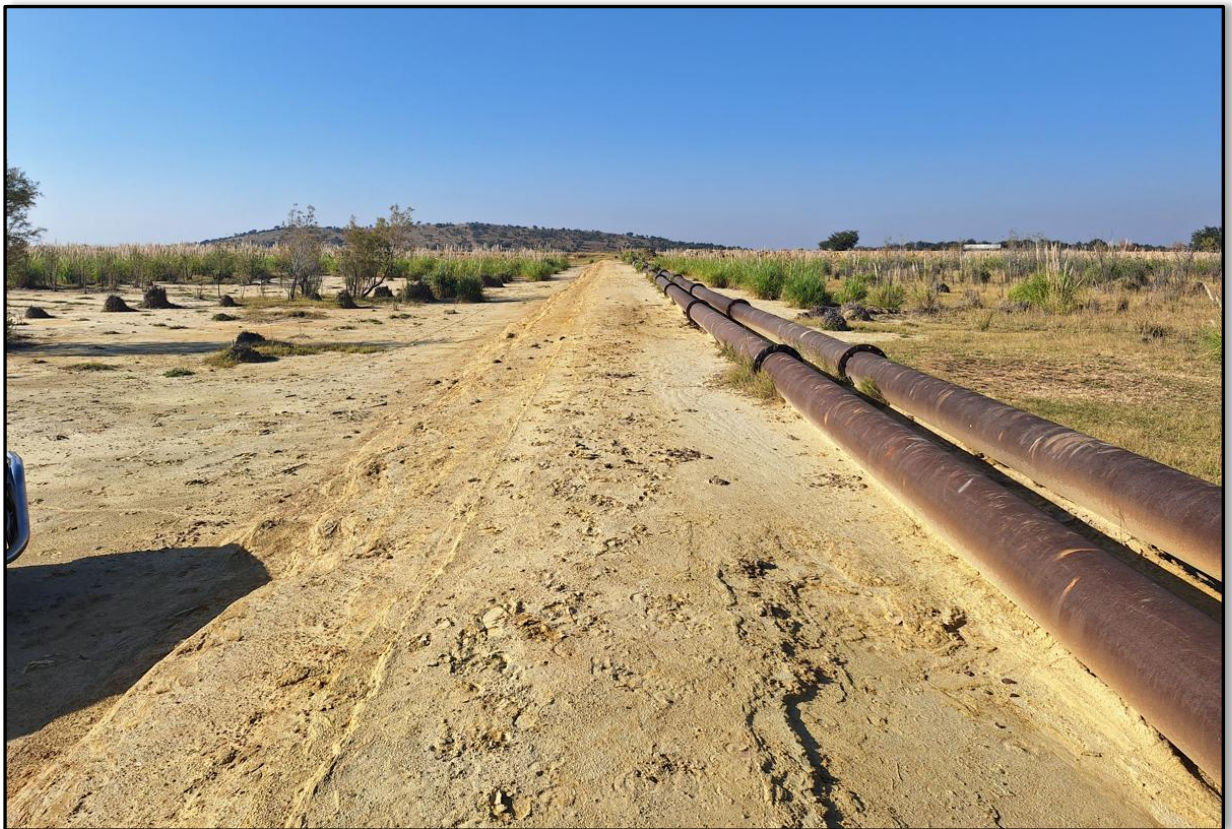
Plate 21. Example of berms constructed between the paddocks serving as access roads.

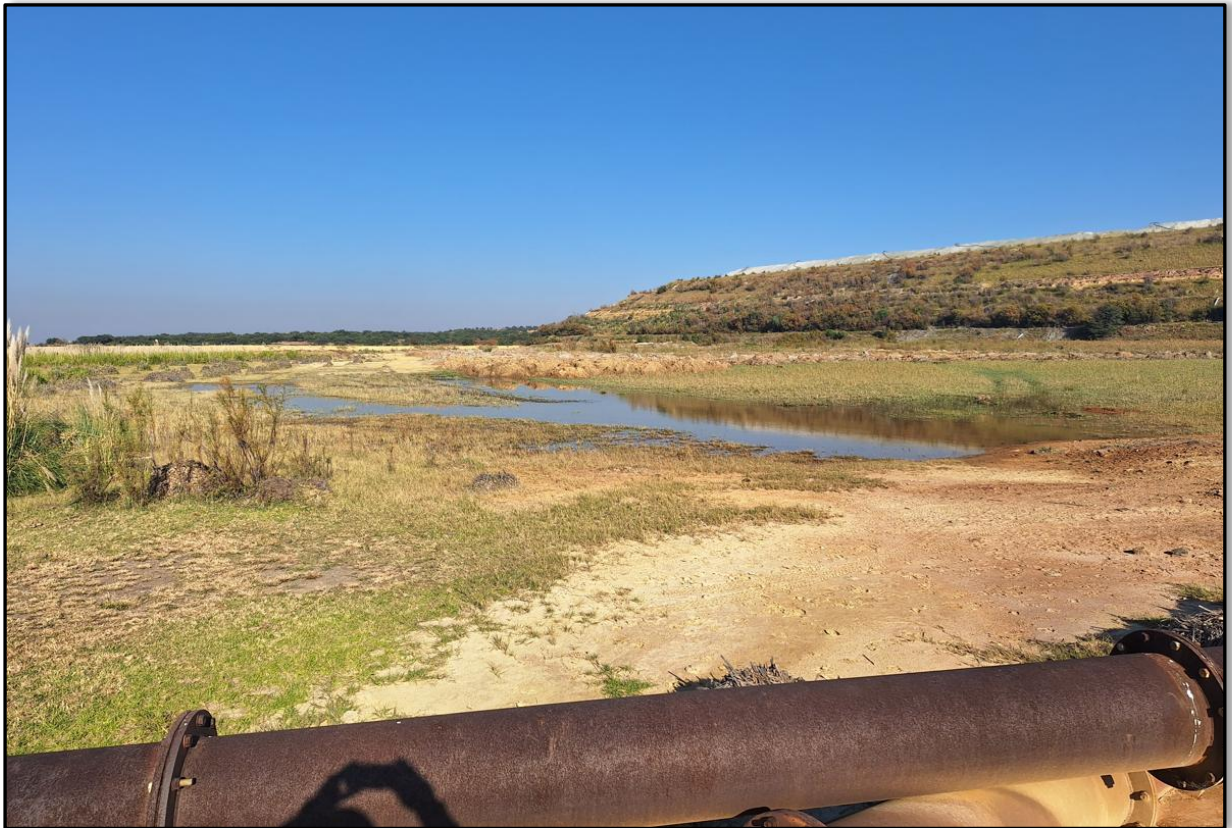
Plate 22. View of the south-western portion of the site near test pit TP4 in a southern direction.

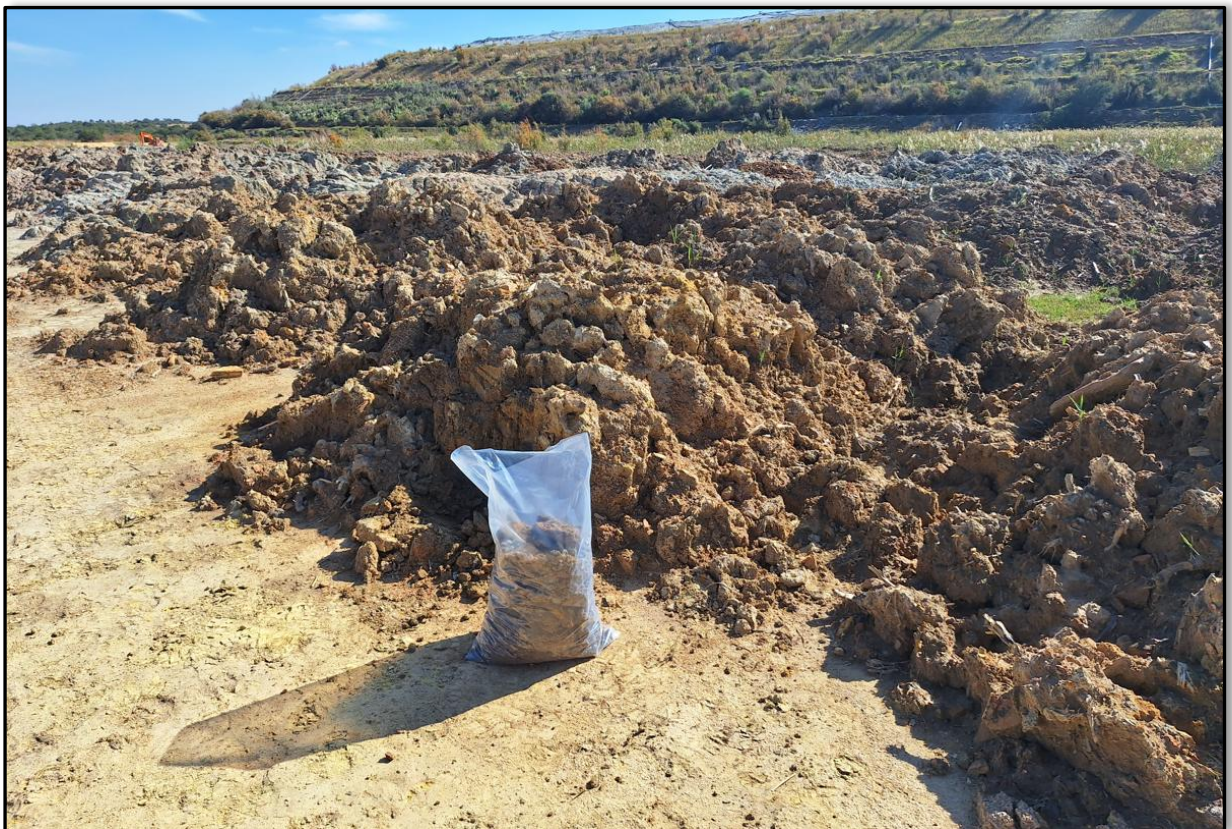
Plate 23. Sampling of soil stockpiled across the south-western portion of the site between TP1 and TP3.

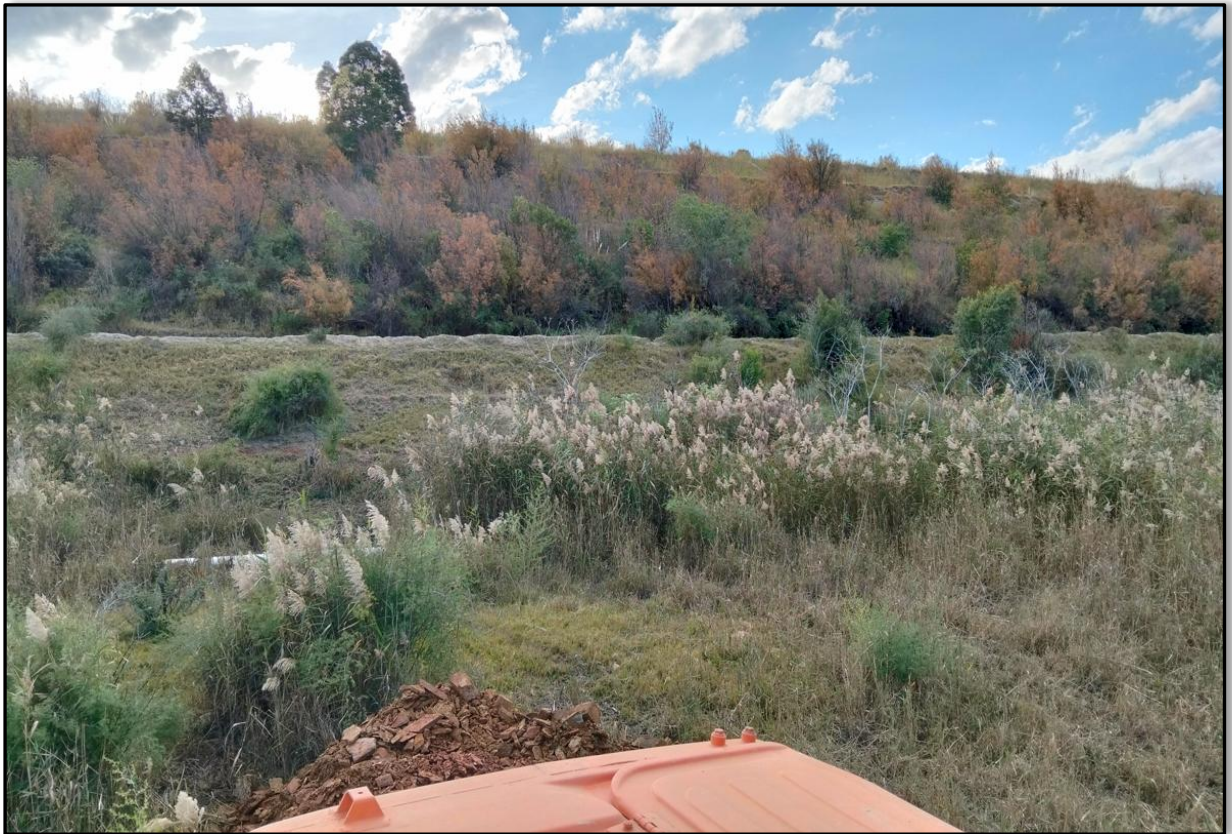
The flora covering the site comprises mostly grass and hydrophilic vegetation. The vegetation along the embankments consists of grasses, shrubs and occasional trees (plates 24, 26 & 27).

Plate 24. State of upper compartment embankment as viewed from test pit TP32.

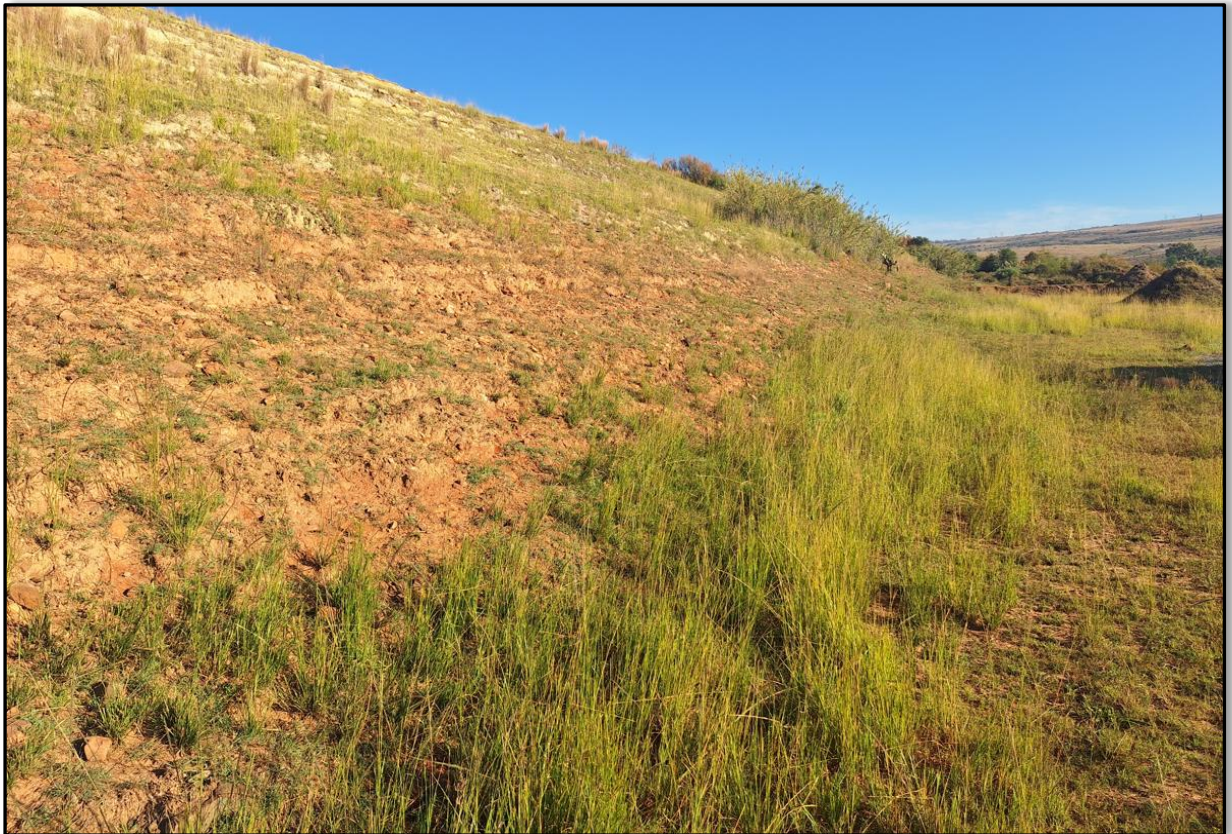
The area between the clean and dirty water dams was also saturated and covered with grass and hydrophilic vegetation (plate 24 & 25). An inspection was conducted along the south-eastern embankment of the lower compartment to determine the extent of the starter wall, viewed in plates 26 to 28. This will be described in detailed in the results. Abundant seepage was noted at the toe of the starter wall at the south-eastern corner (Plate 29).

Plate 26. View of the starter wall along the eastern embankment.

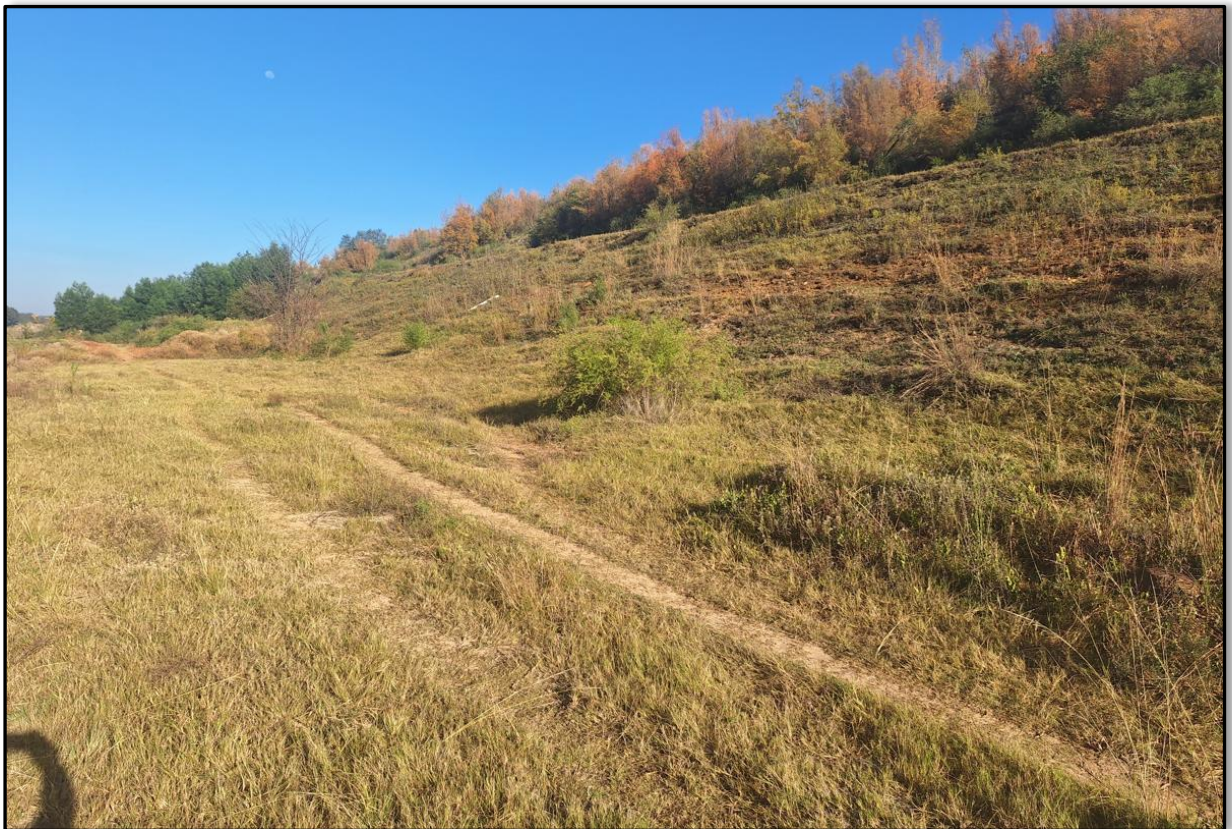
Plate 27. View of the starter wall along the southern embankment.

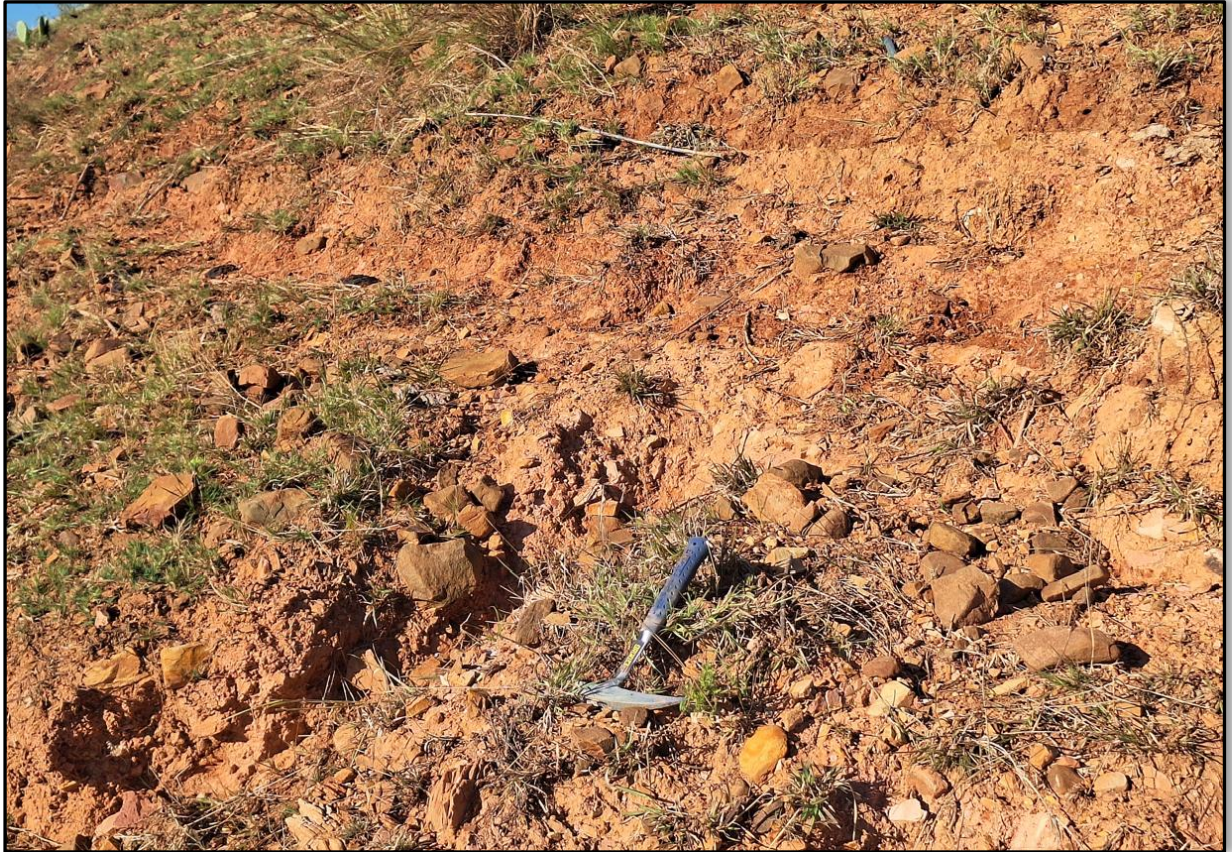
Plate 28. Typical composition of material used to construct the starter wall.

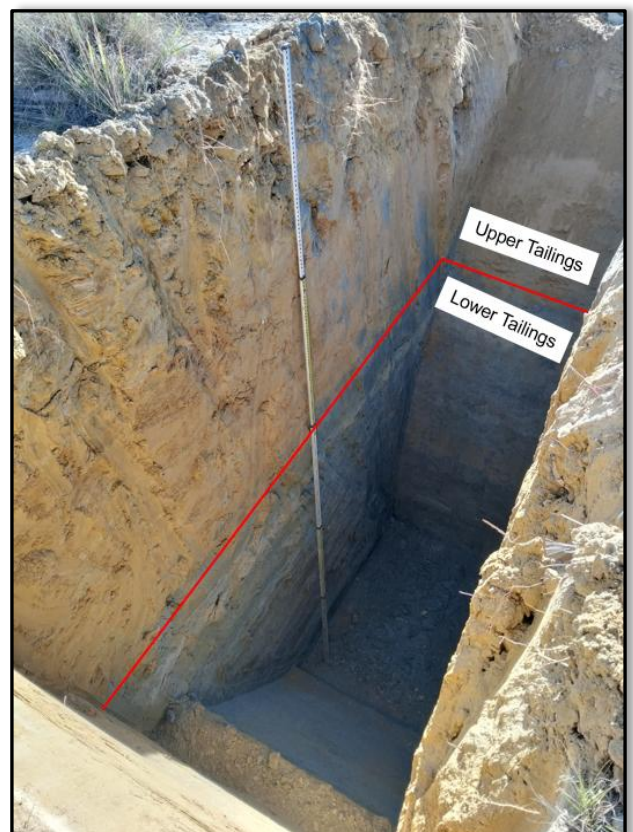
Plate 37. Test pit sidewall at TP10.

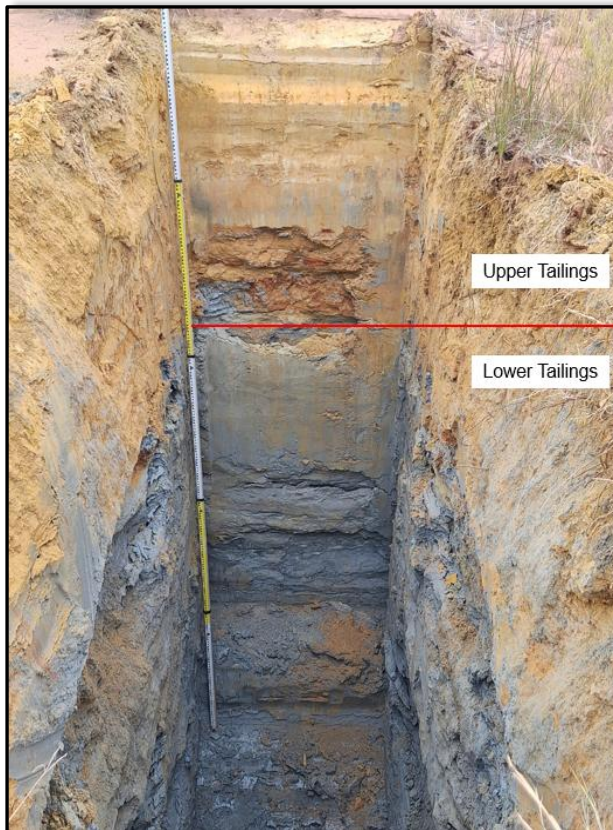
Plate 38. Test pit sidewall at TP11.

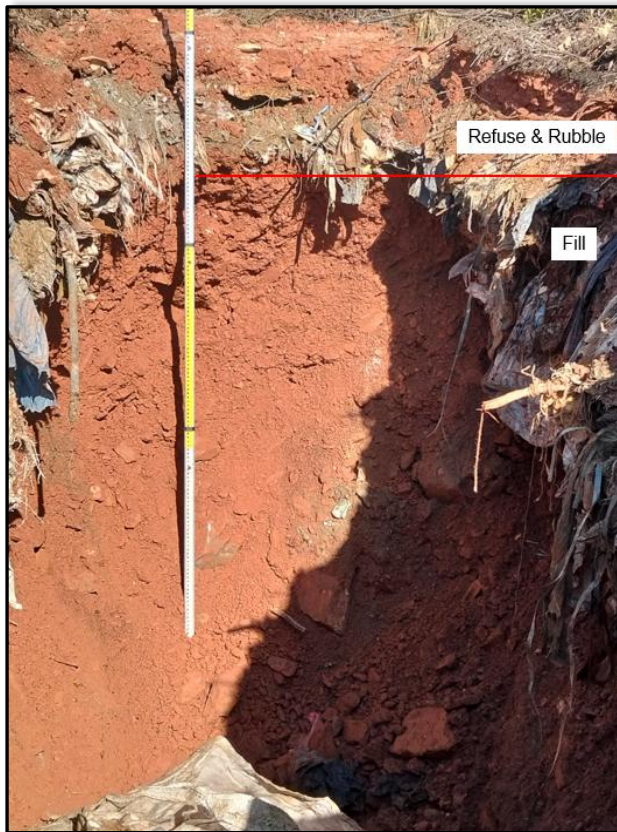
Plate 42. Test pit sidewall at TP17.

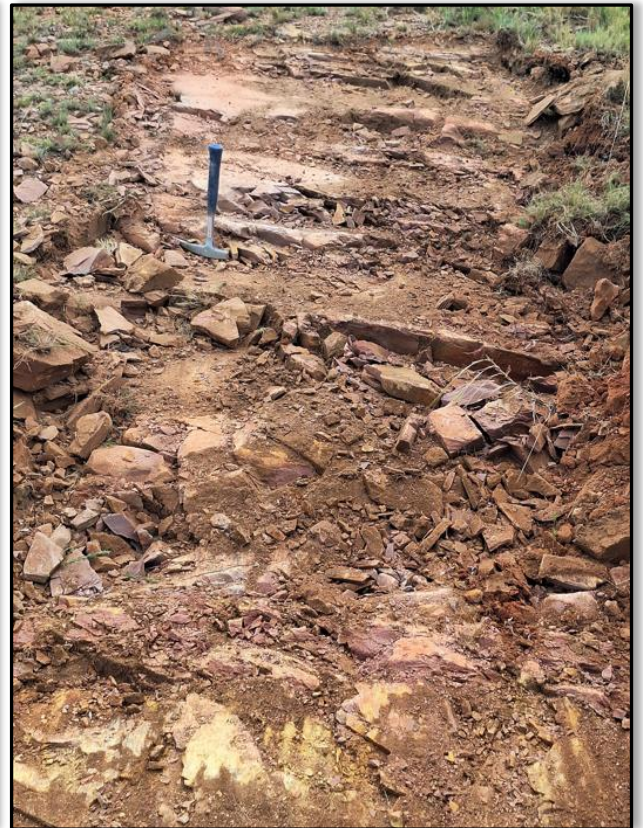
Plate 47. Excavation on bedrock at TP23.

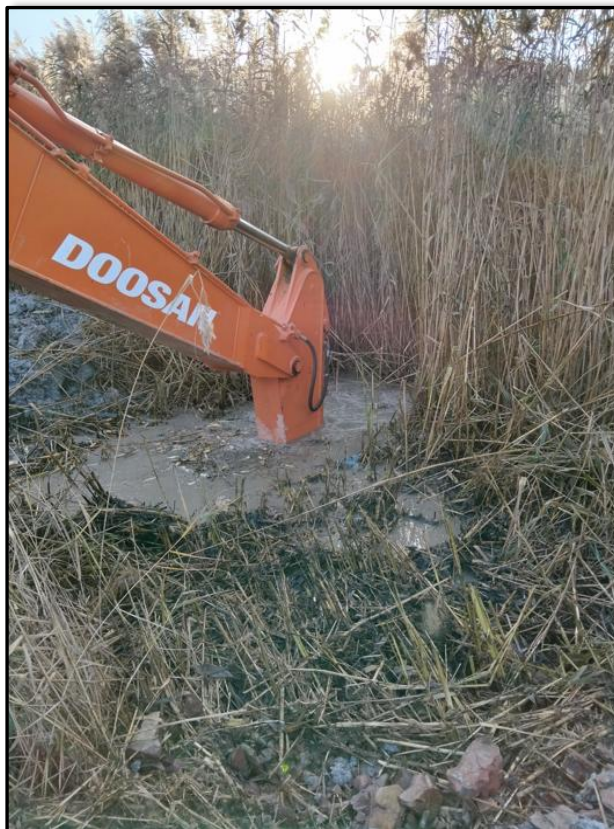
Plate 48. Saturated test pit at TP24.

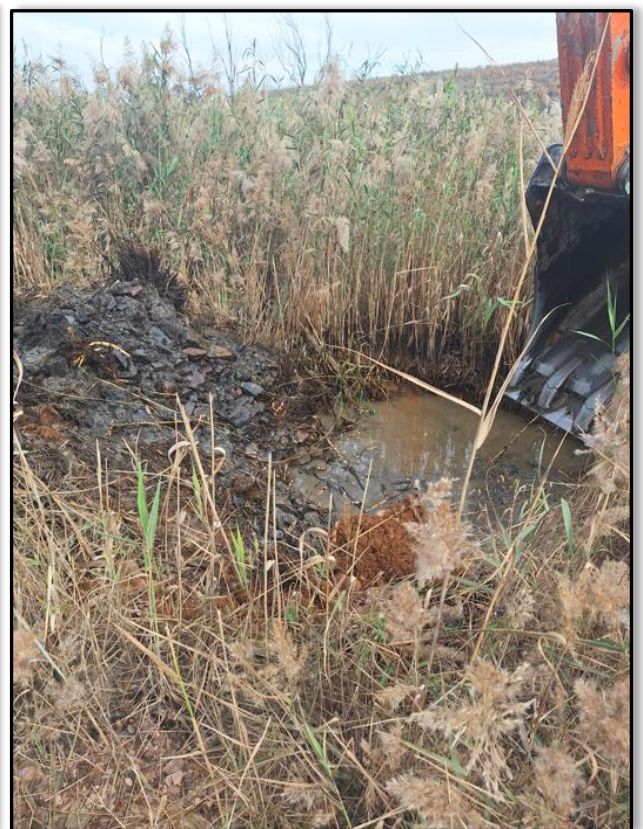
Plate 49. Saturated test pit at TP25.

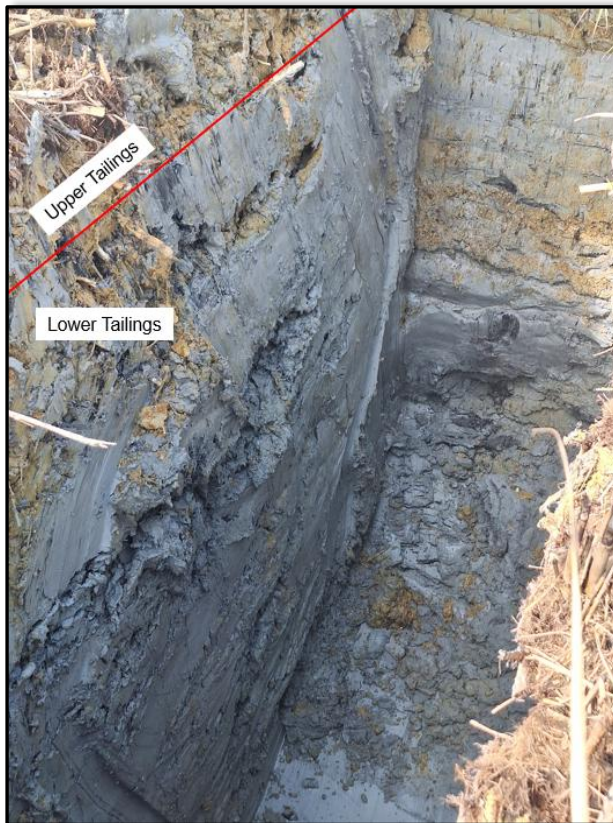
Test pits TP1 and TP26 were excavated next to a paddock embankments and the excavation could reach depths of between 3.8 m and 4.5 m respectively. Both areas are covered by the oxidised tailings and underlain by fresh tailings with depth. At these two test pits the fresh tailings was very moist to wet and comprised a very soft consistency, where the excavations sidewalls continuously collapsed.

Plate 50. Test pit sidewall at TP26.
